A HUFF, AND A PUFF, AND... IT BLEW THE CHIMNEY DOWN

This paper will present case studies and assessment of collapses of tall, free standing residential masonry chimneys resulting from windstorms in North Texas. The case studies will outline the assessment of the causes of the collapses and a discussion of design and/or construction defects.

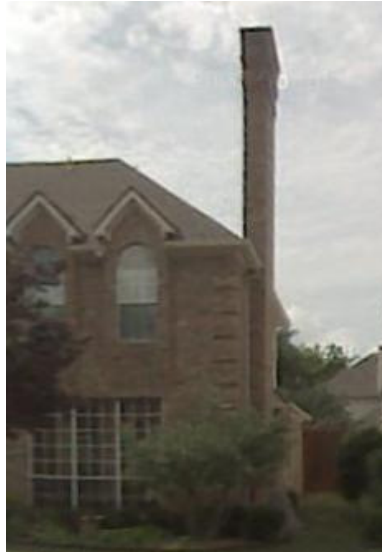
The subject chimney was constructed of brick masonry. Based on pre-storm photographs, the overall height of the masonry chimney was estimated to be over 35 feet above grade with an extension of approximately 12 to 15 feet above the eave. The chimney was measured to be 6 feet wide by 1 foot 8 inches in depth at the base; however, the top portion of the chimney was corbelled for aesthetic appeal and was

wider than the supporting base. This effectively created a large elevated mass at the top of the chimney and resulted in a top-heavy condition.

Figure 1. Pre-storm Chimney at Case Study A (Google Maps Street View)

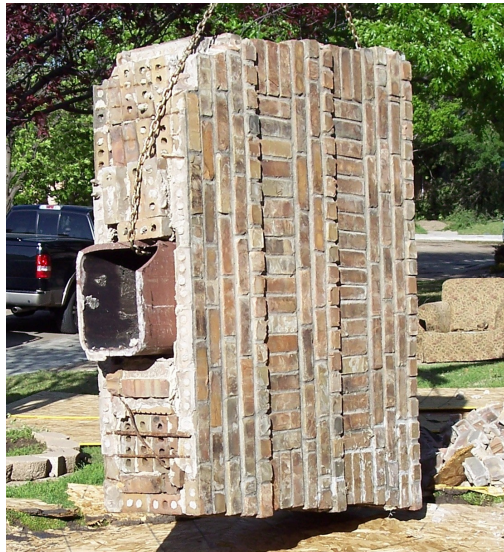
The addition of the solid masonry core at the top of the chimney contributed to the overturning moment and subsequent collapse of the chimney. The top portion of the chimney is visible in Figures 2 and in the left side of Figure 3 below. The bottom section of the masonry chimney was erected such that hollow cavities existed on each side of the flue. These hollow cavities terminated approximately 4 feet from the top where the solid masonry core began as shown in Figure 2.

Figure 2. Solid Masonry Core Formerly at Top of Chimney

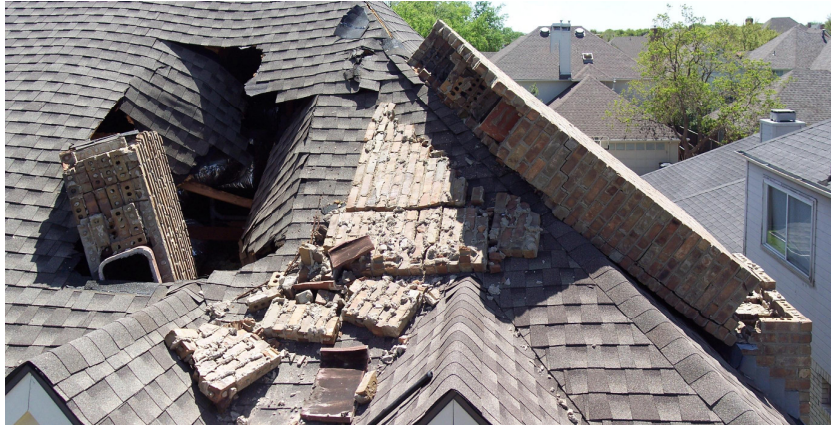
Due to the lateral forces imparted on the chimney by high winds, (but still less than the required 90 mph design wind speeds), the cantilevered portion of the masonry chimney failed, falling into and causing significant damage to the structure below.

Figure 3 below shows the collapsed masonry chimney as well as the detached top portion of masonry that punctured through the roof deck and framing. The second floor ceiling and wall framing stopped the detached section of masonry from crashing into the bedroom below where two young girls were sleeping at the time of the chimney collapse.

Figure 3. Collapsed Section of Chimney Above Children's Bedroom

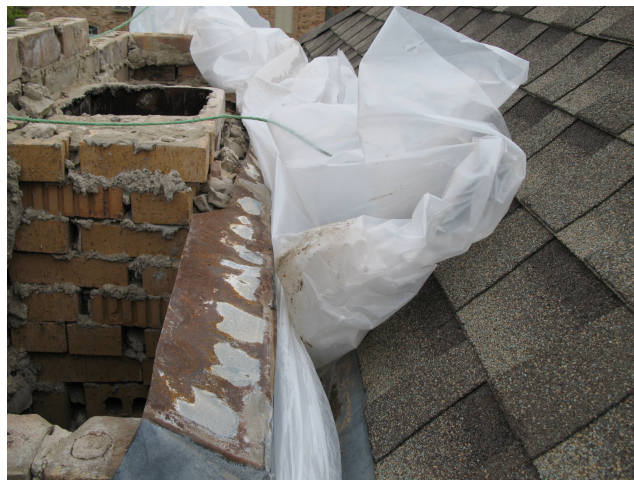
- Continuous vertical reinforcement had not been installed within the masonry.
- A roof cricket had not been installed at the upslope side of the chimney.
- Metal flashing had been installed in place of the cricket and penetrated through the full width of the mortar bed (Figure 4). The full penetration of flashing effectively broke the masonry bond, creating a weak joint in the chimney construction.

Figure 4. Full Penetration of Metal Flashing

The lack of continuous vertical reinforcement effectively limited the tensile forces that the chimney could resist. In this case, the addition of a top-heavy masonry “missile” aided in the chimney collapse. Wind forces laterally displaced the chimney, creating an eccentric loading condition from the solid masonry top section and a subsequent moment that exceeded the tensile strength of the as-built masonry construction. The chimney collapsed at the base of the cantilevered section and into the structure. Fortunately, the roof framing absorbed enough of the chimney’s kinetic energy for the second floor ceiling and wall framing to stop the masonry “missile’s” further descent into the structure; otherwise, the two young girls sleeping in the bedroom below may have been severely injured or even killed.

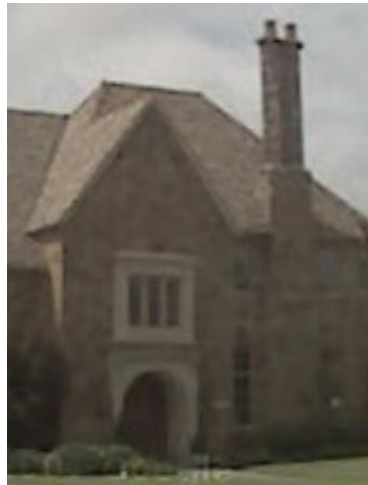
Figure 5. Pre-storm Chimney at Case Study B (Google Maps Street View)

The design and construction for the structure was based on the 1997 UBC with a seismic zone classification of 0 and a 70 mph design wind speed. The chimney was constructed of generally un-mortared, rubble-type construction and was clad with a fieldstone and brick veneer. The height of the chimney was approximately 40 feet above grade; almost half of which stood laterally unsupported above the roof line. This can be seen in Figure 5 above. The shape of the chimney was unusual and transitioned above the roof line from a single rectangle to a pair of parallel rotated squares. The shape transition required the flue to not only offset, but to rotate 45 degrees as well. Information provided indicates that the driving force for the unusual shape and height of the chimney was purely architectural in nature.

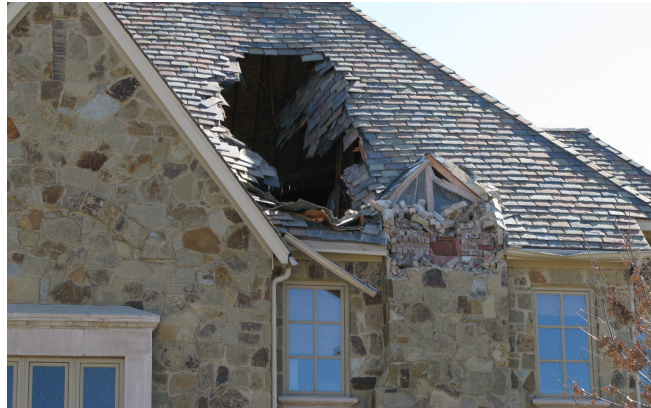
Failure of the chimney occurred at the roof line, allowing for the full cantilevered portion to overturn and fall into the structure below as seen in Figure 6. The collapsed chimney fell through the second floor bedroom and into the first floor

dining room. Review of the construction documents indicated specific portions of the structure were required to be designed by a structural engineer; however, the design of the chimney was not included in the structural requirements. Additionally, the post-tensioned foundation did not account for the additional weight imparted by the solid core masonry chimney at that location and did not account for the lateral wind loads acting to overturn the chimney.

Figure 6. View of Collapsed Chimney

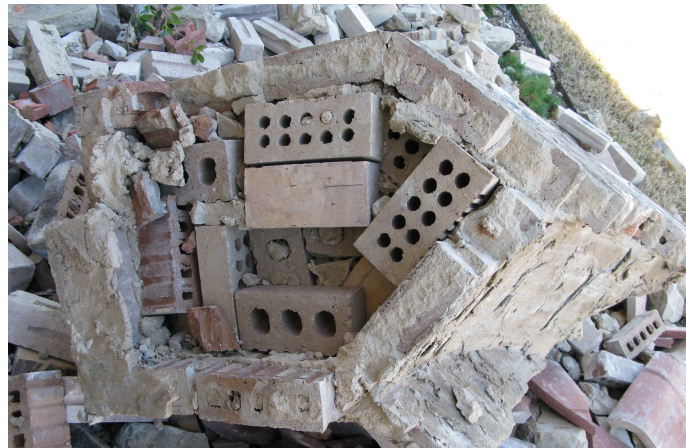
Further investigation of the post-collapse debris revealed that no vertical or horizontal reinforcement had been installed. Additionally, the brick masonry core had been poorly constructed and did not have proper continuous mortar bedding for the bricks. Much of the brick within the masonry core appeared to have been laid loosely with no structure or organization as seen in Figure 7 below. No interlock was observed between the brick core and veneer, allowing for subsequent delamination from the core during collapse. Debris, including aluminum cans, was observed within the rubble of the collapsed chimney.

Figure 7. Lack of Mortar and Interlock at Masonry Core

In addition to the lack of continuous vertical reinforcement, the narrowing of the chimney section and transition from a rectangular section to two separate rotated square-shaped flues aided in the chimney's inability to resist lateral forces. As stated
