Balcony View

Bart B. Barrett, P.E., M. ASCE¹

Abstract

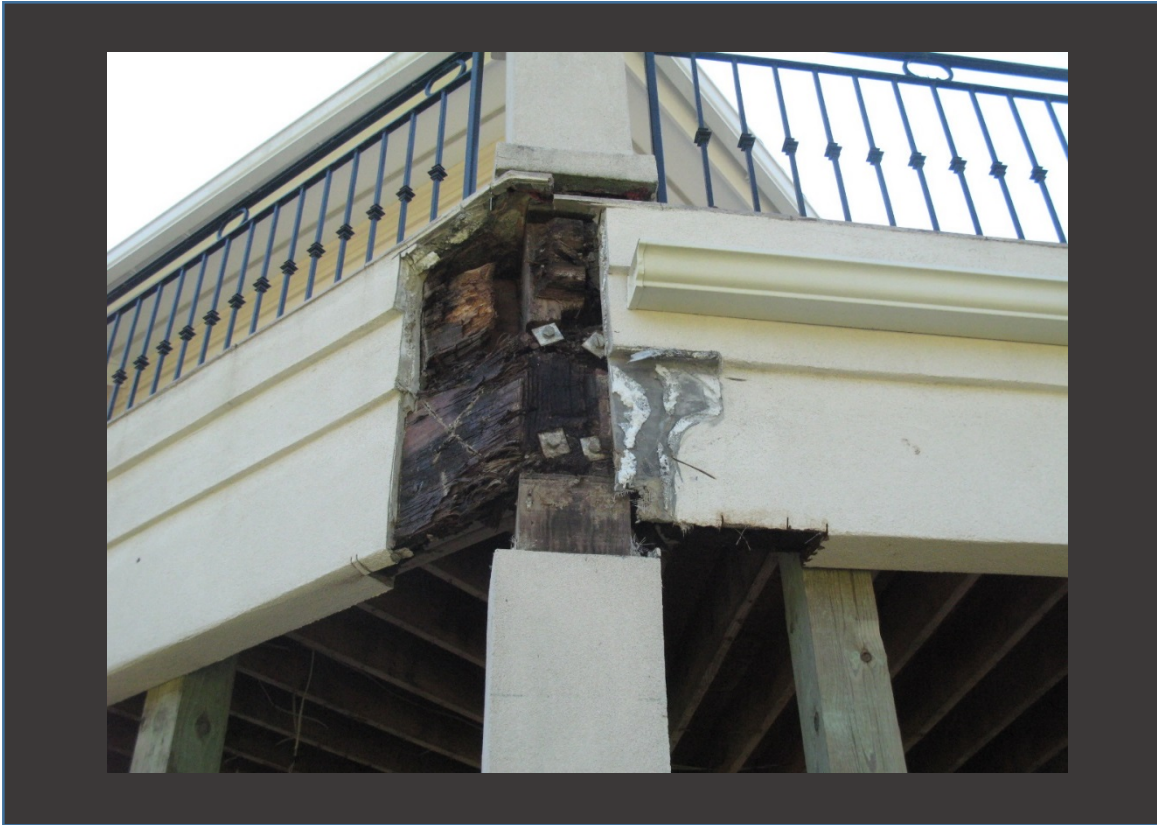
Case Study #1: A single-family residential structure in a North Carolinian coastal city experienced damage to aesthetic features along the perimeter of the balcony. A tiled walking surface, a synthetic stucco cornice and veneer and a gypsum soffit enclosed the structural system of the balcony. Destructive testing exposed discolored and deteriorated wood framing (**Figure 1**).

Figure 1: Exposed balcony assembly

A review of the exposed wood framing indicated that the LVL beams were not wrapped with a water-resistive barrier. Further examination indicated that the waterproofing membrane between the tile floor finishes and the balcony floor sheathing terminated inside the finishes at the perimeter of the balcony and did not overlap any other weather-resisting component. When constructed, this configuration directed water inside the finishes, which was trapped against the LVL beams and caused them to deteriorate behind the finishes. A sketch of the balcony assembly is provided in **Figure 2** below. The waterproofing members are indicated in red, and the path of moisture is indicated in blue.

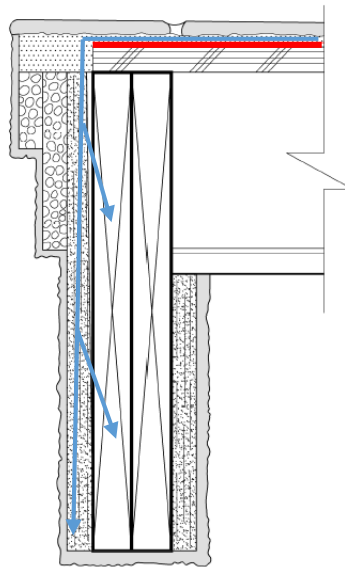
Figure 2: As-built balcony detail

In this assembly, there were no weather-resisting components that directed the water to the exterior of the veneer. In addition, there were no features that allowed entrapped water to escape the assembly.

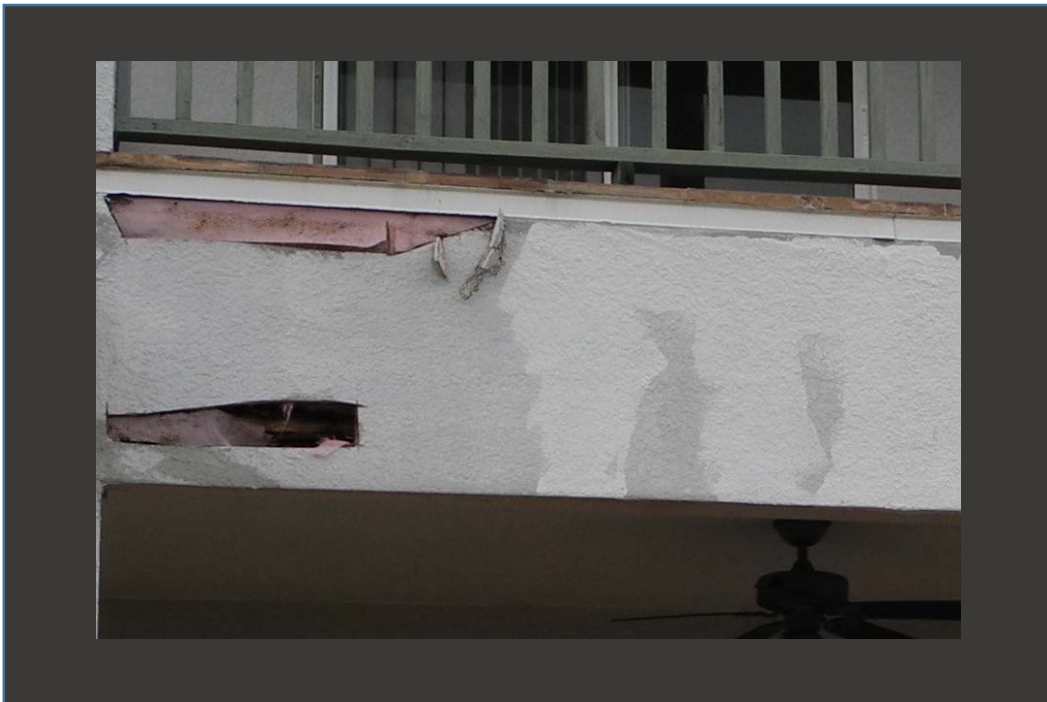
Case Study #2: The balcony of a single-family residential structure experienced excessive deflections and fractures in the stucco veneer. Partial removal of the stucco veneer revealed a beam assembly supporting the balcony that included approximately 1/2" thick exterior oriented strand board (OSB) sheathing attached to both sides of a composite beam. The composite beam contained two (2) 2x12 beams sandwiching a 3/4" thick OSB plate. A vapor barrier was wrapped down the exterior face of the beam and returned approximately 3/4" along the beam soffit. The exterior stucco veneer was continuous down the front side of the beam and wrapped around the base of the beam to the top of its interior side. A granule-coated, bituminous membrane was applied over the wood floor sheathing, and metal drip edge flashing was provided at the top of the stucco veneer along the exterior edge of the balcony (**Figure 3**).

Figure 3: Removed stucco veneer

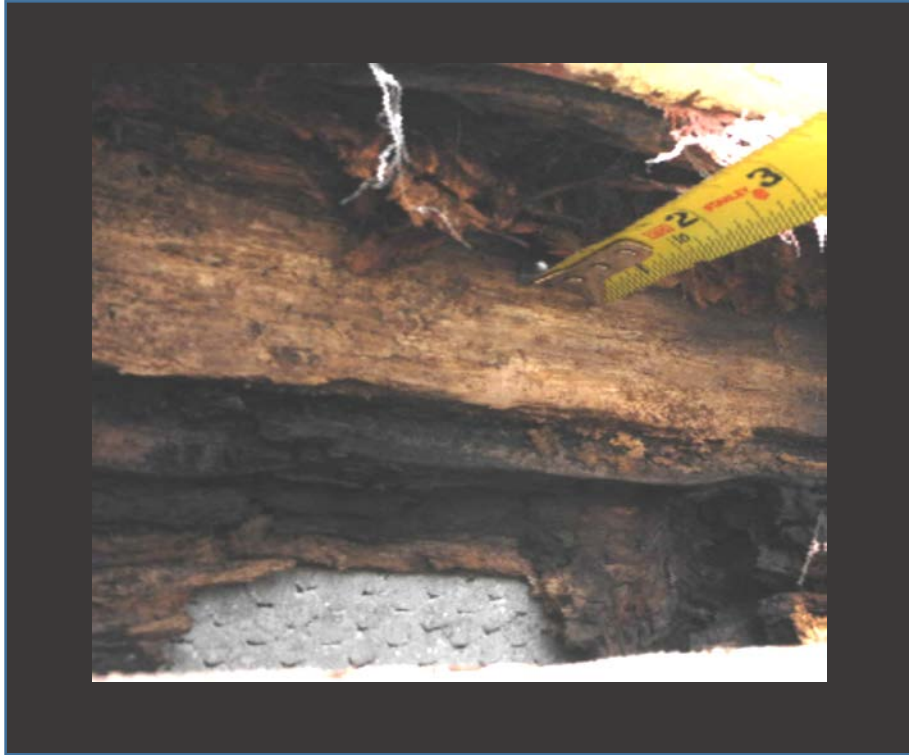
The beam was deteriorated to the extent that the stucco veneer at the opposite side of the beam was visible through the missing sections of the beam (**Figure 4**).

Figure 4: Deteriorated beam with exposed interior face of veneer

The design and construction of this structure allowed water to migrate inside the balcony assembly and access the beam. Even though the installation of a vapor barrier mitigated water intrusion from the exterior face of the beam, the beam was still not protected from entrapped water as the vapor barrier was not provided along its interior face. In addition, there was no mechanism to allow water to drain from the assembly.

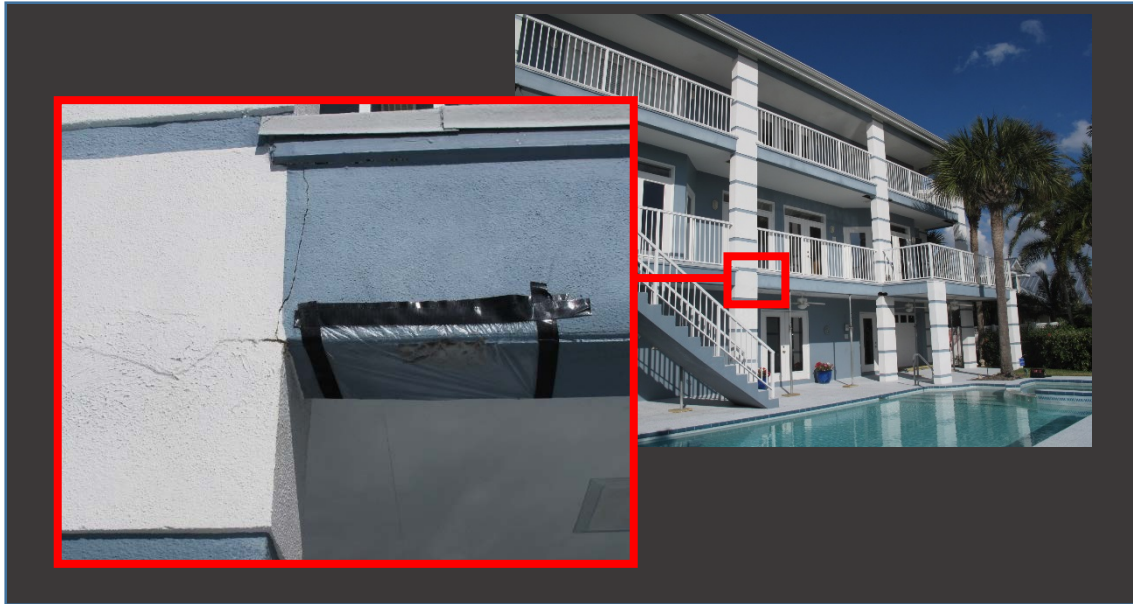
Case Study #3: A single-family residential structure in the Tampa Bay area exhibited vertical fractures around beam and column interfaces at the second and third story balconies. These veneer fractures were indicative of a possible compromise in the balcony's structural system (**Figure 5**).

Figure 5: Stucco veneer distress at balcony beam and column interface

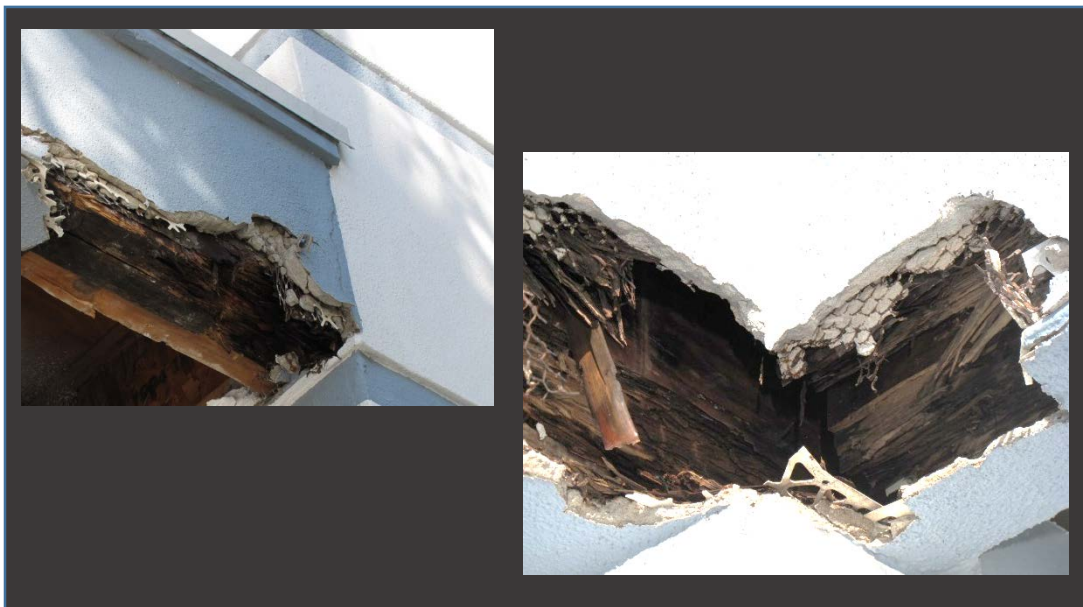
Destructive testing exposing the wood framing revealed the balcony to be constructed with wood I-joint engineered lumber, LVL beams, and concrete masonry unit (CMU) columns. A stucco veneer was applied to the exterior of the beams and columns, and a single layer of felt paper was installed between the stucco veneer and the wood framing. The building paper terminated at the base of the beams with no provision incorporated into the veneer below the beams to allow water to weep from the balcony assembly. The exposed framing exhibited extensive deterioration along the full depth of the LVL members, which were easily disturbed with pressure applied by hand (**Figure 6**).

Figure 6: Deterioration of LVL beams

A fiberglass lining extending a few inches up each of the adjoining walls and columns was installed over the floor sheathing of the balcony. Metal drip edge flashing was installed along the edge of the balconies and was terminated inside the field of the stucco. In addition, no control joints were provided in the stucco at flashing terminations, which allowed veneer fractures to develop above the flashing terminations letting water migrate inside the beam assembly. Water that entered the beam assembly became trapped against the LVL beams causing them to deteriorate to the point of imminent collapse.

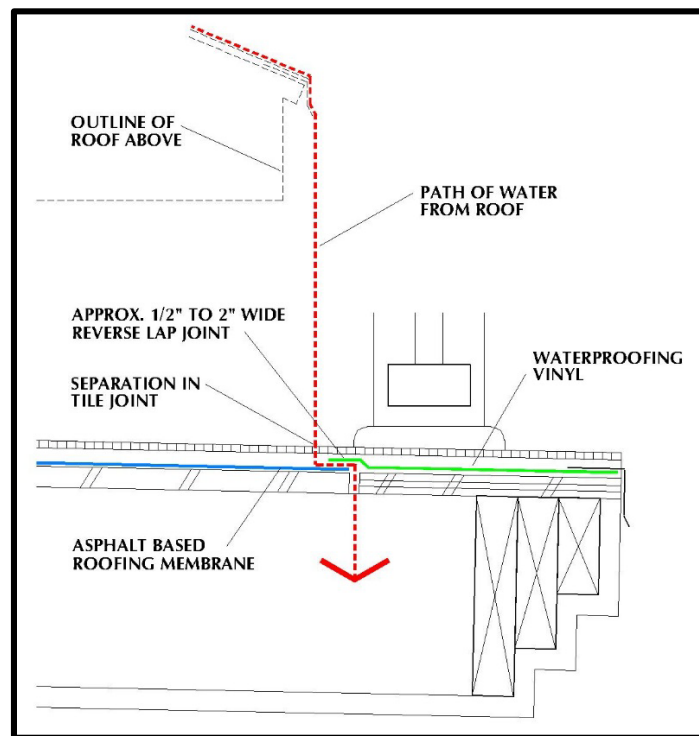
Multiple buildings in a complex of multi-family structures exhibited water damage at the soffit of the balconies. The buildings were configured to project the balcony floor beyond the roof line above. Gutting was not installed along the eave of the roof, which directed roof runoff directly toward the edge of the balcony floor.

An asphalt-based roofing membrane was installed between the tile and floor sheathing toward the interior of the balcony and a vinyl waterproofing membrane was installed along its exterior edge. The vinyl membrane was lapped over the asphalt-based membrane, which created a reverse lap in the membranes (a condition where the lower component is incorrectly lapped over the upper component). This improper lapping of the membranes directed water into the lap, below the vinyl membrane, and into the balcony assembly causing severe deterioration to the structure below (**Figure 7**).

Figure 7: Balcony configuration

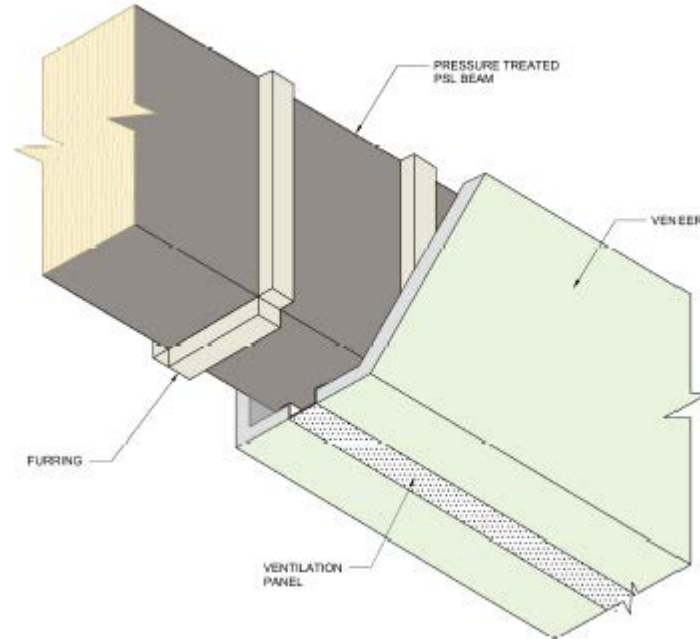
Figure 8: Recommended installation of veneer

Technical literature prepared by one LVL manufacturer explains how restrictive the environment must be by indicating that these products "**are intended only for applications that assure no exposure to weather or the elements and an environment that is free from moisture from any source**" (BC 2013, emphasis added). Another manufacturer indicates that the LVL lumber is intended for "*dry-use*" conditions. This same manufacturer provides a treated parallel strand lumber (PSL) for exterior conditions (TJ 2014). However, technical information they provide for the PSL member indicates that it should not be encased in a solid veneer because the veneer cannot provide adequate ventilation or drainage. In lieu of a direct application of a solid veneer, the manufacture recommends the use of furring strips to offset the veneer from the face of the member and the provision of ventilation panels along the base of the beam, which is illustrated in **Figure 8** below (TJ 2015).
