Case Studies of the Cause and Origin of Fungal Growth in Residential and Commercial Structures

Stewart M. Verhulst, M.S., P.E.¹
Erik L. Nelson, Ph.D., P.E., M.ASCE²
Deepak Ahuja, M.S., P.E., M.ASCE³
Halet G. Poovey, Sc.D., C.I.H.⁴

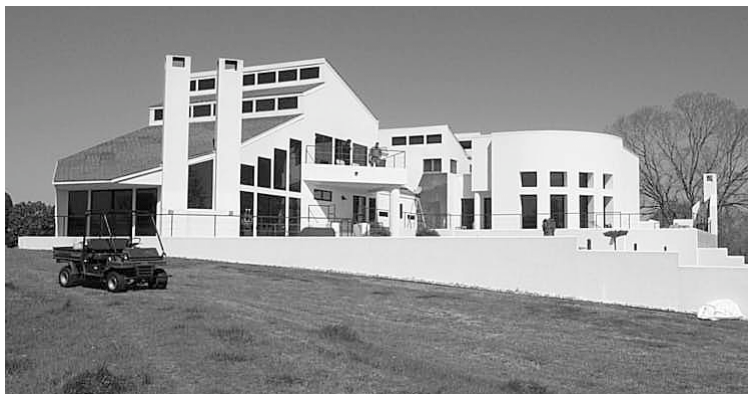
Figure 1. View of Residence.

Case Study Background: The original complaint, filed in 2001, of water damage and fungal growth at this residence was related to the homeowners suspecting leakage at the balcony overlooking the pool deck at the back yard. Figure 1 is a view at the back yard and the balcony is visible. The homeowners reported that the water was entering the exterior wall below the balcony (1st floor wall) due to leakage at the wall-to-balcony interface.

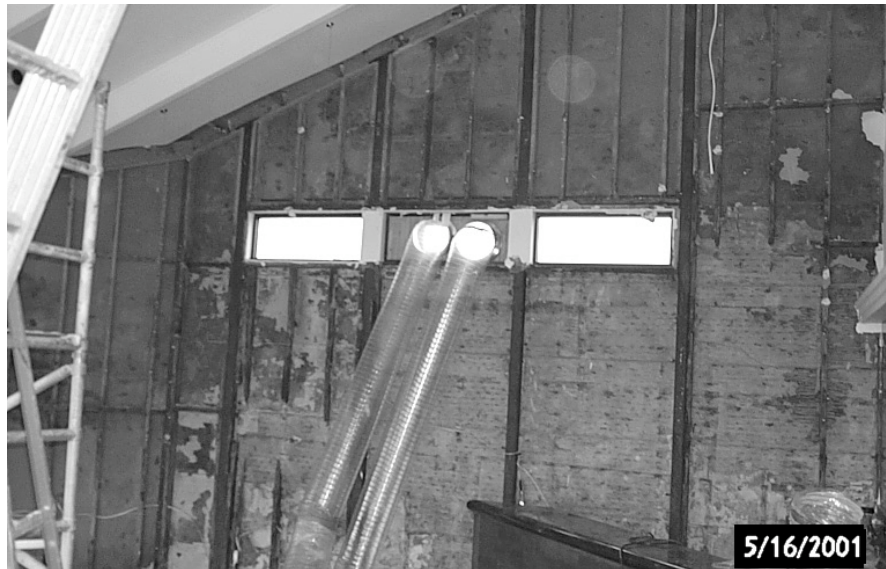
At this point, since the damage was obviously not limited to the balcony area, interior finish removal was continued at a 1st floor wall on the front side of the residence (opposite from the balcony) to help determine the extent of damages. At this wall, staining was observed throughout, especially below windows, and severe termite damage was evident. In fact, termites had completely destroyed several wood infill studs below and adjacent to the high windows. A view of the wall from the interior, with the missing infill studs, is presented in Figure 2. Note the steel framing around the wood infill.

Figure 2. Water and termite damage at interior wall.

In general, termite damage to the wood infill was widespread, affecting the structural integrity of this framing. The steel framing was slightly corroded due to the moisture intrusion, however, the steel framing appeared adequate to carry the load..

Remediation required removal and replacement of the exterior walls (with the exception of the steel framing) and some interior walls, in addition to cleaning of localized interior areas and of the contents of the home. Due to termite damage, the wood flooring was not salvageable and required replacement. Structurally, shoring would be required for the areas where the 2nd floor and the roof relied on wood framing for support (wood framing was used to transfer the load from the roof and 2nd floor to the steel framing).

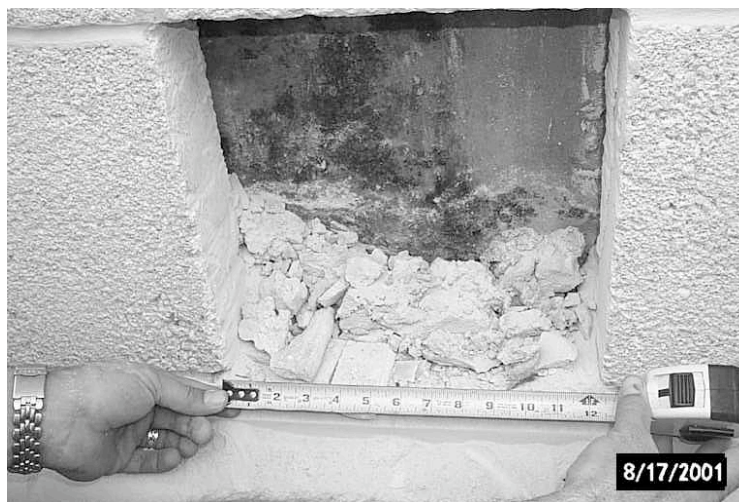
Block B2 was removed from another part of the structure perimeter. The wall cavity was blocked with mortar droppings and the gypsum board sheathing was stained. The stain locations on the sheathing were consistent with the mortar blockage. Figure 4 is a representative view of mortar droppings at the wall cavity.

Figure 4. Typical mortar droppings at removed block B2.

A simple field water test was conducted at the area around test block B2. With the block in place, water was sprayed at the roof and allowed to shed down the exterior veneer. After 5 minutes of testing, the test block was removed and water staining was observed around the test block. Water drops were forming on a visible wall tie.

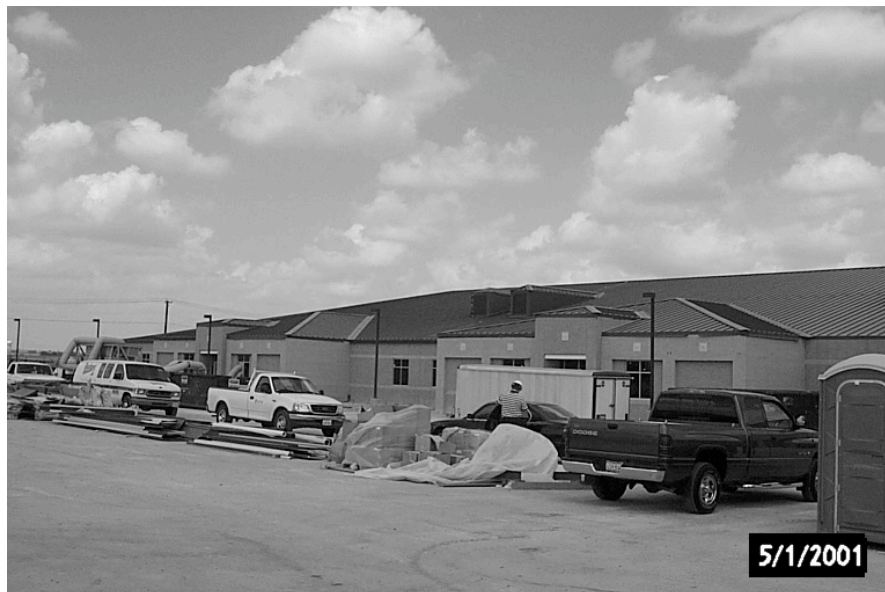
Figure 6. School structure. Note metal roofing.

Case Study Background: The structures (the school actually comprised three connected structures) discussed in this case study were an elementary school, and was still under construction when observations were made. There had been several delays in the construction, especially with regards to the roofing. The roofs for the school were a combination of built-up roofing and standing seam metal roofing. A representation of the standing seam metal roof is included in Figure 6.

Roof: The water leakage was primarily evident at areas roofed with standing seam metal roofing. Some unfinished areas were observed at the perimeter of the flat roofs, however, a majority of the unfinished areas and installation defects were at the metal roof areas. Incomplete items and defects at the metal roofing included a missing ridge cap, incomplete dormers, flashing missing at dormers, flashing missing at metal roof/flat roof intersections, gaps at installed flashing, a gap and exposed insulation at the exterior wall, missing sealant and separations at lap joints. In summary, there were several installation defects and incomplete items at the metal roofing; and the roof was not sufficient to consider the school as "dried-in".

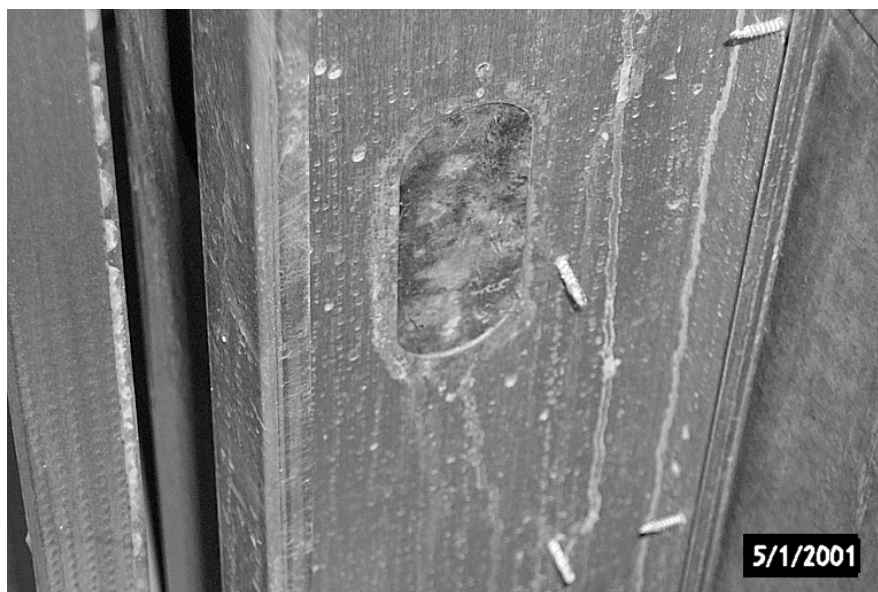
Interior: At the interior, there were several indications of previous water intrusion. Streaking stains were observed on the sheathing and on the metal studs at the perimeter walls. As indicated in Figure 7, fungal growth was observed at the sheathing. The specifications for the project indicated that the gypsum board sheathing was to be protected from the environment.

Figure 7. Streaking at metal studs and fungal growth at sheathing.
