Common Perils of Ceramic Floor Tile Systems

Bart B. Barrett, P.E.¹ and James M. Falls, E.I.²

ABSTRACT

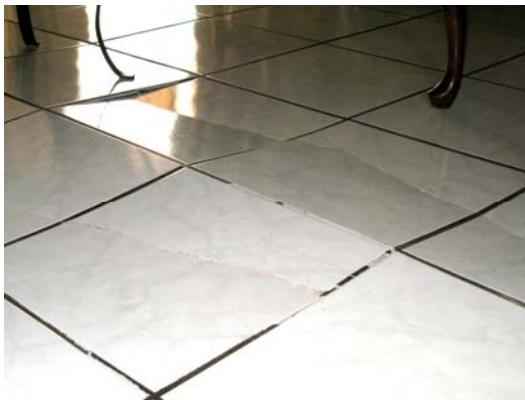
Ceramic tiles expand under moisture and thermal exposure, which may cause the tile system to buckle (**Figure 1** and **Figure 2**). The expansion mechanism between these causes is significantly different in that tiles typically experience contraction after the elevated thermal exposure is abated, whereas, expansion experienced due to moisture absorption is generally nonreversible. The degree of expansion is dependent on multiple variables including the expansion and absorption rates of the tiles, the tile installation, and site conditions. Expansion is also dependent on exposure to water; for this reason water removal from the surface of the tile should be expedited. Sources of moisture intrusion should be mitigated in a timely fashion because failure to do so may increase the intensity and/or extent of tile distress.

Figure 1: Buckling of tile flooring on slab.

Analysis of site conditions in the cases involving buckling indicated moisture sources from plumbing leaks or moisture migration through the building envelope. Exposure to thermal forces in sunrooms may have exacerbated the distress; however, buckling caused solely by thermal effects was not observed.

Buckling in these cases may have been avoided by the installation of movement joints within the field of the tile and by including provisions for expansion along the perimeter. Movement joints within the field generally consist of a flexible material that is dyed the same color as the grout lines. Provisions for expansion at the perimeter typically include a gap between the tile system and finished wall assembly prior to installation of the baseboards. The baseboards are installed over the tile system to hide the gap from view. While provisions for expansion were evident at the perimeter of a small portion of the studied tile systems, the majority of the sites did not include expansion provisions at the perimeter. Movement joints within the field were not provided at any of the investigated sites.

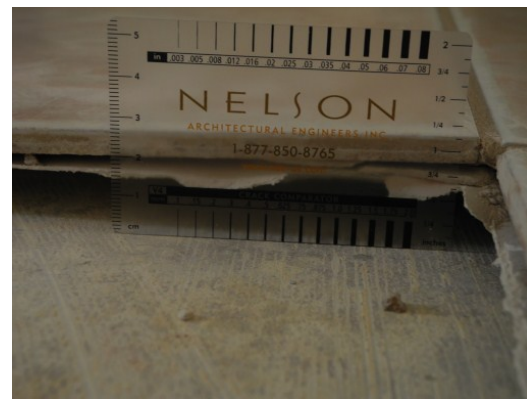
Figure 2: Void created by tile buckling.

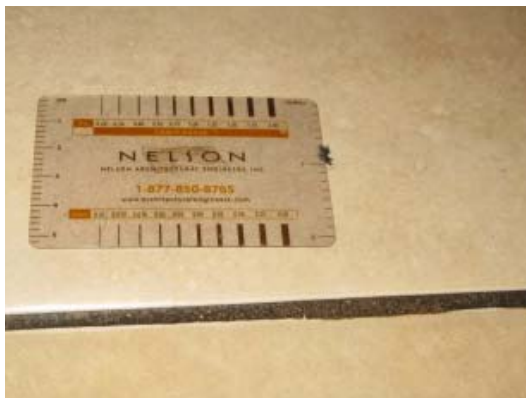
Tile flooring is susceptible to damage caused by impact (**Figure 3**). Chips and radial type fractures are common and are often the result of impacts from dropped objects. The impact fractures are typically located in high traffic areas, such as kitchens or bathrooms. Rolling loads such as those imposed by office-type chairs impart concentrated point loads at the wheels and often induce cracking (**Figure 4**).

Figure 3: Impact fracture at tile.

After the source of the damage is remediated, buckled and fractured tiles should be removed and replaced with reserve or matching tiles after the substrate is properly prepared. Impacted tiles may be painted to match the existing tiles and coated with a clear, high-strength epoxy. Hollow-sounding tile systems that are separated less than 1/8" from the substrate may be repaired by injecting a high-strength epoxy below the tile.

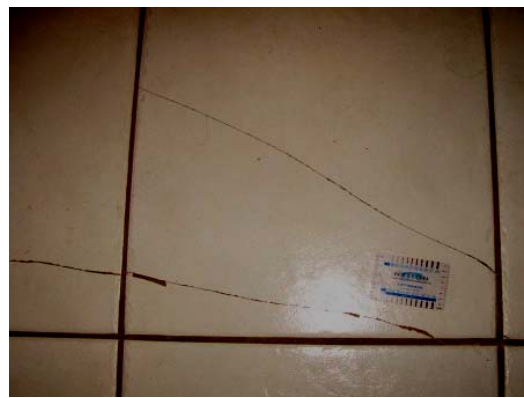
Figure 4: Fractures at tile from rolling load.

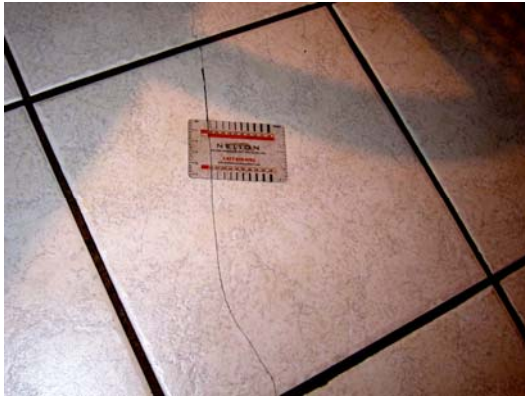
As indicated previously, a relative elevation survey should be performed to determine if the foundation has undergone a specific pattern of deformation resulting in tile distress. Foundation deformations which result in tension along the top surface of the foundation (e.g. edge drop) may cause the tile system to fracture (**Figure 5**). Isolated deflections due to undersized or deteriorated framing members (**Figure 6**) may also result in tile fractures.

Figure 5: Fracture at tile due to differential foundation movement.

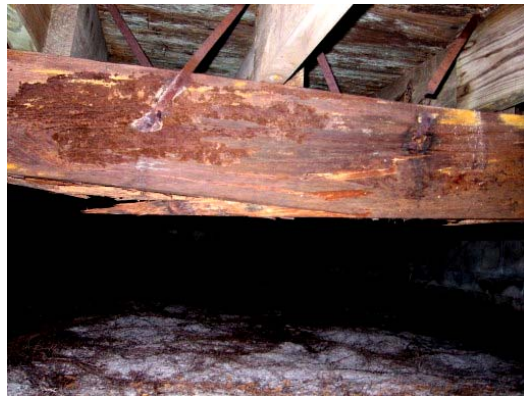
Figure 6: Deterioration of wood framing below tile floor system.

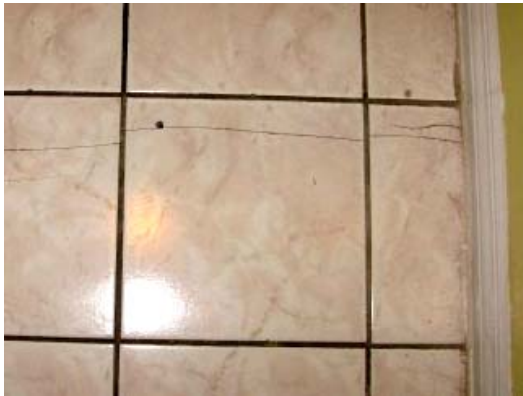
When ceramic tiles are adequately bonded to the substrate, the tiles and substrate will behave as a composite material. As such, fractures in the concrete substrate are frequently reflective in the ceramic tile (**Figure 7**). A commonly observed fracture in the supporting substrate is the untreated shrinkage fracture (**Figure 8**). Shrinkage is continual over the service life of a concrete member and typically results in cosmetic fractures. When thermal/moisture effects and foundation movement have been eliminated as potential causes of tile fractures, it is likely that the tile fracture is caused by shrinkage of the concrete substrate. To prevent fractures in the substrate from reflecting into the tile system, cleavage or isolation membranes can be installed between the tile and substrate.

Figure 7: Reflective fracture in tile.

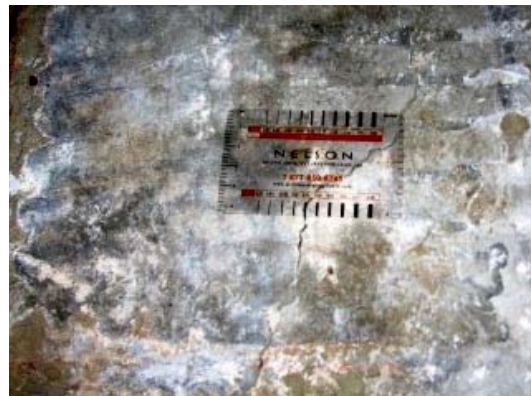
Figure 8: Shrinkage fracture at concrete substrate.

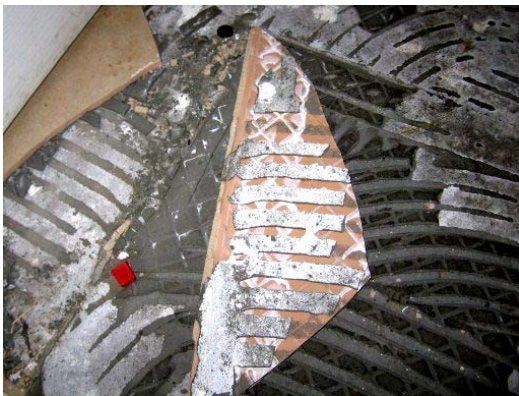
Deleterious materials, including, but not limited to, paint, dirt, laitance, curing compound, and wall texture overspray are often discovered at the substrate when exploratory testing is performed (**Figure 9**). Deleterious materials inhibit the bond between the mortar bed and the substrate from forming; therefore, removing these materials from the surface is a critical part of the substrate preparation.

Figure 9: Deleterious material at mortar and substrate below.

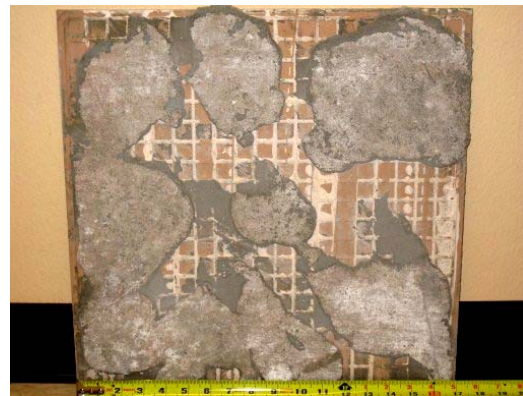
Proper installation of the tile into the mortar bed is also essential. Tiles should be installed while the mortar bed is workable and should be forcibly pushed into the mortar – a practice commonly referred to as "beat in". In addition, proper mortar coverage at the bonded side of the tile is required to adequately bond tiles to the substrate. For interior/dry service application, 80% of the bonded surface area should be covered (bonded) to the mortar (TCNA 2011). The mortar coverage requirement for exterior tile and tile in wet environments is increased to 95% (TCNA 2011). **Figure 10** depicts poor mortar coverage at the underside of a tile.

Figure 10: Poor mortar coverage at underside of tile.
