“Commonality Test Methodology for Residential Structures in Katrina Canal Breaches Class Action”

Abstract

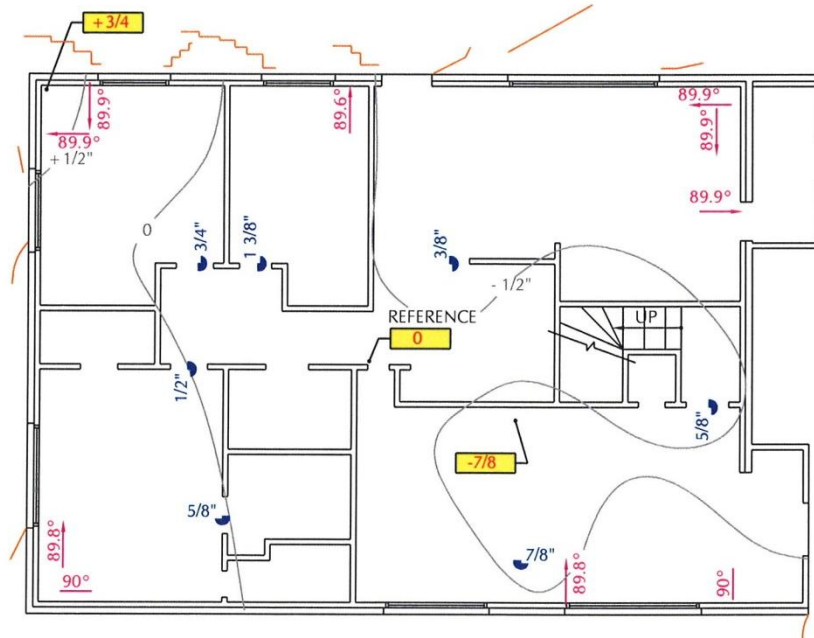
Figure 1: Minor floor total out-of-levelness

For comparison purposes within the scope of the forensic testing, the authors classified total floor out-of-levelness less than 3" as minor (**Figure 1**), greater than or equal to 3" and less than 5" as moderate, and greater than or equal to 5" as severe (**Figure 2**). The authors correlated relative elevation data with distress patterns and

determined that the majority of damage was due to long-term differential foundation movement, and was not hurricane related.

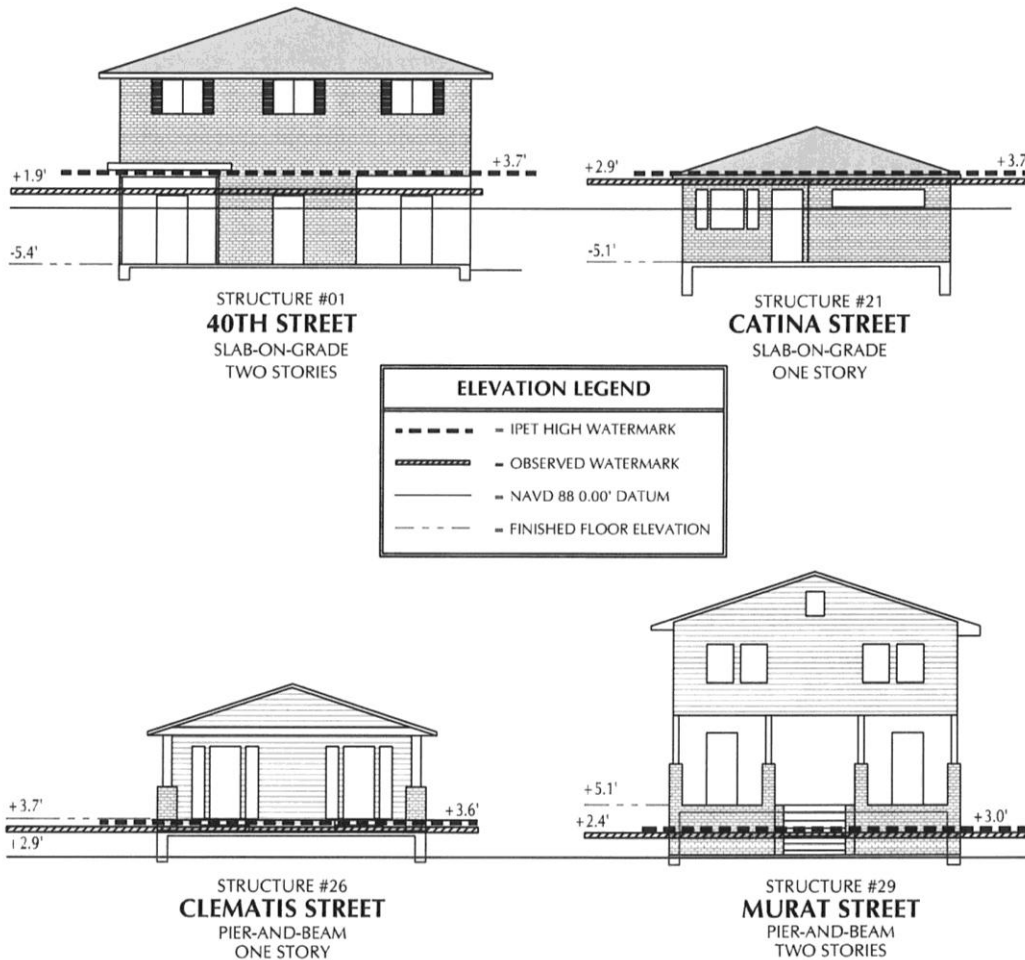
Figure 3: Watermark Data

Watermarks: The authors estimated the maximum flood level within the structures by measuring stains/watermarks left by standing water on interior and exterior finishes including glass window panes, gypsum board, exterior siding, etc. All watermark data were referenced to NAVD 88. The authors found good correlation between watermark data and IPET published data as illustrated in **Figure 3**. (In the Fall of 2005, the U.S. Army Corps of Engineers established the Interagency Performance Evaluation Taskforce (IPET) to provide scientific and engineering answers to questions about the performance of the New Orleans and Southeast Louisiana Hurricane Protection System during Hurricane Katrina. As part of its evaluation, IPET documented flood water elevations throughout New Orleans)

Example 3 – Structure #5 (two-story) vs. Structure #21 (one-story): The third example is a comparative case illustrating the observed variation and degree of distress between two structures based on the number of floors. On all of the two-story structures, the water level did not reach the second floor (**Figure 3**). Damage consistent with flood was not observed (on the second story of these structures.) Therefore, on a per-living-area basis for a given structure, two-story structures sustained less flood damage than one-story structures.

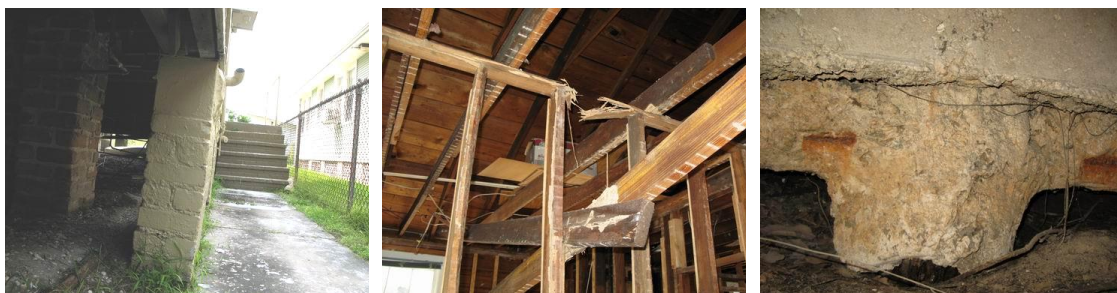
Figure 4: Structural Damage

Tilted Piers

Termite Damage

Scour Damage

At Structure #29, the authors observed several tilted piers, including what appeared to be remedial piers under the floor structure. As the piers tilted, the floor system deflected, causing the superstructure to move. This movement caused distress to architectural finishes as evidenced by plaster cracks and out of square door frames. The tilting of the piers was most likely caused by long-term movement of the subgrade. The maximum riverine type flood water level recorded by IPET was

approximately 2'-1" *below* the finished floor elevation (placing the water level near grade), and unlikely to have caused the tilting of the piers.

Structure #12 featured significant pre-existing (non-hurricane) structural damage caused by termite and wood rot. The extent of the damage was such that large sections of framing members had disintegrated. For example, two ceiling joists had collapsed and several wall top plate sections were near failure. The extent of termite damage at this structure rendered the dwelling structurally compromised and unsafe for habitation.

Structure #6 featured damage in the form of scouring and/or undermining of the wooden piles and concrete grade beams. The IPET observed watermark at this structure was 5'-1" A.F.F. The observed scouring was attributed to flood and/or surge.

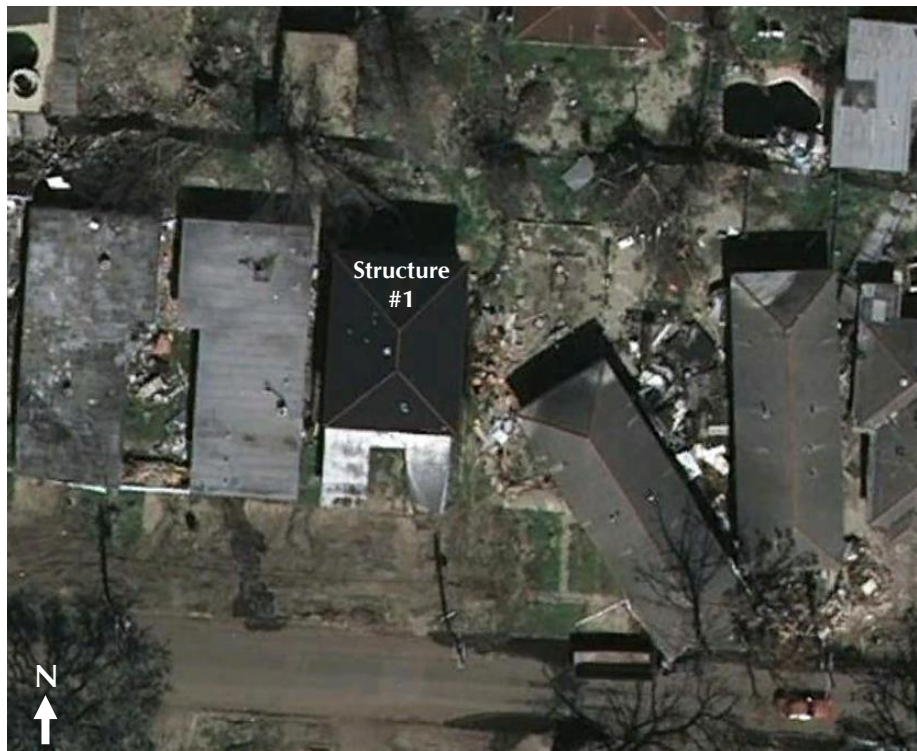
Figure 6: Structure #1 & Adjacent Properties

A satellite image obtained from Google Earth (Google Earth, 2005) (**Figure 6**) shows the condition of Structure #1, a slab-on-grade structure, and the adjacent structures post Hurricane Katrina (Spring 2006). The image shows that the structure located east of Structure #1 was detached from its foundation and displaced from its original plan position approximately 50' south and 8' east. In addition, the structure had been rotated around its original north-south axis by approximately 45 degrees counter-clockwise. Displacement of the structure and associated damage was the result of flood.

The impact of flood and storm surge was very different for the subject 40th Street structure and the adjacent structure on the east side. While the structure east of Structure #1 was detached from its foundation, displaced, and rotated well beyond its

original as-built condition, Structure #1 remained at its original position without any significant displacement, tilting and/or rotation.

The different behavior of these structures during the storm is most likely the result of the structures' different foundation systems. Structure #1 has a slab-on-grade foundation while the adjacent east structure had a pier and beam foundation. Most likely, upward buoyancy (and possibly lateral water forces due to the proximity to the 17th street canal breach) contributed to the displacement and rotation of the structure east of Structure #1. In addition, improper, failed and/or missing hold-downs at the pier and beam foundation might have contributed to the detachment of the structure from its foundation.
