From Concept to Collapse

This paper presents a case study of a new cold-formed steel joist roof framing system/product. The manufacturer designed and manufactured the product, taking it from the concept stage to implementation as a product sold for use in building structures.

In June 2004, a large section of a warehouse roof in the Dallas/Fort Worth, Texas area collapsed during a rainstorm. The collapse caused damage to multiple tenant spaces in this warehouse building. Fortunately, there was no injury or loss of life.

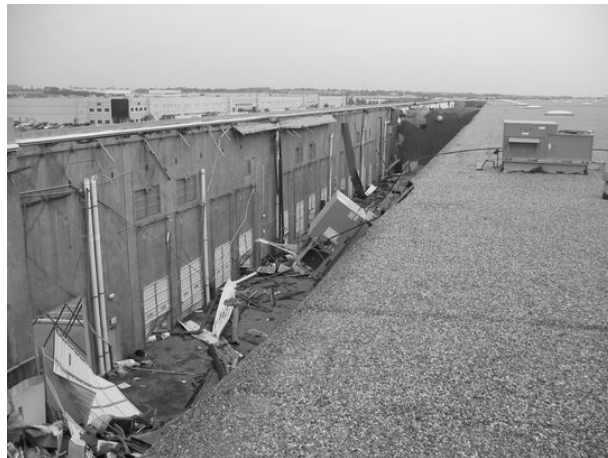
The collapse of the roof was extensive, as indicated in Figure 1. The collapse affected the framing bays along one side of the building for a majority of the length of the building.

Figure 1. Overall view of roof collapse.

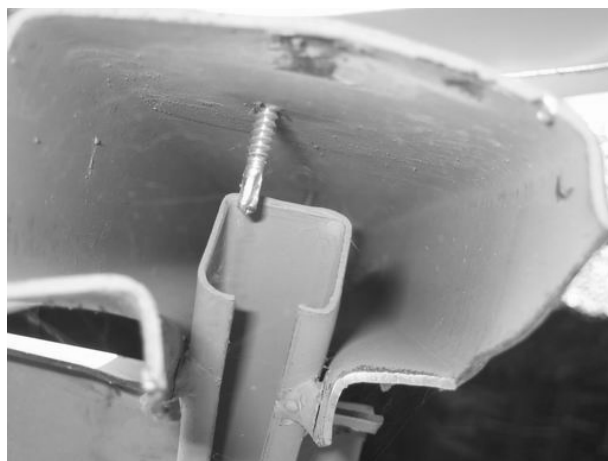
The steel shapes utilized in the joist product design consisted of rectangular channel sections with openings along one side to allow fit-up and assembly. The top and bottom chords had vertical extensions along the openings to facilitate the connections with the web members. Refer to Figures 2 and 3 for a representative view of the joists and the constituent members. It should be noted that, due to their open shapes, the joist members were susceptible to torsional instability in compression.

Figure 2. Web to top chord connection. Also note the weld failures.

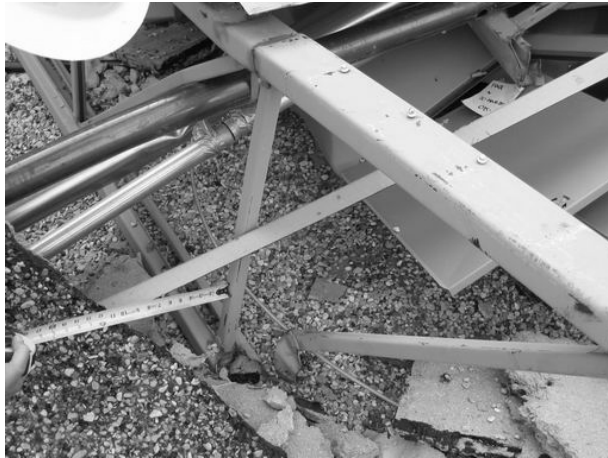
Figure 3. Typical joist geometry. Note the failure at the end web connection at the bottom chord.

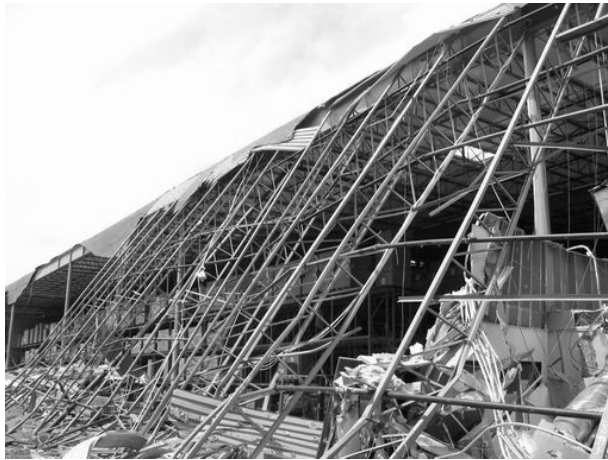
Failure Mode. The shape of the collapsed joists did not exhibit evidence of plastic deformation (refer to Figure 4), nor was there evidence of compression failures at the joists. The primary failure mode for the collapsed joists was failure at the welded connections between the tension webs and the joist chords. The pattern of the joist framing failures and the condition of the joists after the collapse were indicative of sudden failures in the elastic range, not indicative of "ductile" failure. Furthermore, the roof collapse was extensive and was consistent with a progressive collapse, whereby an initial failure caused subsequent failures in adjacent joists and the collapse spread along the length of the building.

Figure 4. Collapsed joists. Note the lack of plastic deformation.

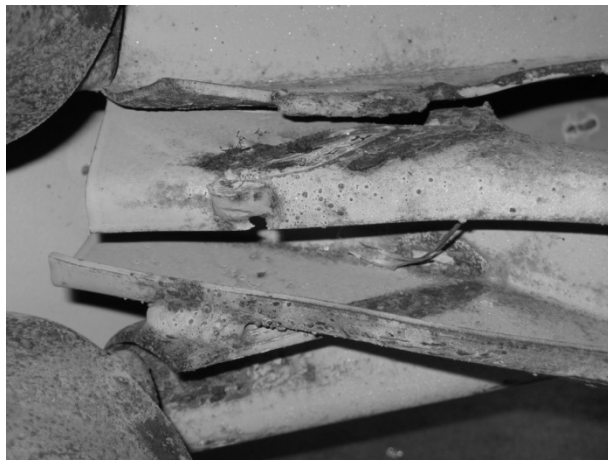
At some welds, paint was observed at the weld surface, as indicated in Figure 5. As noted above, the joists were painted by dipping them after the welding was completed (during the manufacturing process). The presence of paint between the weld and the base metal was therefore indicative of a gap between the weld metal and the base metal from the time of fabrication. The gap indicates inadequate fusion.

Figure 5. Close-up of weld failure. Failure was between base metal and weld metal. Note paint at surface of failed weld near middle of photo.

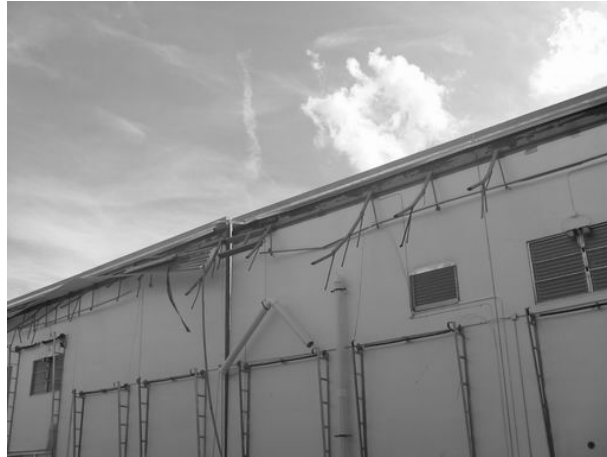
Figure 6 below shows a failed joist at the subject building, where several web members detached from the bottom chord at the connections. The failure mode for each of these connections was separation of the base metal and the weld metal, indicative of a lack of fusion as discussed above. This type of weld failure at multiple connections of adjacent web members indicates that there were multiple poor welds for this individual joist, which was one of many that failed in this manner. Based on a review of the joists at the collapse area, poor welds were frequent. A metallurgical examination of welds from the subject joists indicated that the overall weld quality was unacceptable and that some welds were so poor that they had only 0-10% of the strength of a good weld. Refer to Figures 7 and 8 for typical poor welded connections which failed.

Figure 6. Failed joists. The webs failed at the bottom chord.

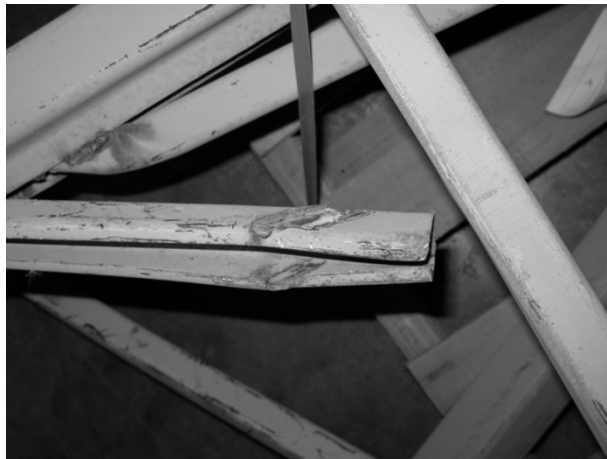
Figure 7. Failure at welded connection.

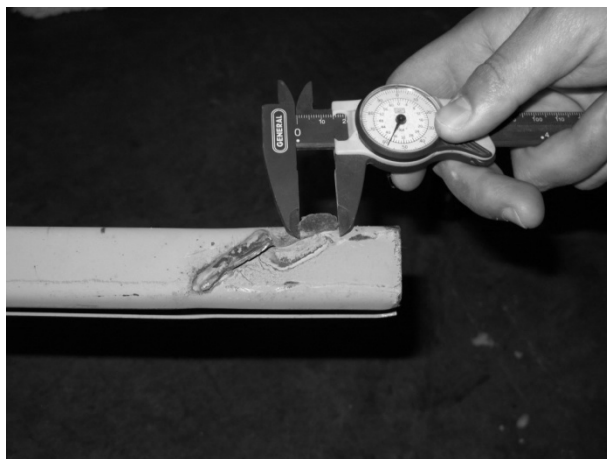
Figure 8. Failure at welded connection.
