A Case Study of Granite Cladding Distress

Deepak Ahuja, P.E., M.ASCE¹ and Matthew D. Oestrike, P.E., M.ASCE²

Abstract

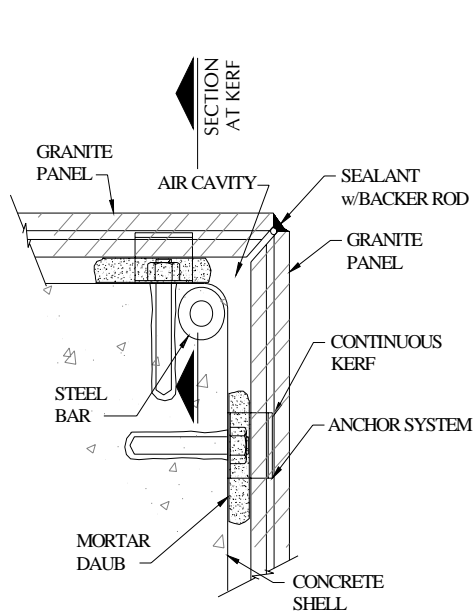
Figure 4. As-built plan at protruding corner.

block and at least two different types of brick masonry. Additionally, steel hollow sections (bar/tube) were noted at the edges of the protruding corners of the dome shell (Figures 4-5). There was no indication on the structural drawings that steel hollow sections (bar/tube) were to be installed. The horizontal blue and pink beaded stone bands were built after the granite was installed (Figures 7-9). No indication of this type of installation and construction was noted in the shop drawings or in the architectural schematic drawings. Details and/or specifications for the horizontal bands were not prepared. Therefore, the contractor installed the horizontal beaded bands under no design supervision, did not conduct the work based on any specific details provided by a design professional, and was not aware of the necessity of allowing the cavity wall to weep excess water. Furthermore, the structural drawings indicated that the dome shell was squared off and open at the top. Observations indicated that the top of the dome consisted of an additional concrete shell, above the specified opening, that was not indicated on the structural drawings.

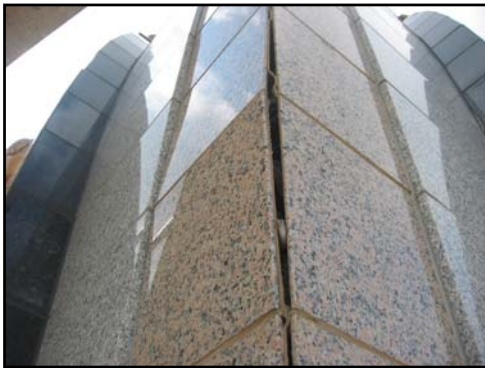
Dome: An initial visual walk-through of the site confirmed that most of the damage was indeed located at the dome with little distress observed at the remaining portions of the temple. Most of the distress was noted at the protruding corners of the dome. The granite pieces at these corner joints were displaced outward on each side of the joint. Figures 6 and 7 show separations at the protruding corners.

Figure 6. Separation at protruding corner.

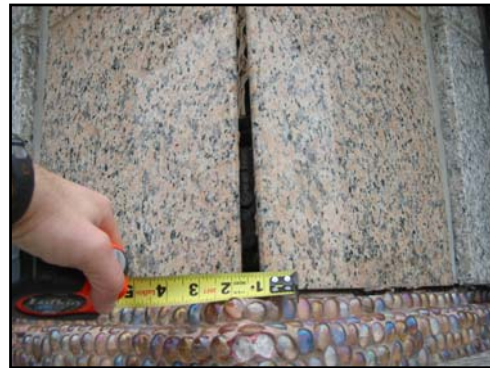
Figure 7. Separation at protruding corner near projection.

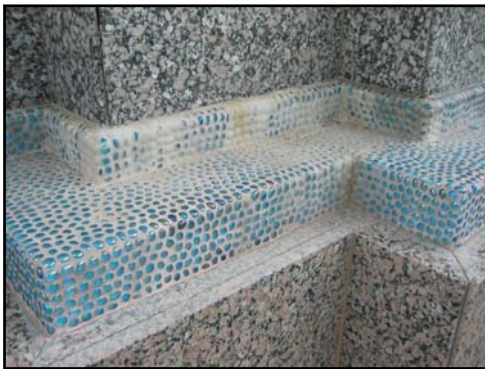
Additionally, localized areas of granite developed fractures in the pieces themselves. Evidence of accumulated and excess moisture including staining, efflorescence, and spalled glass beads at the horizontal banded trim at the base of the dome were noted. Figures 8 and 9 show typical areas exhibiting distress.

Figure 8. Moisture staining at base projection.

Evidence of the effects of this water intrusion is noticed at the dome exterior especially at the blue beaded stone bands that surround the base of the dome (Figure 8). Additionally, upon removing the granite panels and at locations where the granite had already been removed, bubbling and blistering of the paint/coating that was applied over the CMU block was observed. Additionally, mineral deposits were observed to be leaching through the coating from the bump-out projections/shell locations. The mineral deposits and bubbling/blistering is a typical affect of water transpiring from the shell and/or CMU block through the applied paint/coating. Rust streaks and corrosion of the embedded steel hollow sections were observed at the protruding corners of the shell. Corrosion and the effects thereof are discussed in detail in the following section.

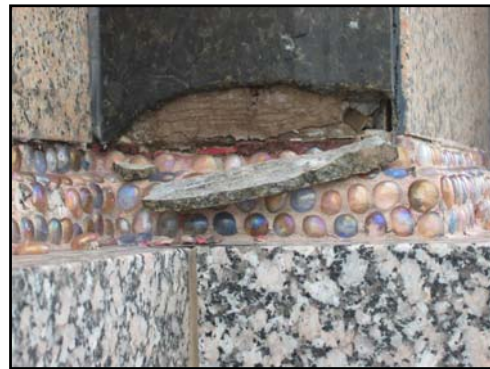
Figure 9. Granite fracture.

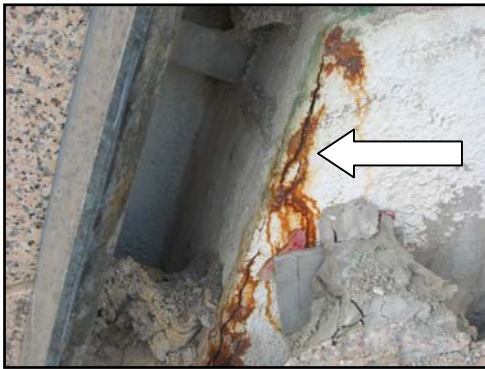
A hollow section steel bar was embedded (cast-in-place with the concrete) at the protruded corners of the shell without an effective cover or clearance. It was noted that the cover over the hollow steel bar was either non-existent at corroded portions along the bar or very thin at other locations. Due to the lack of an effective cover, the bar was exposed to the elements in the cladding cavity. This exposure resulted in significant corrosion at the hollow steel sections. No signs of protective coating in the form of galvanization or paint on the hollow steel section was noted on the steel bar. The embedded bar does not perform a load bearing or structural purpose and was not shown on any of the drawings. It is not clear what function the exposed steel bar served other than to aid in forming the shell. If a bar was required for reasons, which were not structural, then it is not clear why a steel hollow section without any protective coating was used.

Water and oxygen are essential for corrosion to occur. The lack of any cover at these protruding corners in conjunction with the abundance of water affecting the exterior of the shell, allowed corrosion to develop and affect these metal bars/tubes. Unhydrated ferric oxide (Fe_2O_3), or rust, when fully dense has a volume of about two times that of the steel it replaces. Broomfield (Broomfield, 2003) reports that when ferric oxide gets hydrated it swells even more and becomes porous. Hydrated ferric oxide ($\text{Fe}_2\text{O}_3 \cdot \text{H}_2\text{O} + 2\text{H}_2\text{O}$) is approximately two to ten times the volume of original steel. Kaminetzky (Kaminetzky, 1991), reports that the increase in volume of rusted embedded steel (typically reinforcing bars) produces internal pressures in the concrete that split the concrete in the path of least resistance. Figures 10 and 11 are typical views of the effects of the corrosion at the protruding corners of the shell.

Figure 10. Corrosion at protruding corner of dome shell.

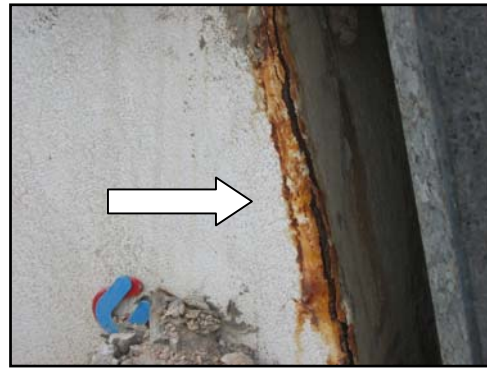
Figure 11. Similar as Figure 10 at another location.

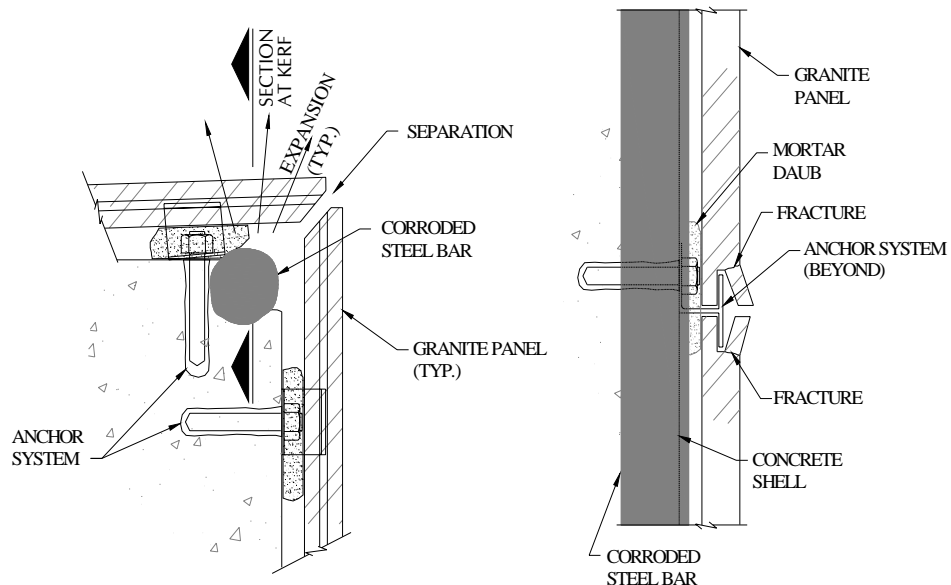
Figure 12. Plan at protruding corner after corroded bar expansion.

Furthermore, fractures at some of the granite panels (black in color) located at the sides of the leaves, correlates with the area of the stainless steel anchor attachment. As discussed above, the stainless steel anchors were attached to the shell, proximate to the corroding steel bar. The expansion creating by the corroded bar led to outward pressure at the anchor. This resulted in the split-tail portion of the anchor, which was attached to the granite panel, to induce an outward force on the sides of the kerf located at the center of the granite panel. Figures 12 and 13 show how the corroded bar affected the granite.

Figure 13. Section at kerf after corroded bar expansion.

The panel is 1 1/4" thick with a 1/4" wide kerf. The granite thickness on each side of the kerf is approximately 1/2" thick. The section at the exterior face of the kerf is less than half the thickness of the panel (approximately 1/2") and is weakest at this location. The outward movement of the anchor creates a localized bending and shear at the exterior face of the granite panel. Where the capacity of the granite panel has been exceeded, it is exhibiting fractures.
