## **Hail Evaluation of Bituminous Roofing Membranes: Understanding Interply Mopping Voids**

### **Abstract**

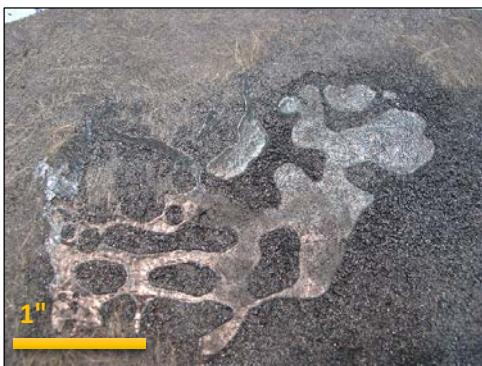
**Figure 2** – Example of mopping void from a delaminated membrane sample

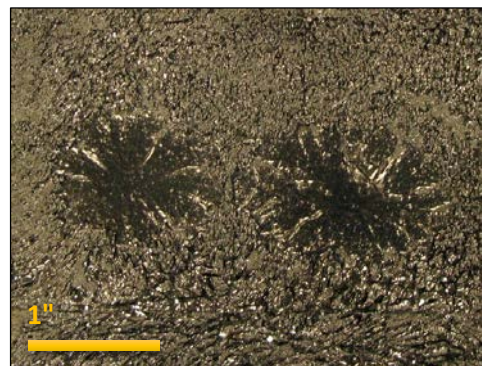
**Figure 3** – Example of mopping voids from a delaminated membrane sample

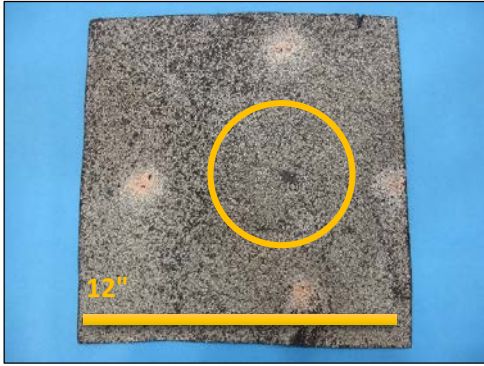
- *Granule-Surfaced Mod-Bit Membrane*: The surface distress typically manifests as a discrete area of granule loss over the void (**Figure 5**). The area of granule loss will often approximate the shape of the mopping void below, albeit typically smaller in size (**Figure 6**).

**Figure 5** – Area of granule loss over mopping voids in mod-bit membrane.

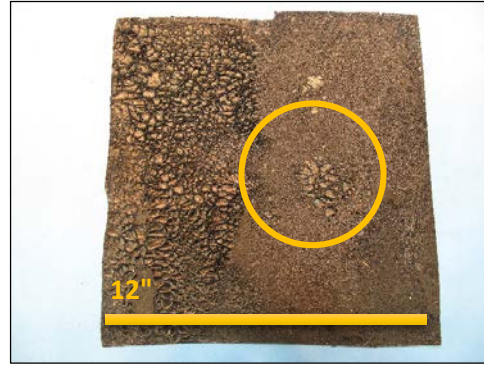
**Figure 6** – Mopping voids below granule loss from Figure 5.

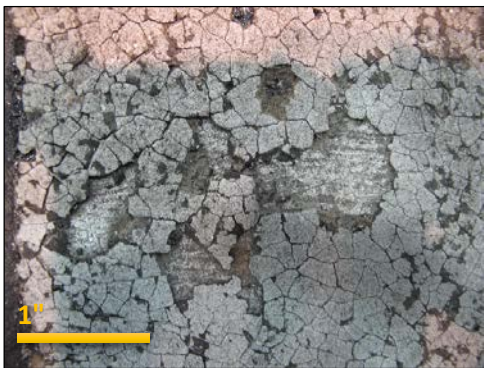
**Figure 7** – Loss of flood coat over mopping voids in BUR membrane.

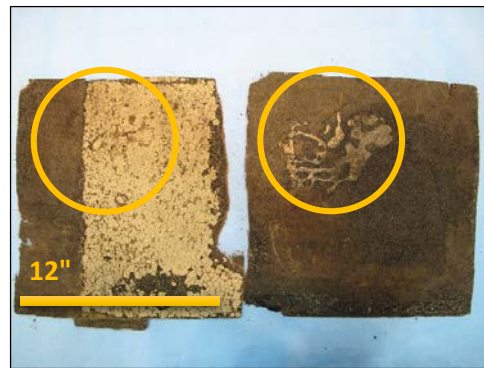
**Figure 8** – Mopping void below flood coat loss from Figure 7.

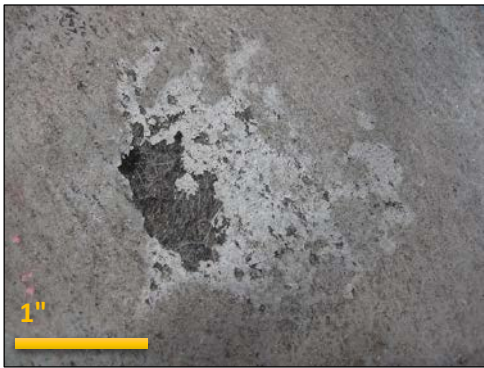
**Figure 9** – Discoloration and loss of surface coating over a mopping void in a BUR membrane

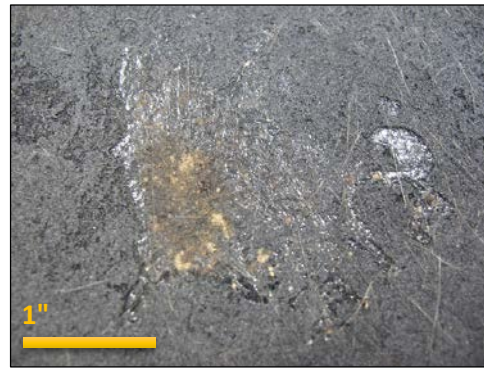
**Figure 10** – Mopping void below coating loss from Figure 9.
