## **A Case Study of the Impact of Wind and Wave Action on Floating Dock Anchorage Systems on Lake Brownwood, Texas**

David C. Jones, B.S., P.E., M.ASCE<sup>1</sup>  
Marco A. DeLeon, M.E., P.E., M.ASCE<sup>2</sup>  
Matthew L. Breidenthal, M.S., P.E., S.E., M.ASCE<sup>3</sup>  
Kurt W. Cady, M.E., P.E., S.E.<sup>4</sup>

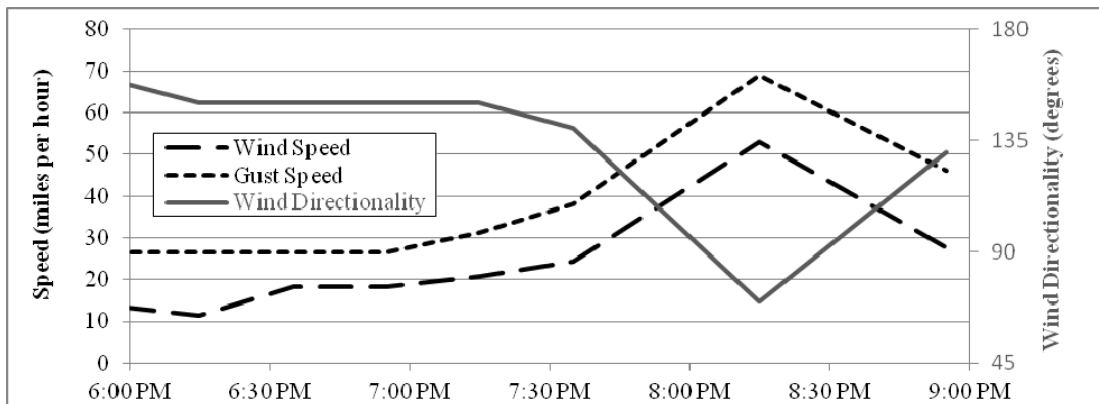
During the storm event, Brownwood Regional Airport (KBWD), located approximately 5 to 10 miles southeast of the investigated docks, recorded wind speed and directionality data as indicated in **Figure 1**. A substantial change in wind direction – from 150° (SSE) to 70° (ENE) to 130° (SE) – occurred from 7:35pm to 8:55pm. A maximum wind gust speed of 69 mph, from the east-northeast, was recorded at 8:18pm (Weather Underground, 2009).

**Figure 1.** Wind speed and directionality at KBWD airport, evening of May 8, 2009 (Weather Underground, 2009).

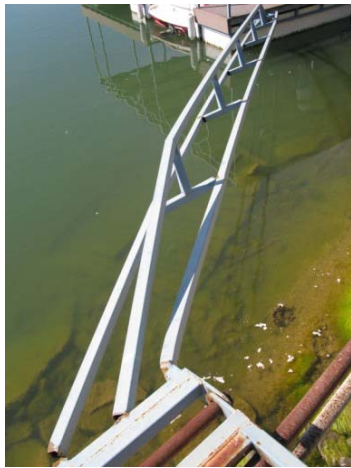
The most common deficiency of the observed anchorage systems was the deteriorated condition of the steel components from aging, corrosion, lack of a protective coating, modifications, and deferred maintenance. Many of the system anchors were composed of steel pipe with nominal protection from corrosion, embedded vertically in cast-in-place concrete foundations or the exposed bedrock of the shoreline, or driven into the lakebed, depending on the water level and shore profile. These conditions resulted in progressive failure of cored bedrock or foundations, embedded pipe anchors, steel pipe hinges, and stiff-arm connections. Very seldom was there any evidence of global buckling of compression struts or frames.

The second most common failure mechanism was the hinged connection at both ends of the stiff-arm and gangway elements. The development of large bending moments due to lateral wind forces acting at the end of relatively long moment arms resulted in failure of the hinge connector plates, the hinge pin, or the connection of the strut to the hinge. Subsequent loss of the lateral fixity of the strut element resulted in progressive failure of similar components and lateral translation of the dock.

**Figure 3.** Failed stiff-arm.

In the anchorage type that relies on a single, laterally-fixed gangway (Category A), the proposed enhancement is the addition of opposing diagonal tension cables and strut components. In anchorage systems that rely on the lateral fixity of multiple stiff-arms and gangways (Categories B and C), the proposed enhancement is the addition of opposing diagonal tension cables. For embedded anchor pole systems (Category D), the proposed enhancement is an increased number of anchor poles. Alternatively, the use of stronger/stiffer anchor poles and/or the use of more rigid connections to the dock would increase the strength of the system. For cable anchorage systems with stiff-arms (Category E), the proposed enhancement is an increased number of cables and/or installation of stronger/stiffer stiff-arms.

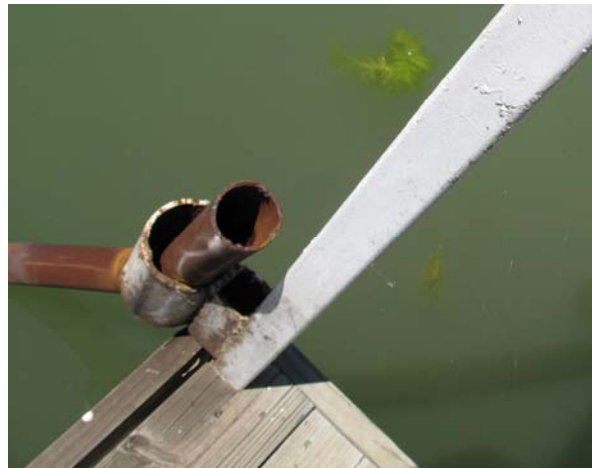
**Figure 4.** Failed anchor pole.

Displacement of the docks with anchor pole systems was typically the result of flexural overstress and yielding of the cantilevered anchor poles. Subsequent damages were related to deflection and twisting of the anchor pole sleeves and the structural framing directly connected to the sleeves.

Due to the steep inclination and inaccessibility of much of the shoreline of the lake and its islands, a marine-based anchorage installation would be most effective. Of the observed dock structures, the anchor pole systems exhibited the best performance. Their observed deficiencies included insufficient capacity of the system and corrosion of the anchor poles. The authors propose a more robust anchor pole system with greater lateral capacity constructed of a material that is more resistant to deterioration. One possibility is a system consisting of two or more precast concrete piles embedded into the lakebed. Concrete is much more durable than steel in a marine environment and the use of fewer, but stiffer/stronger, piles would provide the required strength while minimizing their impact on the functionality of the dock and on the amount of required coring of the lakebed.
