## **Masonry Veneer Failure: A Case Study of Wall Tie Corrosion**

Erik L. Nelson, Ph.D., P.E., M.ASCE  
Deepak Ahuja, M.S., P.E., M.ASCE  
Peter Schönwetter, M.S., E.I.T., Assoc.M.ASCE<sup>1</sup>

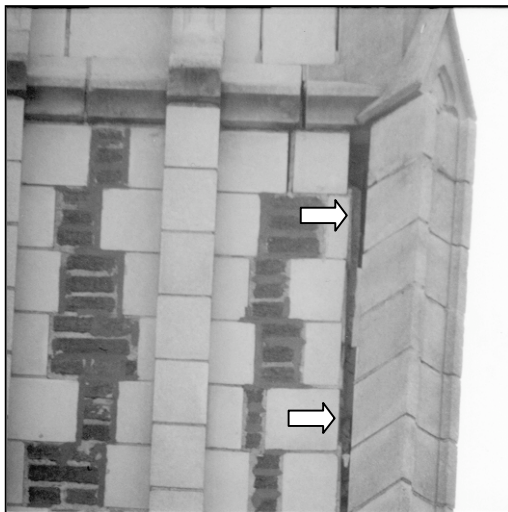
**Figure 2**

On the morning of September 19, 2002, portions of the cast stone veneer were observed to be leaning away from the building. In some locations, gaps as large as 3 to 4 inches were observed (Figures 2, 3). At the owner's direction the loose stones were immediately removed using an overhead crane and were stored on plywood sheets for observation. Approximately two weeks after the failure was observed, our firm was asked to determine the cause of the distress.

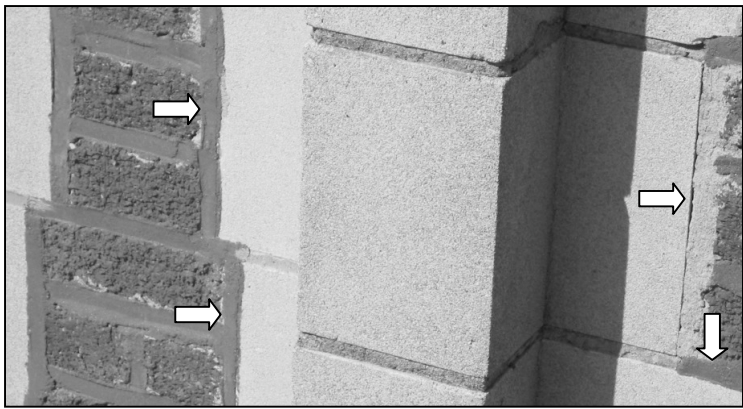
Figure 4

Fractures were observed at interfaces between the brick and cast stone units; however, previous repairs to the mortar joints have hidden the extent of this distress (Figure 4). The fractures promote water penetration of the veneer, and the repairs indicate the water penetration has been occurring for some time.

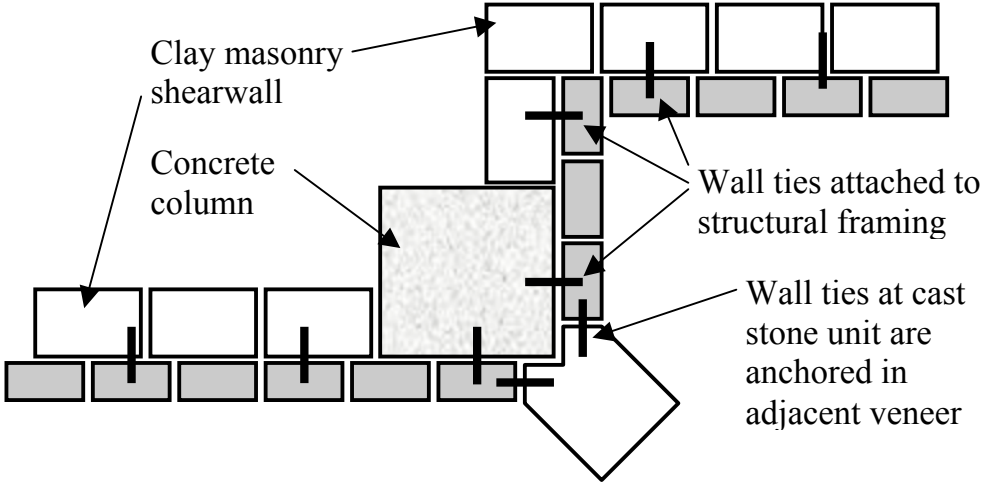
Figure 5

The cast-stone masonry units are attached to the building in a unique configuration: the wall ties holding the units are anchored in the adjacent veneer. In contrast, wall ties for the typical clay brick masonry unit are anchored in the structural framing (Figure 5).

The corner wall ties are more susceptible to weathering than the typical wall ties because they are anchored in the adjoining masonry, nearer to the exterior surface – there is less cover available to protect the corner ties.

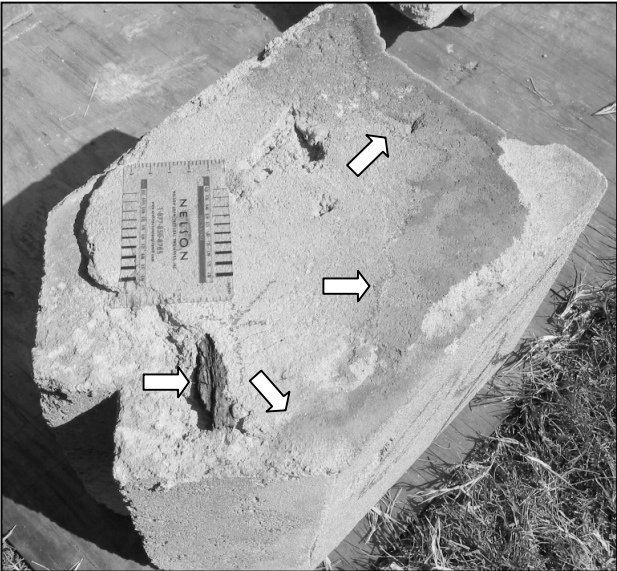
Figure 6

Discoloration, water staining, and efflorescence of the brick veneer were observed. In particular, water staining was observed on interior surfaces of some of the distressed cast stone veneer (Figure 6). Deterioration of mortar joints and roof-level cast stone spires was also noted. It is likely that the acidity of the droppings left by pigeons and similar pests has contributed to weathering of the masonry and mortar joints at the roof level, allowing additional moisture to penetrate the veneer.

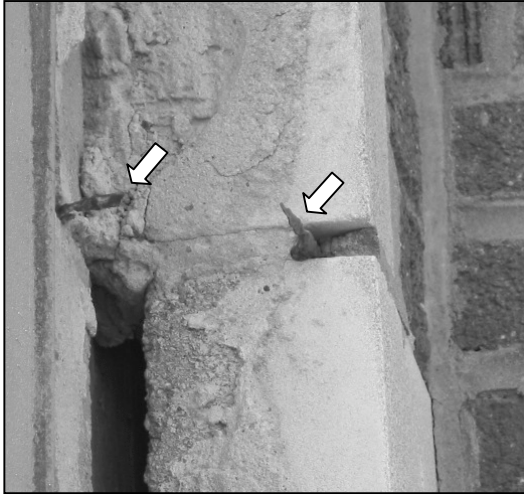
**Figure 7**

Corroded and failed wall ties were observed at the corners of the tower (Figure 7), and at the interior surfaces of the exterior walls (Figure 8). Similarly, corroded and failed wall ties were noted at the removed masonry units (Figures 9, 10). Some of the corroded anchors appear to be part of the original construction, while other corroded anchors appear to have been installed remedially.

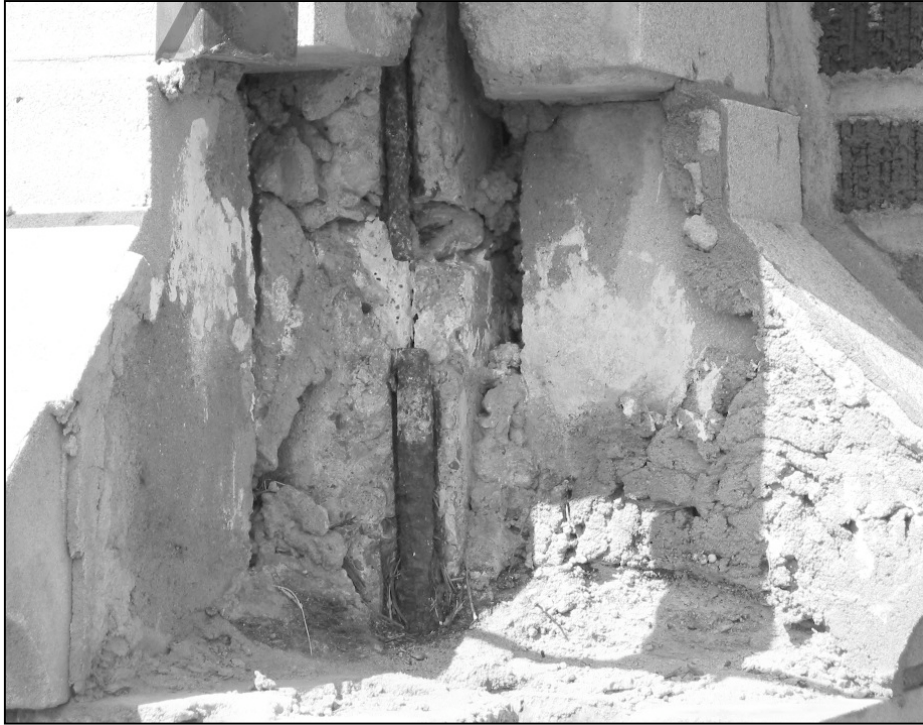
**Figure 11**

Distress due to corrosion expansion was also observed at reinforcing bars in the southwest corner of the tower (Figure 11) and at the connecting "pins" at the decorative spires at the top of the tower (Figure 12). Furthermore, corrosion expansion was noted at reinforcing bars with shallow or insufficient cover and at lintels at the first floor windows. The widespread corrosion expansion indicates that the building is exposed to an environment where moisture intrusion is common.
