## **Needle in a Haystack: Identifying Failure Origin Pieces in Heat-Treated Glass**

Stewart M. Verhulst, M.S., P.E., M. ASCE<sup>1</sup>

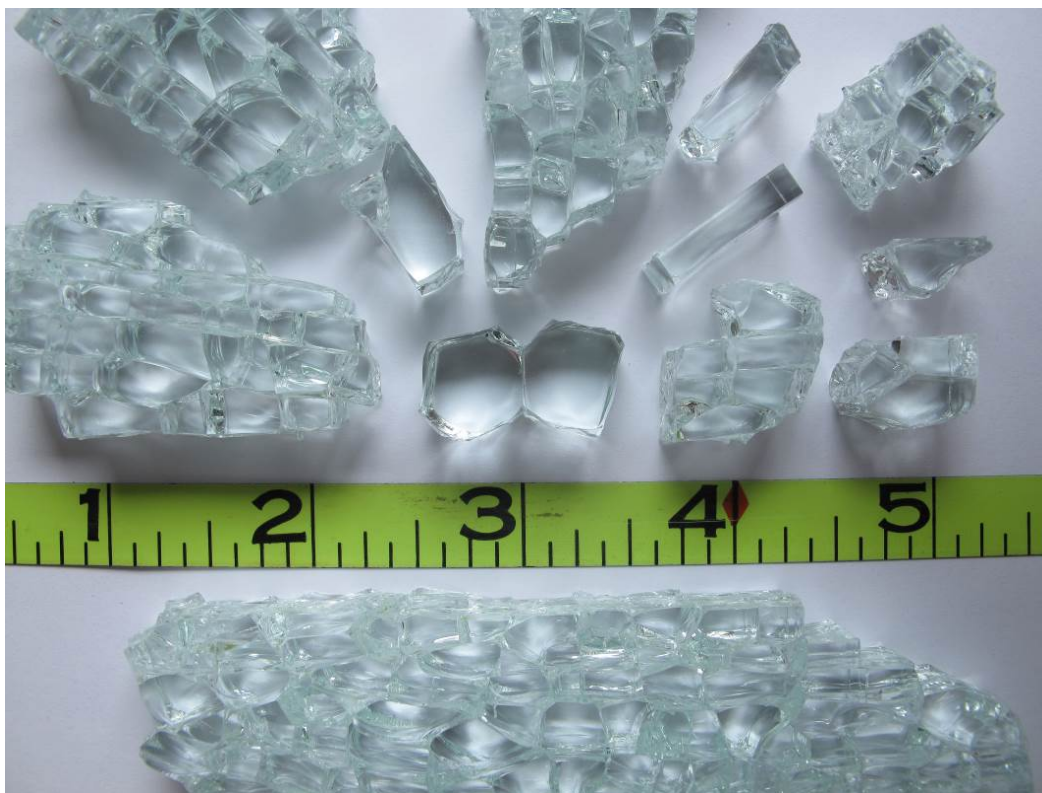
The geometry and size of the origin pieces are often distinct in comparison with the remaining fracture pieces from a failed panel. The origin pieces are often larger than other pieces, resembling a hexagon or polygon shape, and containing more sides than the other pieces. Figure 1 depicts the contrast between failure origin pieces and typical pieces of glass from a fractured heat-treated glass panel.

**Figure 1:** Recovered failure origin pieces in comparison with other pieces from a panel failure.

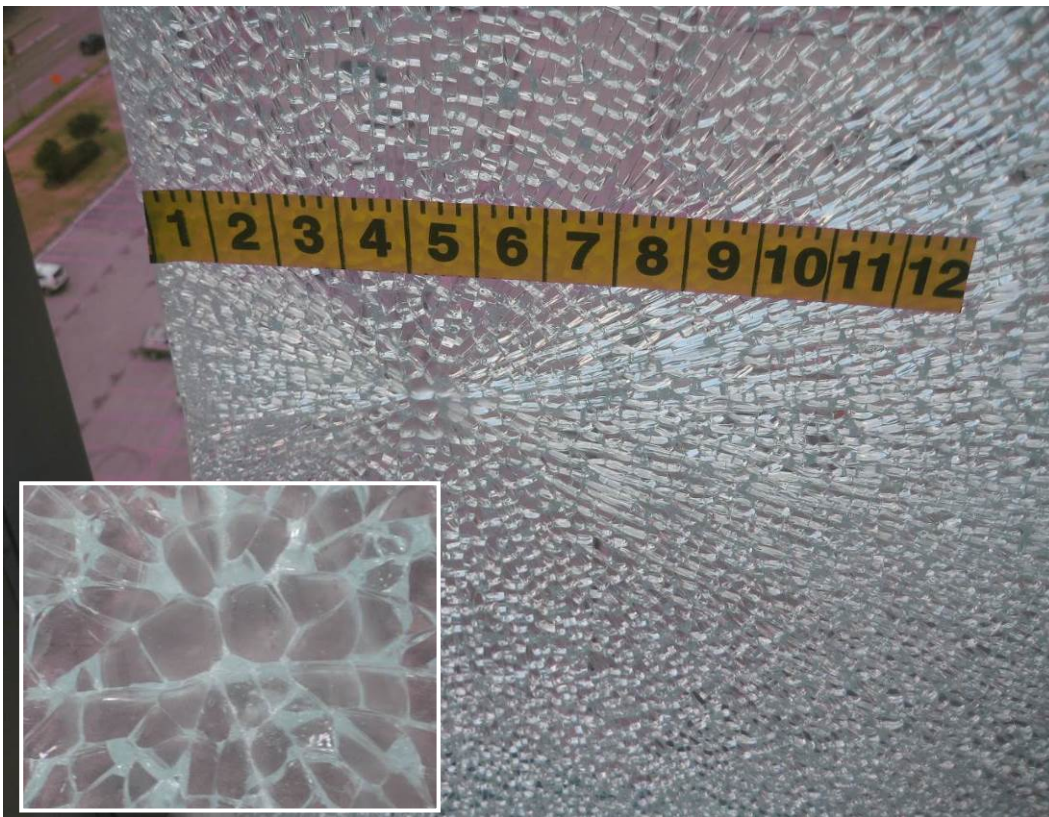
After a series of failures of non-laminated heat-treated glass, the remaining glass panels were coated with a plastic film and the attachment of the panels was modified to alleviate safety concerns and to maintain the fracture pattern if another failure occurred. An additional failure occurred and the modifications performed as intended, leaving the panel intact after failure. The failure origin was easily located upon inspection due to fracture pattern and distinct shape/size of the origin pieces. The panel was documented prior to removal, carefully removed, and the origin pieces recovered. Figure 2 depicts the intact panel failure and fracture pattern with a close-up of the origin (see inset photo for close-up).

**Figure 2:** Fracture pattern of tempered glass panel that remained intact and detail of failure origin.

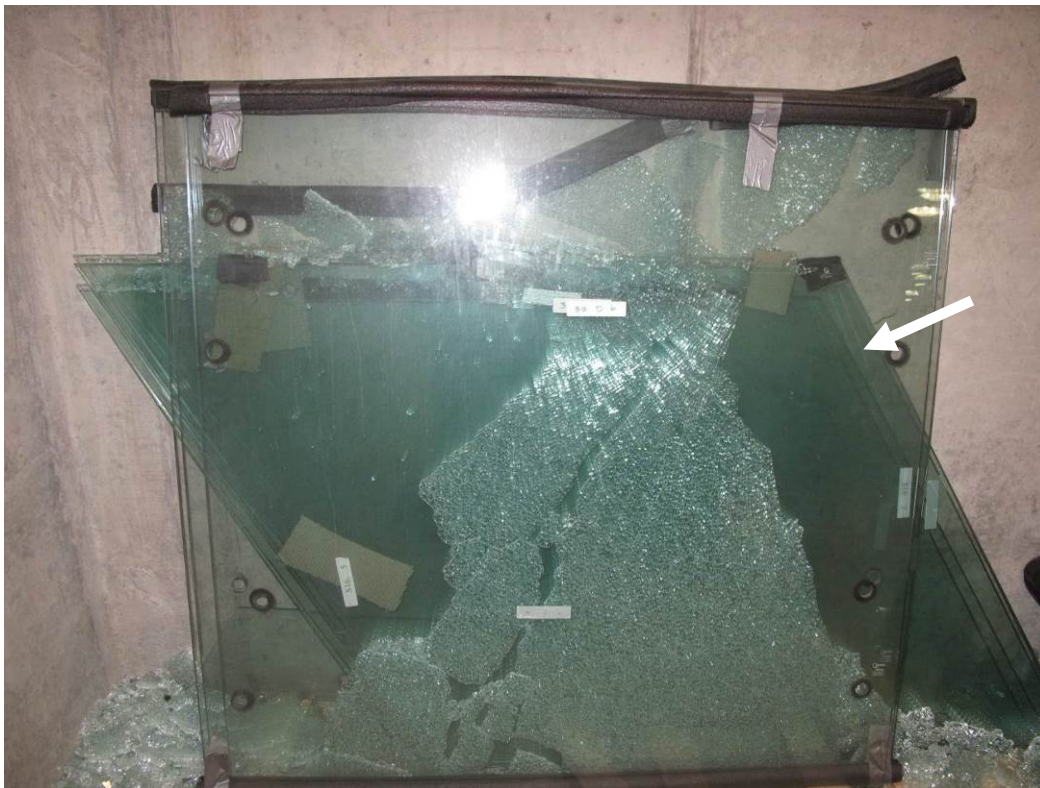
After a series of failures of heat-treated glass in service, all glass panels were removed from the structure and placed in storage, stacked upright in groups against the wall of the storage area (refer to Figure 3). A panel failed while in storage. The failed panel was within the interior of the stack (i.e., there were panels in front of and behind the failed panel) such that when the panel failed, the fracture pattern remained

partially intact and large groupings of pieces were still visible. Upon initial inspection, the fracture pattern indicated that the failure originated near the upper right quadrant of the panel. Therefore, the origin pieces were most likely either attached to the intact portion near the approximate location of the origin, or were within the glass material that had fallen to the floor below this area. Figure 3 depicts the partially intact panel and the most likely area where the failure origin pieces would be located, as deduced from the fracture pattern.

**Figure 3:** Partially intact tempered glass panel. Failure origin pieces are indicated.

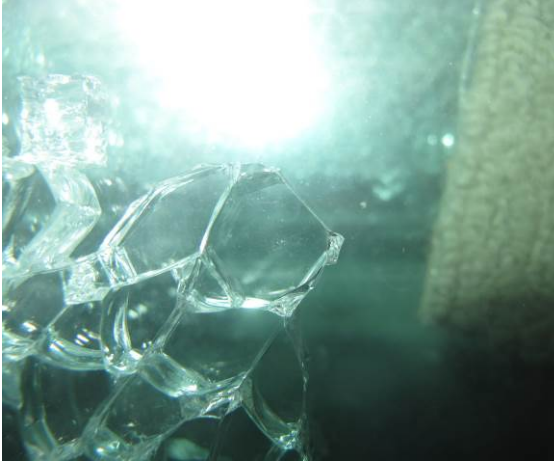
The first origin piece recovered was in fact still attached to the intact portion of the panel and carefully removed without disturbing the remainder of the panel (Figure 4). The second origin piece was located within the material that had fallen to the right of the origin location (Figure 5). Due to the glass panels in front and behind the failed panel, which held portions of the failed panel in place while allowing visibility of the failed panel, locating the origin pieces was relatively easy.

**Figure 4:** Detail of fracture origin piece remaining on the intact portion of the panel. **Figure 5:** Detail of fracture origin piece among the fallen debris.

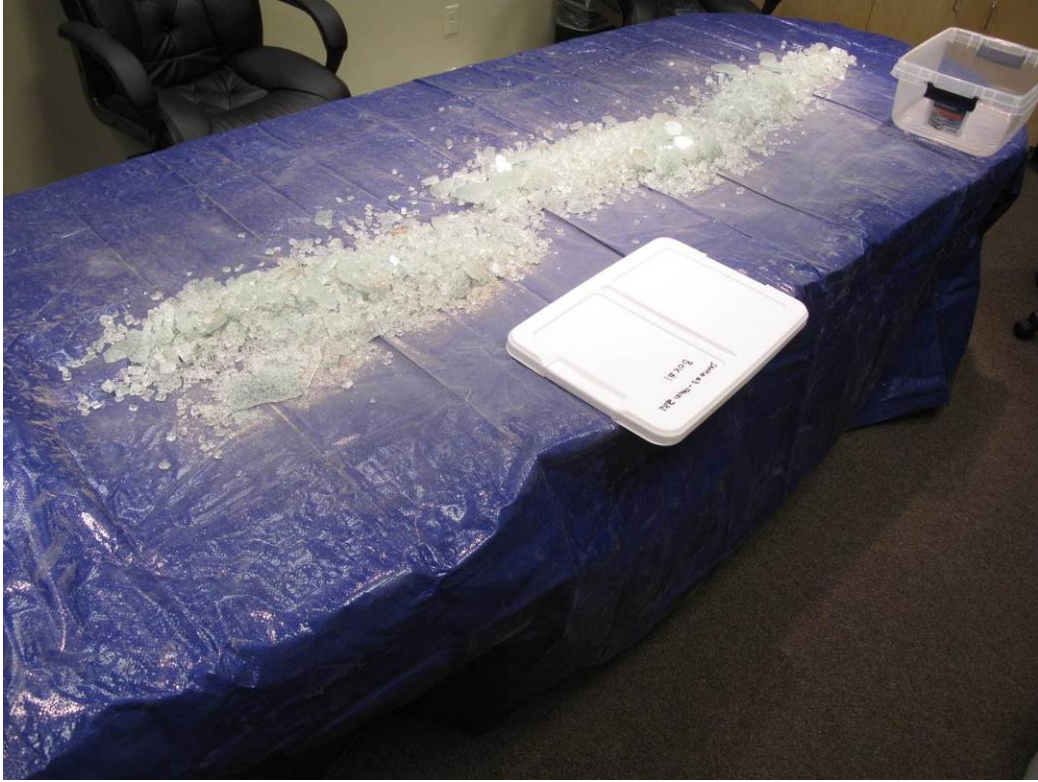
**Figure 6:** Material from container poured onto viewing surface.

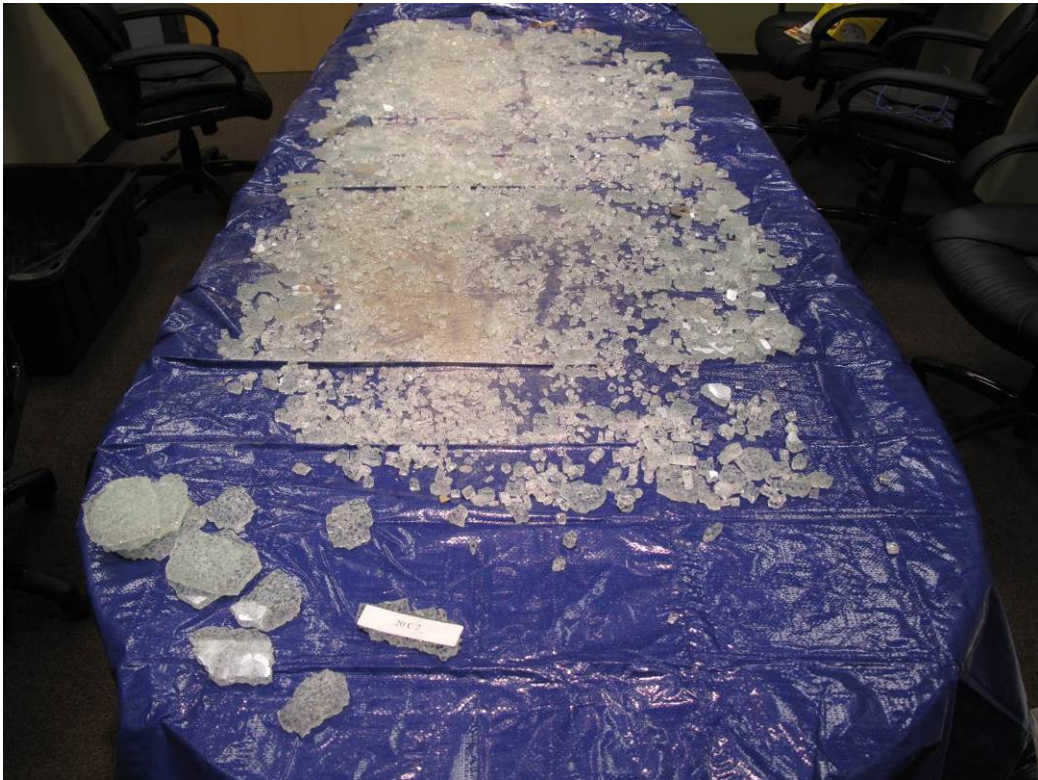
**Figure 7:** Material spread, larger groupings separated.

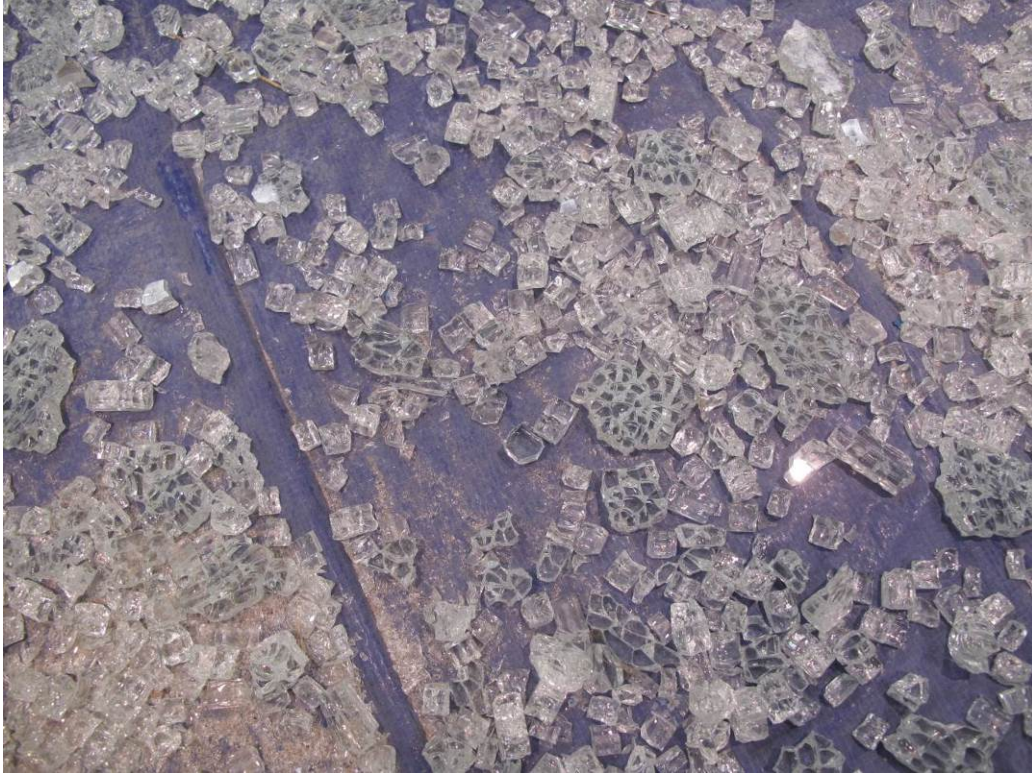
After a panel failure several stories above ground level, the debris was collected by building maintenance personnel. No documentation of any intact portion of the panel was maintained immediately after failure. The authors utilized the methodology contained herein. The debris was removed from the site and taken to a well-lit area and spread over a viewing surface (Figure 6). Groupings of pieces were sorted and inspected first and moved to the edges of the viewing surface (Figure 7). Then the remaining pieces were spread over the viewing surface and small, manageable quantities of the pieces were inspected and set aside before inspecting another quantity. In this particular case, a fracture origin piece was located by the authors while spreading the smaller pieces, due to its distinct size and shape in comparison with the other pieces (Figures 8 and 9).

**Figure 8:** Small groupings and pieces dispersed.

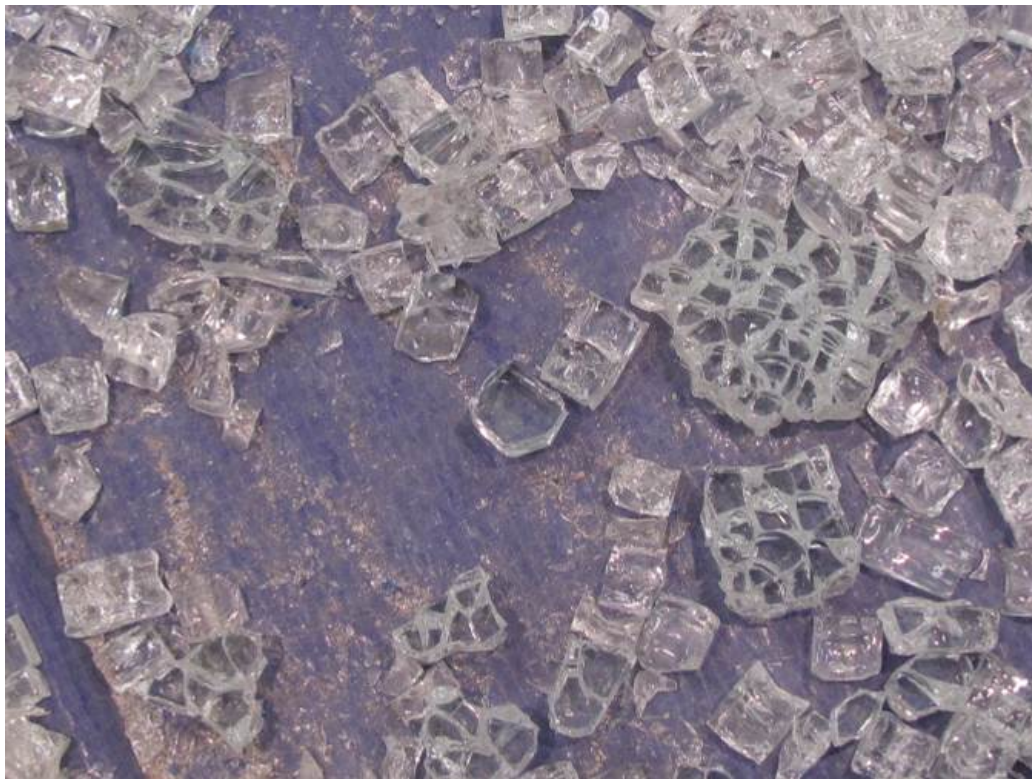
**Figure 9:** Closer view of previous figure. Failure origin distinct among other pieces.
