PERFORMANCE OF STRUCTURES SUBJECTED TO WEST FERTILIZER COMPANY EXPLOSION

Erik L. Nelson, Ph.D., P.E., M.ASCE¹

Jeffrey L. Hull, M.S., E.I.T.²

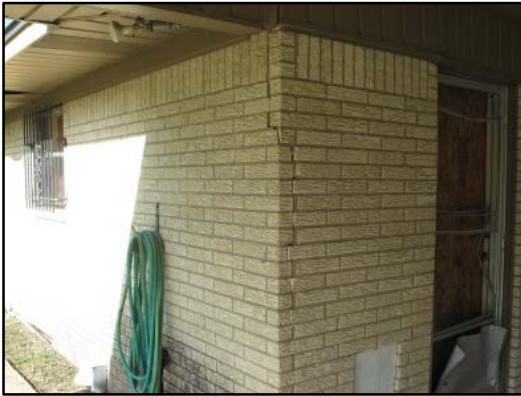
The failure planes of significant diagonal fractures and stair-step veneer separations were typically oriented in a direction consistent with the travel of the shock front and are consistent with shear failures due to rapid and severe loading. The near-vertical separations and fractures were observed at the corners of structures (see Figure 1) are consistent with both in-plane and out-of-plane deformation of the veneer.

Figure 1. Near-Vertical Fractures at Exterior Corners

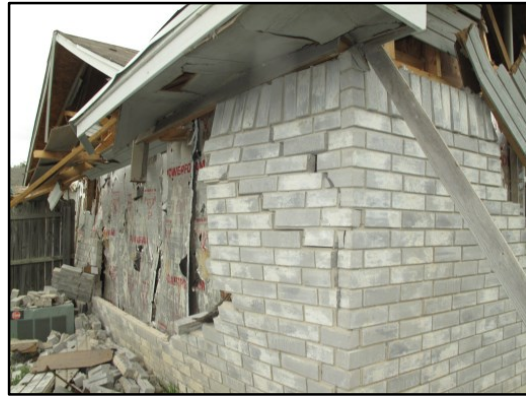
Due to the rapid and significant loading on the structural framing induced by explosion overpressures, the structure and its framing members can undergo significant displacement and deformation, even before rupturing of framing, which can lead to unanticipated transfer of load to "non-loadbearing" components. Large areas of collapsed veneer were often located adjacent to significant structural distress to roof eave framing and at locations where brick ties were not installed and/or engaged (see Figure 2). In general, the presence of severe and widespread veneer distress correlated with structures exhibiting severe structural damage.

Figure 2. Buckled and Collapsed Veneer at Structure Exhibiting Severe Structural Damage

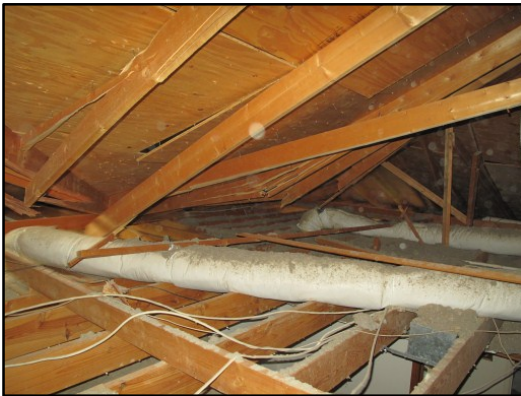
Rafters were fractured on both blast-facing and "leeward" roof planes (see Figure 3). The fractured rafters were permanently displaced inward on both of these planes, indicating dominance of positive loading throughout the roof. In addition to rafter fractures, many instances of fractured and detached purlins, and fractured and displaced struts, were observed within the attics.

Figure 3. Fractured Roof Framing

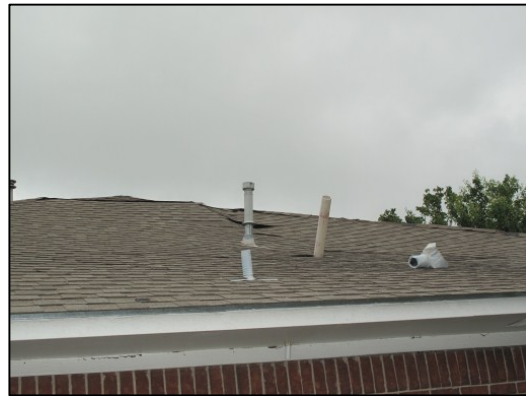
A pattern of shingle distress was not evident at the evaluated structures and is evidence of the relatively minimal contribution of dynamic pressures to the observed distress. Distortion of the shingles was limited to areas of fractured and permanently displaced roof framing and decking (see Figure 4). The lack of distress to shingles within high wind pressure zones and to nearby trees at

Figure 4. Shingle Distortion Isolated to Areas of Structural Roof Damage

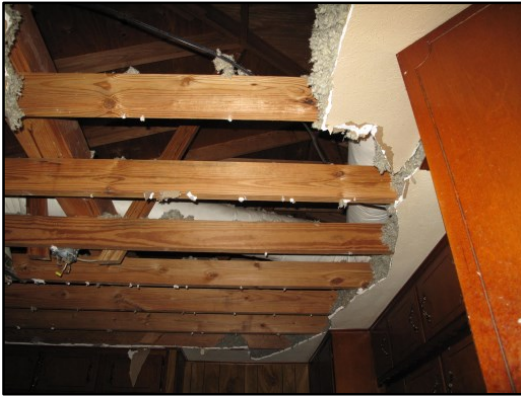
One of the more unique distress patterns related to explosion loading is the collapse of interior gypsum board ceiling finishes (see Figure 5 and Figure 6). This indicator has been repeated in other explosion events investigated by the author's firm. Pressurization of the attic space, which occurs due to openings in the attic envelope and displacement of the roof framing/decking, creates an unbalanced load on the gypsum board ceiling panels, ultimately causing failure of the panels. Openings in the attic envelope can occur due to attic venting and severe structural distress to the roof framing and decking.

Figure 5. Collapsed Ceiling Finish

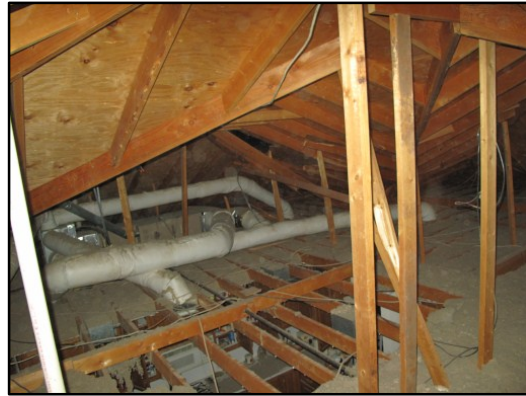
Figure 6. Collapsed Ceiling Finish

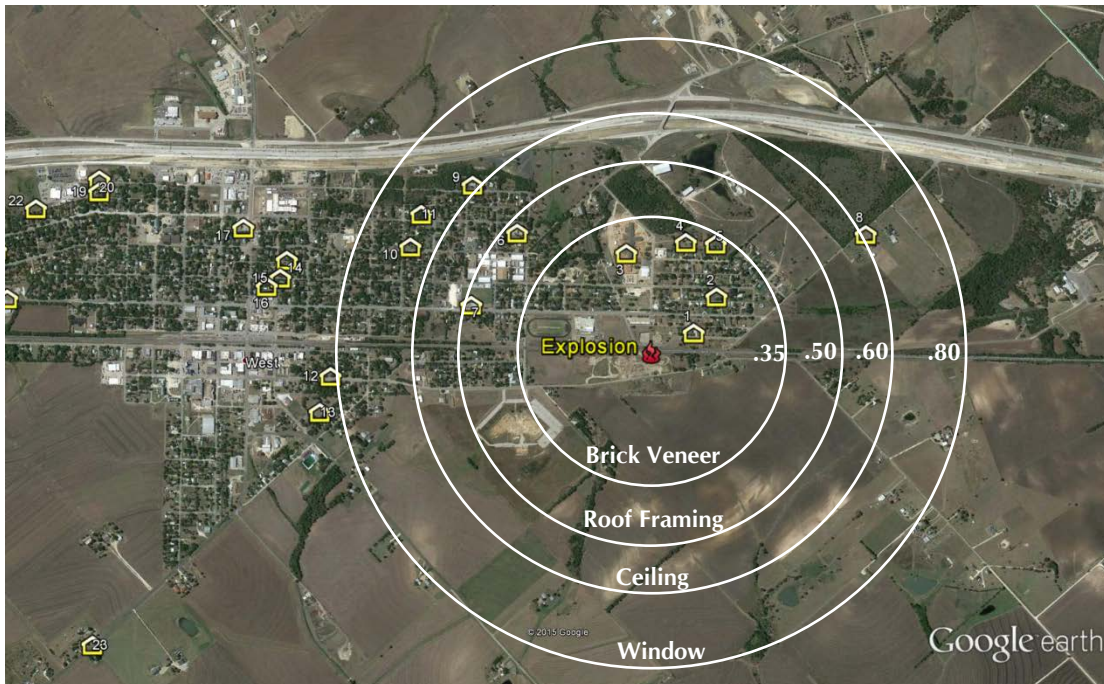
Figure 7 shows the locations of select structures evaluated by the author's firm. Radial distance markers are overlaid on Figure 7 to show the extents of distress mechanism propagation as determined by the authors from the collective review of the 35 evaluations. Table 3 summarizes key observations from the 35 evaluations and can be correlated to the structure numbers in Figure 7.

Figure 7. Overview of Evaluated Structures and Extents of Distress Propagation
