Potential Pitfalls of a Green Building Material: A Case Study of Cellulose Insulation

CASE STUDY

Introduction

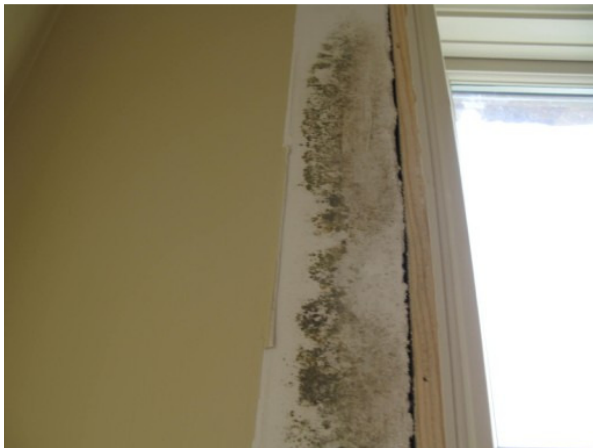
- Efflorescence on the exterior stone veneer typically below window sills.
- White staining on the hardwood wall paneling *behind* the clear finish.
- Mold on the gypsum board *behind* the painted wood trim (**Figure 1**).
- Mold on the exposed gypsum board *behind* the hardwood paneling (**Figure 2**).

Figure 1. Mold behind removed wood trim

The mold growth on the interior wall surfaces was noted behind the finished hardwood and painted wood trim, but not at the exposed painted gypsum board walls. The relevant difference between the gypsum board and the enameled wood trim and varnished paneling is that the latex-painted gypsum board is vapor permeable, while the enamel-finished wood trim and varnish-finished plywood paneling act as vapor retarders.

Moisture was trapped at the back side of the varnished and enameled materials because these finishes are vapor retarders and prevent the wet cellulose insulation from drying to the inside of the structure. Moisture passed across the vapor permeable painted gypsum board surfaces. **Figure 4(a)** represents the walls with painted gypsum board finish. **Figure 4(b)** represents the walls covered with hardwood paneling and painted trim.

1. Masonry cavity wall moisture intrusion is inevitable and drainage of the cavity wall is an intrinsic design requirement. It is imperative that cavities are kept clean of mortar droppings during construction.
2. Cellulose insulation should be allowed to dry in at least one direction. Installation of cellulose insulation between two materials that perform as vapor retarders in an exterior wall is not recommended. The same recommendations should be considered when vapor semi-permeable materials are used.

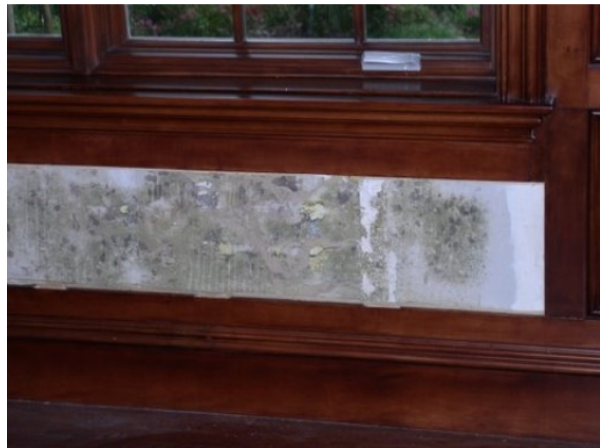
Figure 2. Mold on gypsum board behind removed wood paneling

In the subject structure, moisture was trapped between the exterior vapor semi-permeable OSB and the interior vapor retarders (varnished hardwood paneling and enamel-finished wood trim). Water condensed behind these interior elements when the dew point of the moist air was reached within the stud wall. The use of vapor barriers in walls insulated with cellulose is not recommended (CIMA 2011).

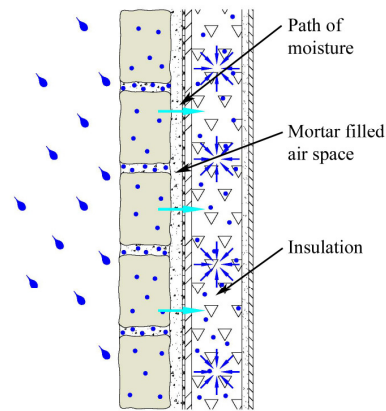
If the water cannot shed properly from and through the air space, it will collect in the air space, locally increasing the humidity inside the building envelope and eventually finding another path to escape the air space such as migrating towards the interior of the structure. **Figure 3(a)** illustrates a properly constructed cavity wall where moisture that has traveled through the porous veneer drains down the drainage plane within the air space to the exterior. **Figure 3(b)** illustrates a non-functioning air space filled with mortar. The moisture absorbed by the veneer migrates across the mortar by capillary suction and into the wood framing and insulation.

Figure 3(b). Improperly constructed wall cavity

Additional stones were then removed from various locations on all sides of the structure in areas corresponding with observed interior distress, both in the field of the wall and adjacent to windows. The stone removals revealed a general lack of an air space behind the stones, with mortar packed against the Tyvek barrier. At the exposed window locations, improper or missing flashing was observed.

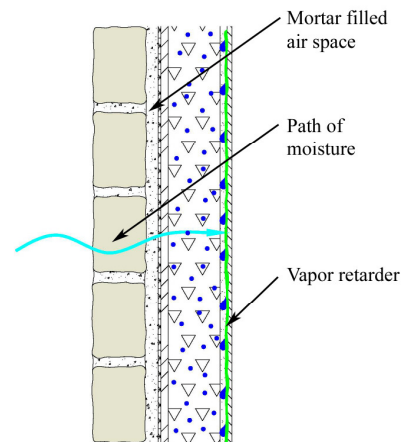
Figure 4(b). Moisture blocked by vapor retarder
