Case Study of Stone Veneer Failure
Deepak Ahuja, M.S., P.E., M. ASCE
Stewart M. Verhulst, M.S., P.E., M. ASCE
Andrew M. Noble III, B.Arch., R.A.

Abstract

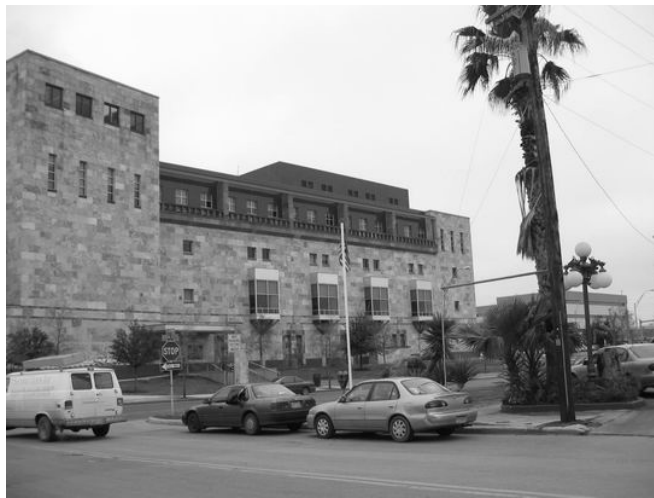
Figure 1. General view of Building A exterior.

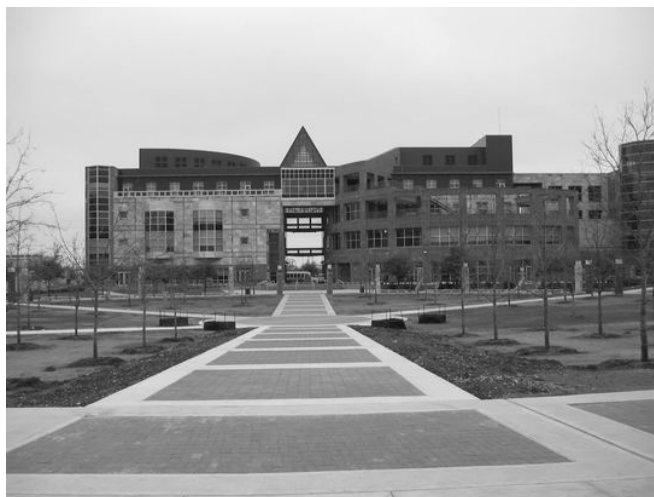
Figure 2. General view of Building B exterior.

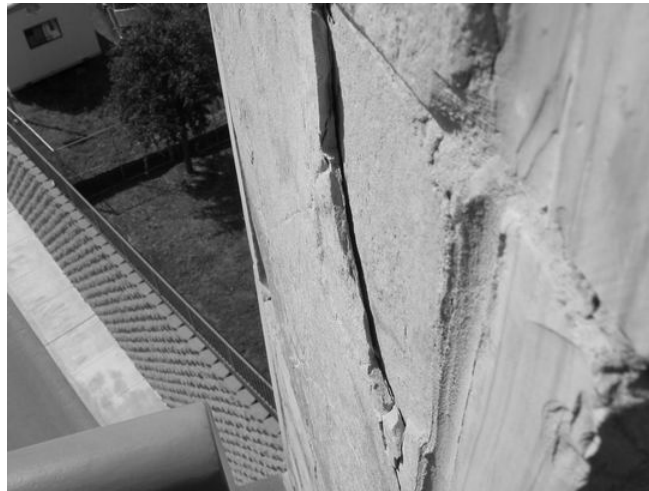
General. Dimension Stone is defined as, "a natural building stone that has been cut and finished to specifications" (MIA, 1999). Two main types of dimension stone veneer were used in the veneer for the buildings, limestone with a natural rock face and red sandstone with a natural rock face. All of the stone veneer on the buildings has been observed to have the rift or grain in a vertical orientation. Therefore, the

forces from the stones' self-weight are in-line with the direction of the layering within the stone (refer to Figure 3). The specifications indicate a dimensional stone depth of 2 1/2"-3" for the veneer system; and Type N mortar with Type S lime for the mortar in the dimension stone veneer system. A typical dimension stone in the veneer system measures 24" wide x 20" high and has an estimated weight of 115 lbs. The specifications indicate stainless steel anchors, spaced at 18" on-center, for the stone veneer anchors. The design documents indicate a steel lintel support for the veneer at each floor level.

Figure 3. View of stone veneer – note vertical orientation of the grain.

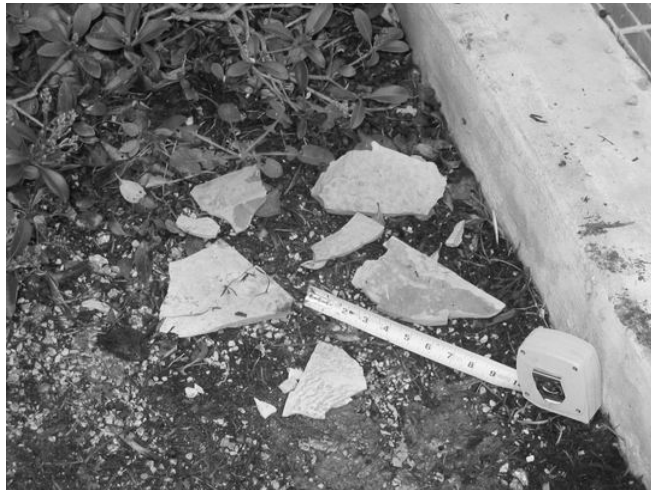
Delamination of Stone. Pieces of delaminated stone were noted all along the perimeter of the building (Figures 4 and 5). The stone debris at the surrounding ground was of various sizes, although it should be noted that the size of debris is misleading, as the stone shatters when it falls from the wall above and impacts the ground. The largest debris pieces observed were up to 7" in length (Figure 5) and were generally about 1/4" thick. All of the limestone veneer on the buildings has been observed to have the rift (or grain) in a vertical orientation.

Figure 4. Pieces of delaminated limestone veneer on the ground.

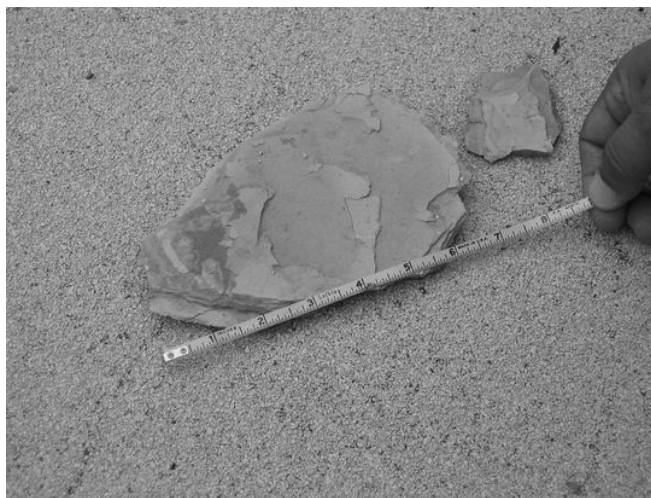
Figure 5. Piece of delaminated limestone measures 7" in length.

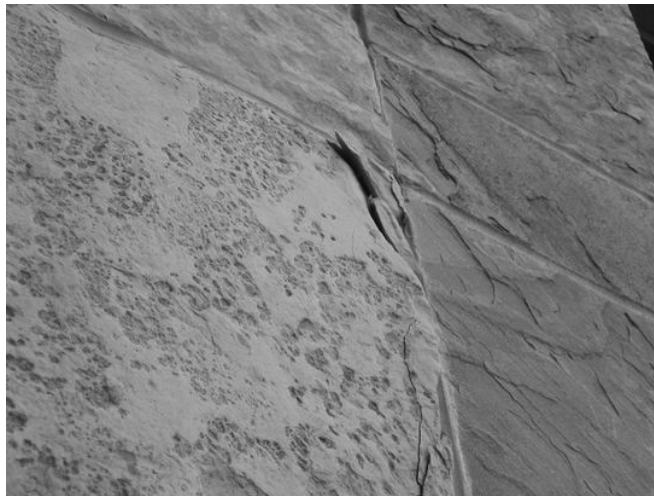
Active delamination was observed at the limestone veneer for the buildings. Figure 6 indicates a piece of limestone which has delaminated from the surface of a veneer stone, but has not yet fallen. This condition exists throughout the exterior veneer walls of both buildings.

Figure 6. Delaminated limestone veneer at Building A.

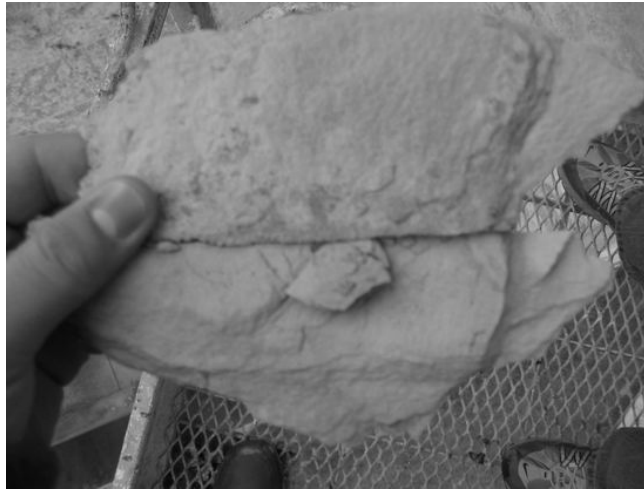
During evaluation of the buildings, the horizontal expansion joints were measured to have joint widths typically less than that indicated on the plans. Some expansion joints were completely closed, that is, the stones on either side of the joint were in

direct contact (Figure 7). Also, expansion joint sealant material appeared compressed and was observed to be bulging at many joints. Delamination of the stones was observed at the corners of the joints where the stones were in contact.

Figure 7. Delaminated stone pieces with no expansion joint.

Measurements of the expansion joints were commonly only 1/4" wide, and several joints were determined to not extend for the full depth of the stone. Also, at some expansion joints, stones were observed to be "buckling" (i.e. deflecting outward at the joint). The lack of proper expansion joints was contributing to the delamination of the stones at the corners. The lack of joints also causes increased stresses in the stone veneer when it experiences movement or expansion, such as related to temperature or moisture.

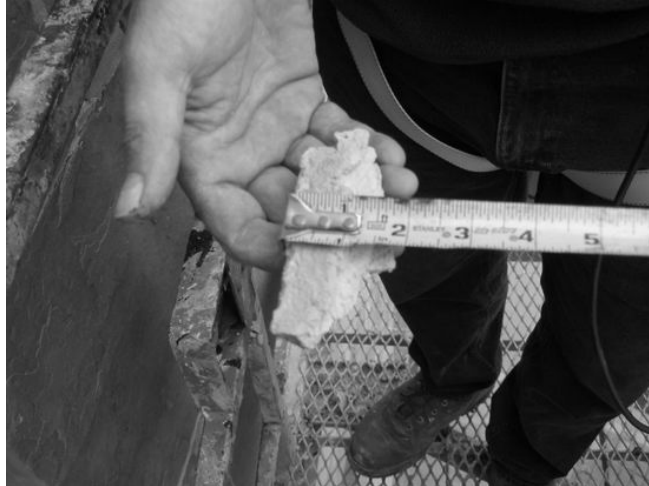
Based on measurements from mortar samples taken from the site, the bed depth of the samples ranged from 1" to 3", and averaged 2" on one building and 1 5/8" on the other. Of the samples from both buildings, 64% had measured mortar depths of 2" or less. Figure 8 indicates a typical piece of mortar extracted from the joints, measuring only 1" in depth.

The lack of full mortar joint depth indicates improper construction and contributes to a loss of strength in the overall veneer wall system. Incomplete horizontal mortar beds would also cause increased bearing stresses at the ends of the stone veneer. This could cause stress concentrations at the stone surface and could contribute to the failure of the stone along lamination planes.

Figure 8. Depth only 1" at extracted mortar.

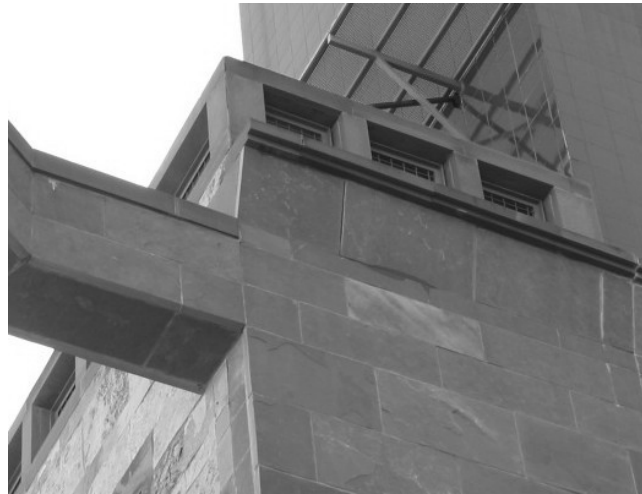
- At the corner of the fourth floor terrace (at the front façade and located over a high-traffic courtyard area), stone coping and angled veneer were present along the wall. The coping at this corner was observed up close from the terrace above and also with the use of an articulating boom man-lift. Separations and displaced mortar were noted at the joints between the angled veneer stones and between the coping stones. The veneer is angled 45° at this location (see Figure 9 to view the angled stone veneer).

At the first stone from the corner, mortar was missing from most of the vertical joint and the second coping stone from the corner had apparently rotated outward. Evidence of residual moisture was observed at the joints between the coping and the angled veneer and also at the joints along the bottom of the angled veneer. These joints and the stone adjacent to the joints appeared to be saturated with water.

At the northeast corner, the stone at the corner was separated 1/4" and the horizontal mortar joint below had fractured, apparently from differential movement. This corner stone and the two stones adjacent were loose. They could be rotated slightly at the outside edge by hand. These stones, especially the corner stone, exhibited a range of rotational movement which was not consistent with the attachment detail indicated in the drawings for the building.

A metal detector was used to locate the anchors for the coping stones and for the angled veneer. Generally, it was observed that there were two anchors along both the top and bottom of the angled veneer. However, at the corner coping stone, no anchor attachment was noted.

Because the loose and rotating coping stones at the northeast corner were a concern, a block of the stone veneer at the east side of the corner was removed to allow visibility into the wall cavity and behind the coping. This removed 15" x 7" block was not anchored to the wall at the top or bottom and was only

supported by the mortar joints at the bottom and the sides and by the caulk material in the joint along the top of the stone. From this opening, the condition along the back side of the coping stones was visible. Metal shelf angles for the stone railing and for the coping at the edge were noted. Corrosion was observed at visible sections of the angles. Also, the coping was not set flush with the concrete frame and there was no anchor attachment visible from the coping into the concrete. The lack of a coping-to-concrete anchor was noted along the entire visible length at the back side of the coping.

The conditions at this area of the building represented a danger to public health, safety, and welfare.

Figure 9. Angled stone veneer at fourth floor. There is no mechanical horizontal anchorage to the concrete structure.

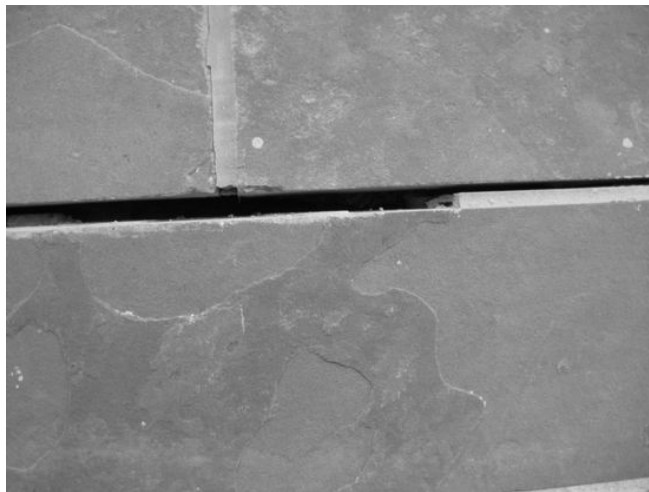
- At the main ground level entry to one of the structures, separated and displaced dimension stone veneer was observed. The mortar joints in the stone veneer above the center opening were separated, and a downward movement of the veneer was observed in the approximate shape of an arch starting from the header course above the opening. Figure 10 below shows the displacement of the veneer above the entry and the loose mortar. The separations were measured, as 15/16" at horizontal joints and the mortar was loose and easily removed by hand. Some repairs had been done previously; however, the separations re-opened and the stone continued to displace. Although the support could not be seen from the wall cavity due to excessive mortar, similar details at other openings had a lack of full support for the stone. At one location above another entry door, a gap between the stone and the steel support lintel was observed.

Figure 10. Veneer displacement and loose mortar above entry.
