Structural Evaluation Procedures and Case Studies of Damage Related to Wind Storms, Tornadoes, and Hurricanes

Kerry S. Lee, MBA, P.E., MASCE¹

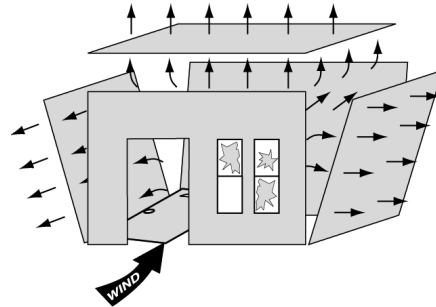
During the exposure transition, design wind pressures on the windward wall and roof effectively transition from a positive pressure in the direction of wind flow to a negative pressure, acting in the opposite direction from the prevailing wind. In addition to the pressure reversal on the windward side, the pressures acting on the leeward side and ends of the structure increase by 60% and 63%, respectively. If an internal pressure coefficient of 0.8 is used, this increase in leeward pressure increases by an average of 200% from the values obtained for an enclosed structure. "An opening on the windward face of the building can also lead to a failure by allowing positive pressures to occur that, in conjunction with negative pressures, can 'blow the building apart.'" (FEMA, 2000)

Figure 1. Building Failure Due To Internal Pressurization (FEMA, 2000)

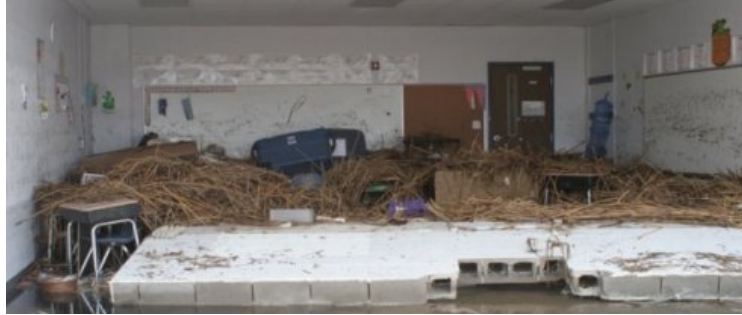
At School A, approximately three to six feet of storm surge was incurred at the structure. The post-storm photographs taken by others indicated that the south non-structural stack bond concrete masonry unit walls had collapsed in a manner consistent with being pushed inward at the bottom, which is indicative of storm surge damage as shown in Figure 2. Additionally, the post-storm photographs showed that the papers and posters in the classrooms were still attached to the walls, as shown in Figure 3, indicating that the winds were not strong enough to damage the papers taped or tacked, to the walls, much less a CMU wall.

Figure 2. Collapsed CMU walls

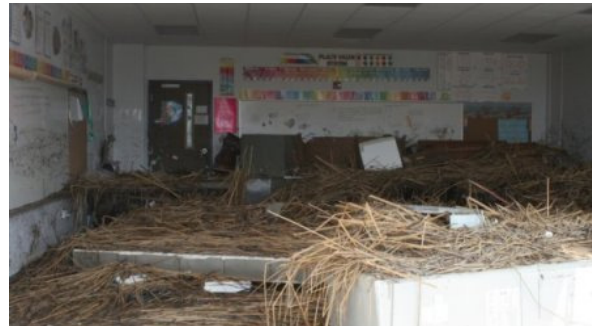
Figure 3. Papers still intact at interior

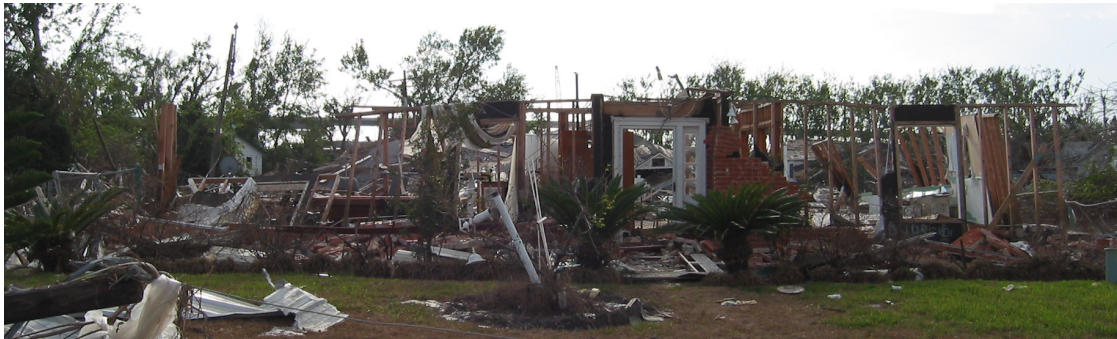
The cladding of the structures as well as the framing, was generally completely destroyed by Hurricane Katrina, as shown in Figure 4. Typically, the brick was observed to have fallen away from each face of the structure while the wood wall framing and windows ranged from partially intact to completely collapsed, as shown in Figures 4 and 5.

Figure 4. Typical condition of remaining structure

The subject structures indicated common evidence of structures that had burst, or effectively exploded consistent with internal pressure build-up. The brick veneer on the structures was typically observed to have fallen outward from each face of the structure, which is consistent with a bursting or explosion of the structure due to high wind forces.

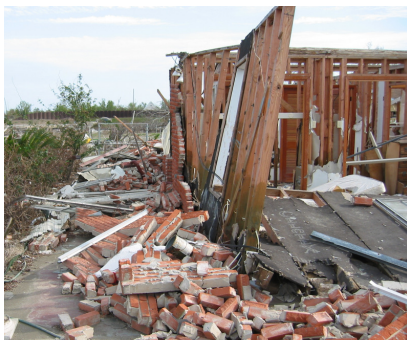
Figure 5. Brick veneer distress

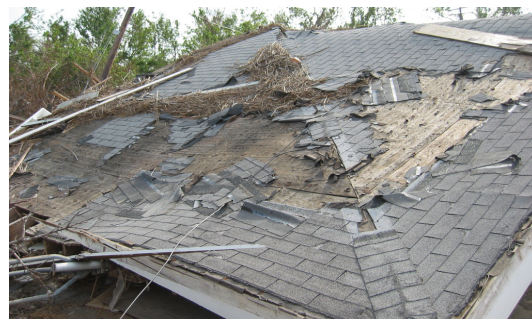
Figure 6. Typical roof distress

The roofs of the structures investigated were observed to be completely dislocated

from the structure and some of the roofs were observed to have been deposited on the ground, while others were completely gone. Additionally, extensive wind damage was observed to the roof shingles at the displaced roof systems, as shown in Figure 6.

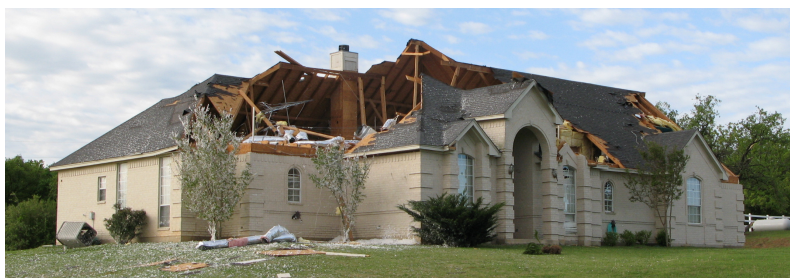
The north pitch of the structure was severely damaged with large portions of the roof decking and rafters displaced from the northwest and northeast planes of the roof and deposited into the yard at the east elevation (Figure 7). Missing and fractured rafters, ridge beam, and hip and valley members were observed at the north side of the structure as shown in Figure 8. Minimal damage was observed at the south pitch of the roof framing system.

Figure 7. Condition of structure

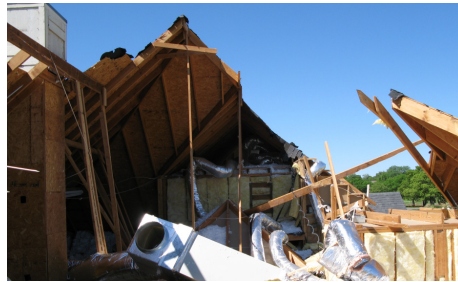
Figure 8. Roof framing distress

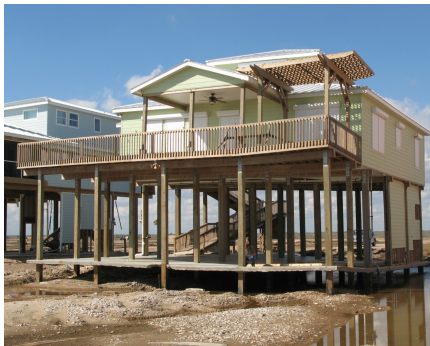
Typical observations at the ground level of the structures included undermined concrete seal-slabs, displaced and missing breakaway wall framing, and in some cases, a significant amount of soil scouring and erosion (Figure 9). The exterior siding and any impacted wood framing was typically displaced by storm surge and wave action. In addition, many of the wood pilings were displaced as the deck support framing was removed (Figure 10). Roof distress was typically limited to isolated areas of loose and missing shingles.

Figure 9. Erosion of soil

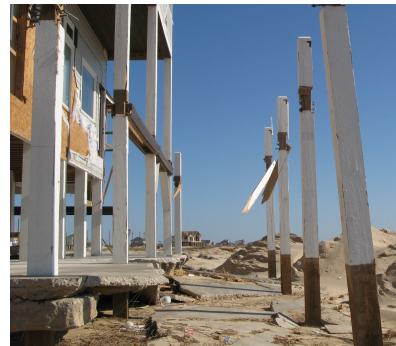
Figure 10. Missing/displaced framing
