**The Impact of Market Demands on  
Residential Post-Tensioned Foundation Design:  
An Ethical Dilemma**

**Abstract**

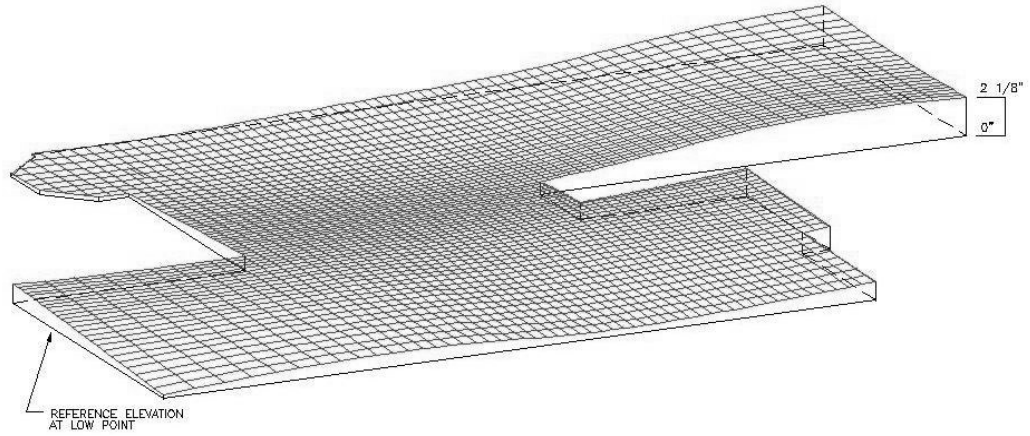
**Figure 1. Three Dimensional Representation of Total Out-of-Levelness  
Floor Plan A (28 Total Beam Tendons)**

The relative elevation survey of the foundation systems for these Floor Plan A plans indicated more out-of-levelness in the foundations as the number of beam tendons decreased. The out-of-levelness for the foundations with 28 total beam tendons, 23 total beam tendons, and 20 total beam tendons was measured to be 2 1/8", 3 3/8", and 4 3/8", respectively. Representations of the change in out-of-levelness in Floor Plan A are provided in the following Figures 1, 2, and 3:

<b>Date of Design</b>	<b>02/24/98</b>
<b>Total Number of Beam Tendons</b>	<b>28 Tendons</b>
<b>Total Out-of-Levelness</b>	<b>2 1/8"</b>

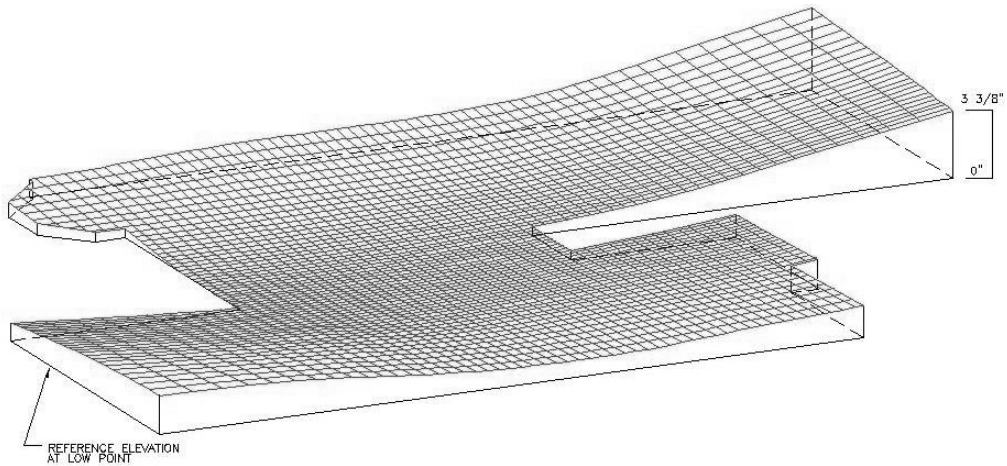
**Figure 2. Three Dimensional Representation of Total Out-of-Levelness  
Floor Plan A (23 Total Beam Tendons)**

<b>Date of Design</b>	<b>06/12/98</b>
<b>Total Number of Beam Tendons</b>	<b>23 Tendons</b>
<b>Total Out-of-Levelness</b>	<b>3 3/8"</b>

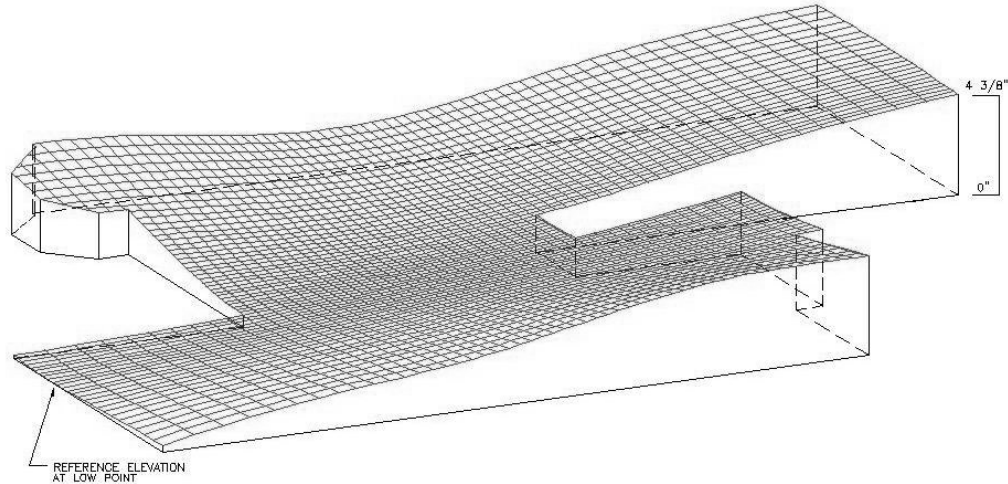
**Figure 3. Three Dimensional Representation of Total Out-of-Levelness Floor Plan A (20 Total Beam Tendons)**

<b>Date of Design</b>	<b>06/20/98</b>
<b>Total Number of Beam Tendons</b>	<b>20 Tendons</b>
<b>Total Out-of-Levelness</b>	<b>4 3/8"</b>

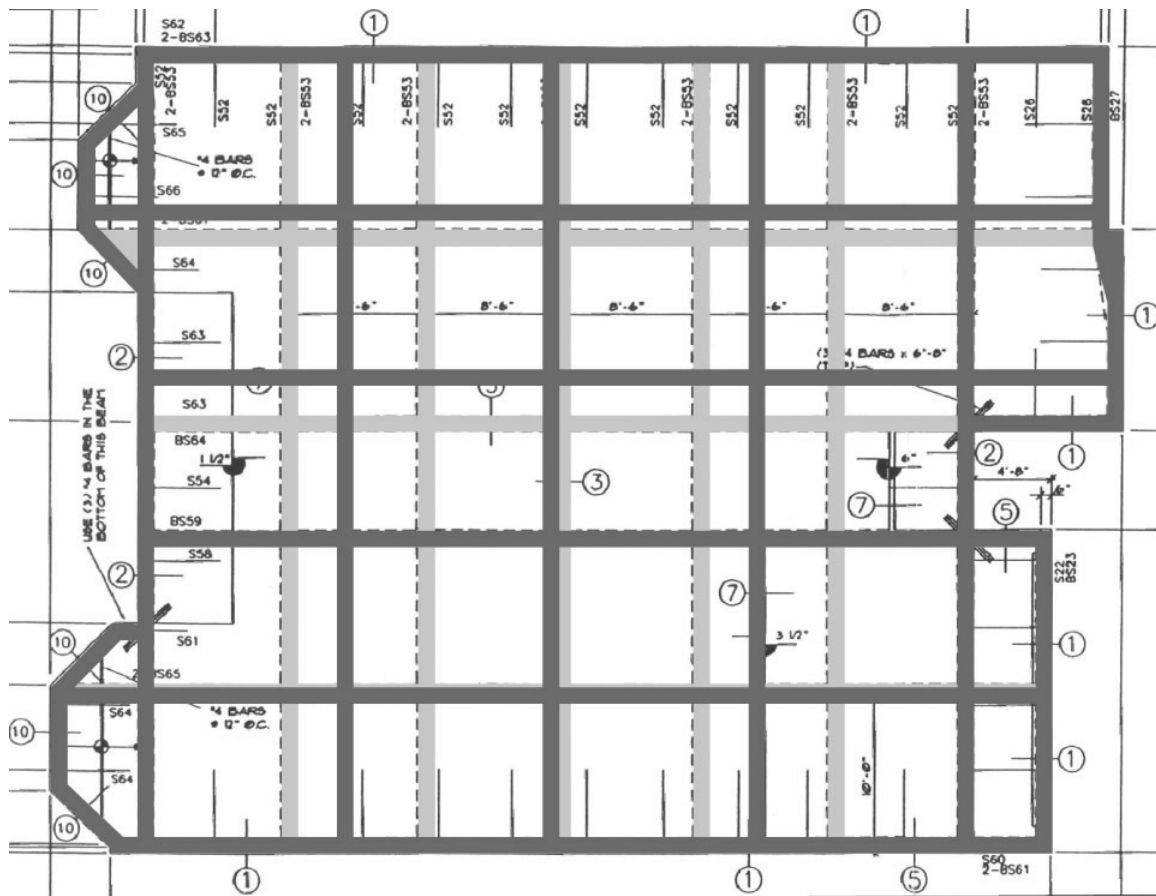
**Figure 4. Beam Layouts from Foundation Designs for Floor Plan B**

A graphic presentation has been prepared to demonstrate the differences in beam layout between Engineers Alpha and Beta. The grade beam locations were highlighted in a floor plan used by both engineers (Floor Plan B), and the highlighted grade beam locations from the plan designed by Engineer Beta was overlain on top of the highlighted beam locations from the design by Engineer Alpha. The graphic presentation is provided in Figure 4; the darker beams are representative of the design by Engineer Beta. Note that there are fewer short direction grade beams in the design by Engineer Beta.

It is interesting to note that Engineer Beta had the deepest grade beams of the three engineers, and, for this sole reason, was not brought in as a party to the litigation. However, due to the use of fewer beams and less reinforcing tendons, the designs performed by Engineer Beta actually failed with much higher design overstress than Engineer Alpha.
