## **Use of Watermarks for Discerning Hurricane-Induced Flood Levels**

Erik L. Nelson, Ph.D., P.E., M. ASCE <sup>1</sup>

### **Abstract**

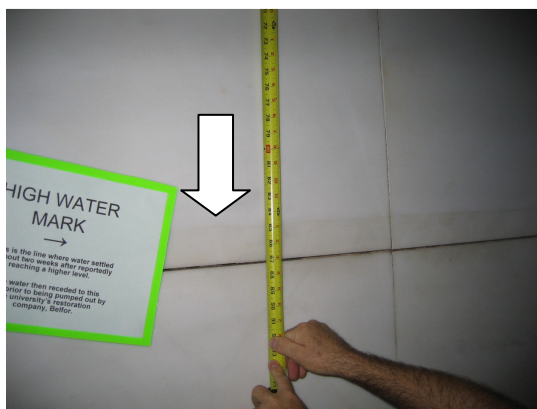
Figure 1: Tulane University Library Basement

**Watermarks:** The author estimated the maximum flood level within the structures by measuring stains/watermarks left by standing water and debris on interior and exterior finishes including glass window panes, gypsum board, exterior siding, etc. All watermark data were referenced to NAVD 88. Typical watermarks found on these and other structures in the New Orleans area can be viewed in **Figure 1 through Figure 6**, below.

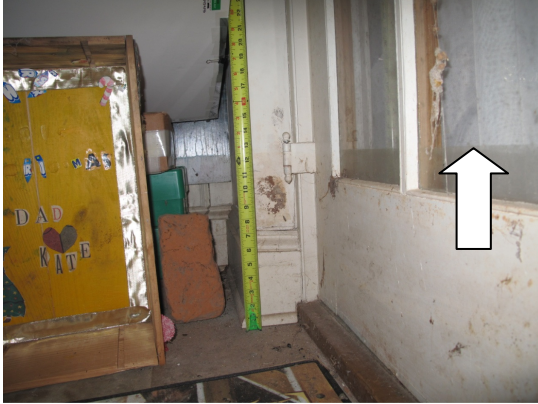
**Figure 3: Glass Paneled Door**

It was the author's experience that the clearest watermarks appeared along vertical glass surfaces, such as window panes or storefronts. Watermarks along organic materials, such as wood and gypsum board, were often accompanied by fungal growth that masked a clear line of previous flood water elevations. Masonry materials found along the exterior of structures were less conclusive in the discovery of a clear watermark due to the cleansing of the masonry surfaces during rain storms.

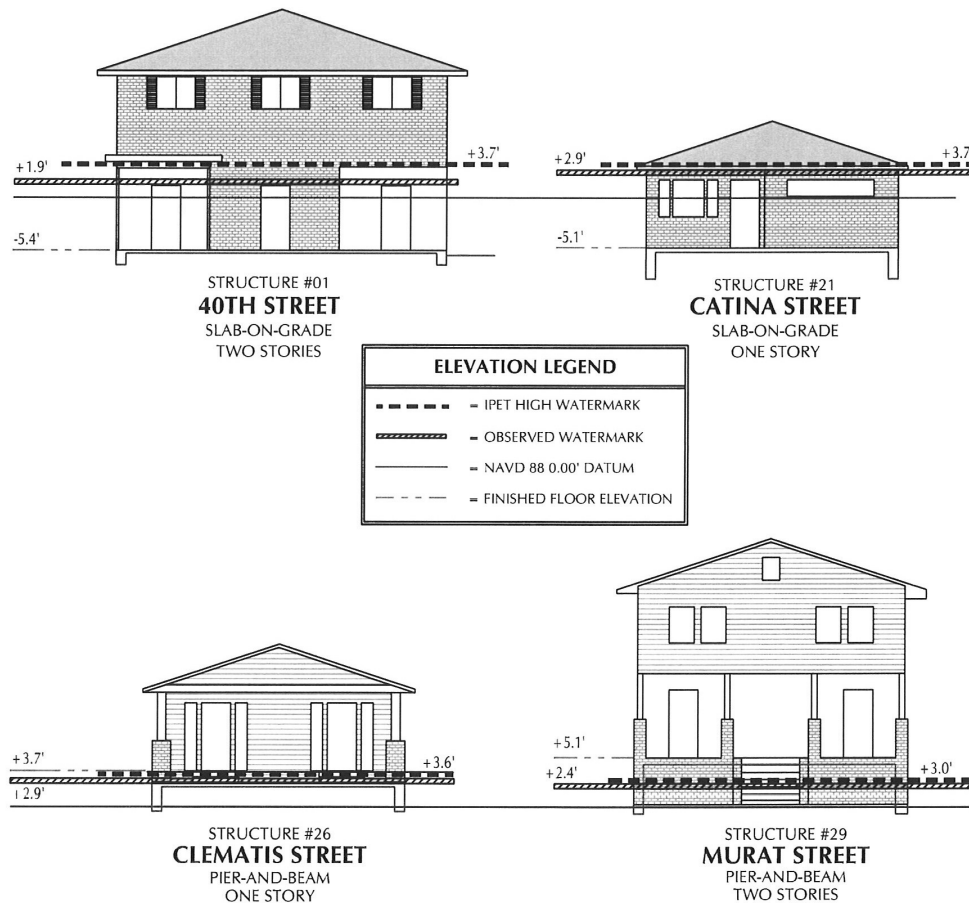
**Figure 7: Watermark Data**

**The Interagency Performance Evaluation Taskforce (IPET)** was established by the U.S. Army Corps of Engineers in the fall of 2005 to provide scientific and engineering answers to questions about the performance of the New Orleans and Southeast Louisiana Hurricane Protection System during Hurricane Katrina. As part of its evaluation, IPET documented flood water elevations throughout New Orleans. The author found reasonable correlation between watermark data and IPET published data as illustrated in **Figure 7** and the graph of author-observed watermarks versus IPET-reported elevations in **Figure 8**.

The author estimated damage to interior finishes using the field-measured watermark elevations, when available. In some instances, due to the perishable nature of watermarks, the author estimated damage to interior finishes using water elevations above finished floor (A.F.F.) based on the IPET high water elevations (IPET, 2006). However, with an instinct for knowing where to look, such as unfinished spaces, crawl spaces or basements; watermarks could be located on most of the structures, even years later.
