Wright House, Wrong Peril A Case Study in Hail Damage to a Frank Lloyd Wright Residence

Erik L. Nelson, Ph.D., P.E., M. ASCE ¹

Abstract

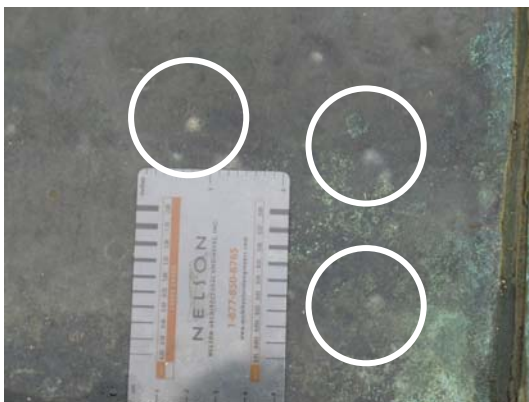
A site visit and examination of the damage were performed by the author initially on April 30, 2004. Indentations consistent with hail impacts were evident throughout the roof (**Figure 2**). Weather research revealed that over 400 hailstorms had occurred in the vicinity of the structure since initial construction. The indentations represented superficial damage to the roof, but according to the adjuster triggered coverage for the copper panels. Therefore due to the obvious hail indents, the focus of the initial engineering investigation was on the cost of repair/restoration to the upper roof and not on the cause of loss. It was determined that roof could be "restored" for a cost slightly less than \$2,000,000.

Figure 2. Hail Indentations to Copper Roof

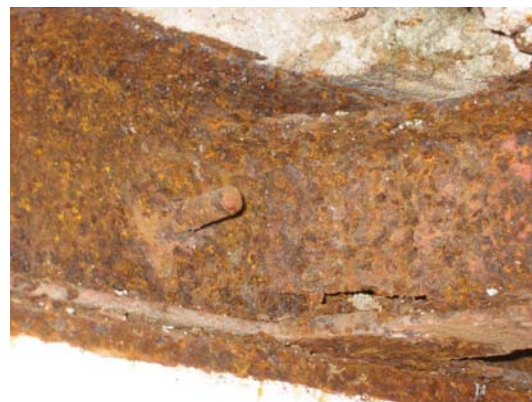
Restoration of the roof began in June 2004. However, as copper was removed and the associated underlayment, batten boards and concrete deck were uncovered, problems were revealed. This work essentially became inadvertent destructive testing and allowed viewing of the original construction. The original underlayment was severely deteriorated and the concrete deck was spalled and friable at the edges. Further, the owners had associated areas of plaster soffit removed only to find severe corrosion to the lathing, its supports, and structural steel framing (**Figure 3**). Expenses soared and soon the restoration scope of work became much more than a \$2,000,000 project.

Figure 3. Corrosion of Steel Framing (Claimed as Hail Damage)

During the course of the restoration, structural repair documents were prepared for steel framing repair; but at some point, policy limits of \$2,500,000 were reached and accordingly the insurance policy did not respond to corrosion and the other extensive water damage and mold that existed throughout the structure. The homeowners disagreed and later filed suit in 2008.

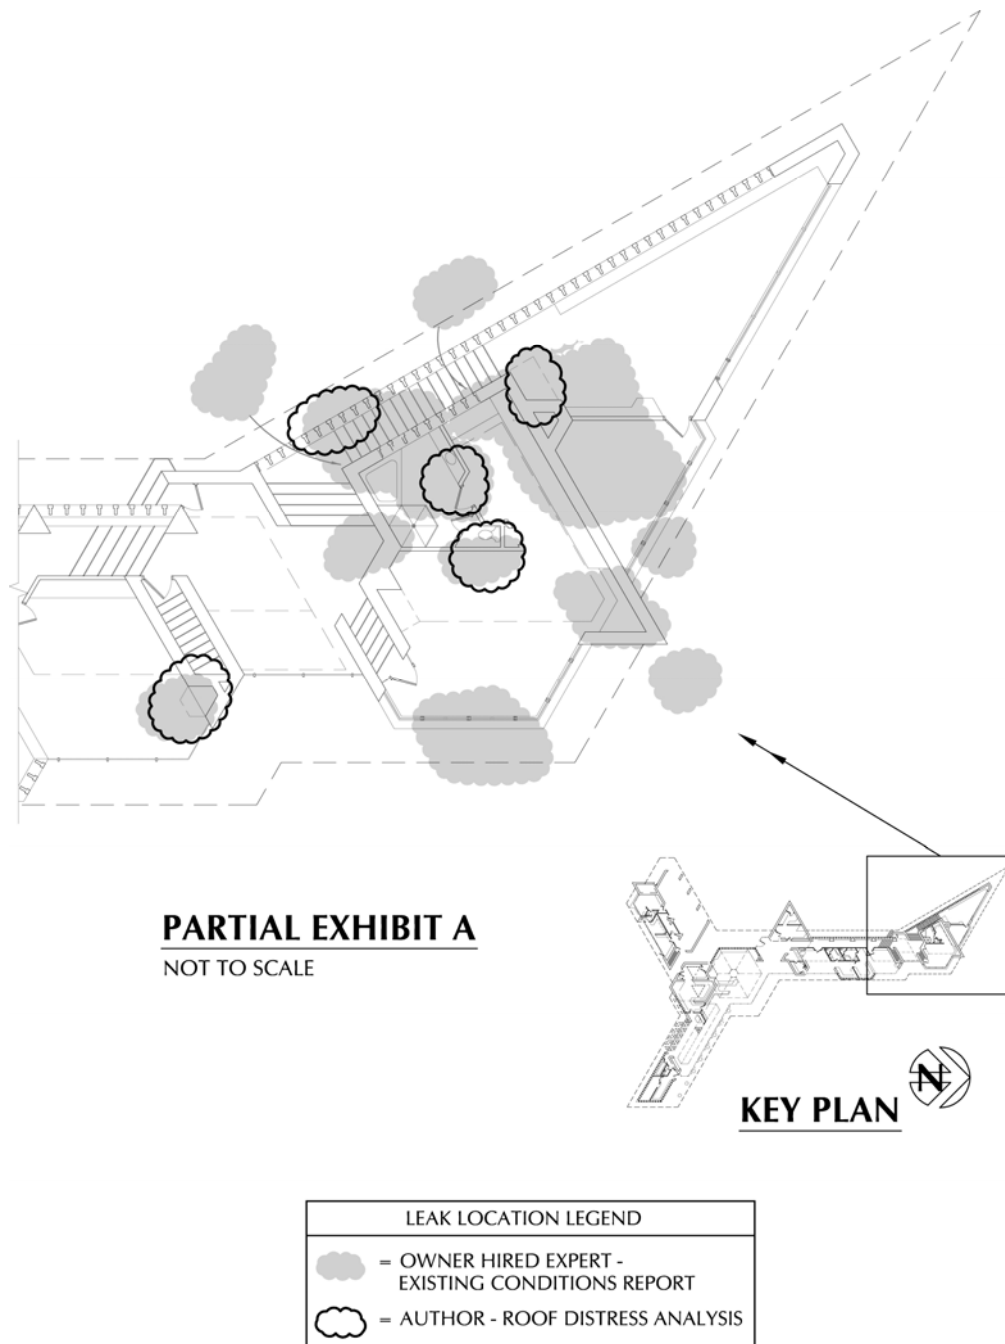
Enter Exhibit A (Figure 5): Data collection from the April 2004 site visit was compared to data collected by the restoration architect who had prepared a report dated March 20, 2003. Interestingly, the grid lines as established by FLW in the original design had been used by the restoration architect to locate approximately 50 primary areas of water intrusion. Thus, the grid lines provided a very accurate way to pinpoint the location of the previously reported leaks. By comparison, the author plotted the 2004 documented areas of water intrusion (many located by the owner and claimed as a result of the hail storm) and superimposed them on an architectural plan creating Exhibit A. The hail-claimed areas of water intrusion were shown to have pre-existed. In fact, the restoration architect documented many more that pre-existed the hailstorm.

Figure 5. Partial Exhibit A, Overlay of Author’s Findings versus Restoration Architect’s Pre-Storm Findings

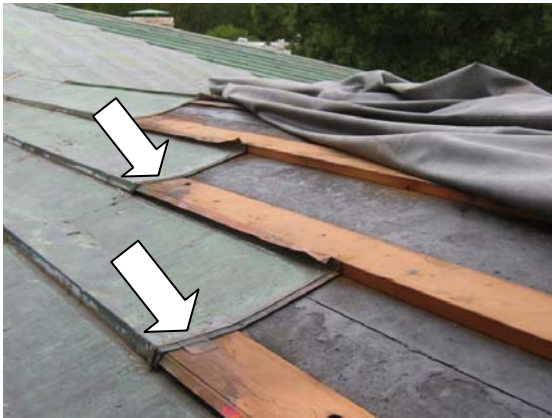
The mechanism for water intrusion was clear from destructive testing. Staining and drainage patterns on the batten boards told the story of water intrusion at the seams through normal wear and tear. Unraveling of the solder joints over time and the associated lower slope of the batten and bent copper, led to repeated long-term water intrusion (**Figure 6 & 7**).

As the low sloped roof changed close to a flat roof at the tapered batten, the drainage became poor. Water accumulated at these points and constantly "tested" the system. As time went on and the solder joints deteriorated from wear and tear (most likely thermal cycles), the joints eventually leaked and long term water intrusion damaged not only the roofing materials, concrete deck and steel framing, but the interior finishes of plaster and mahogany. Figures 6 & 7 clearly illustrate this mechanism by the staining patterns revealed.

Figure 6. Cause and Origin of Water Intrusion

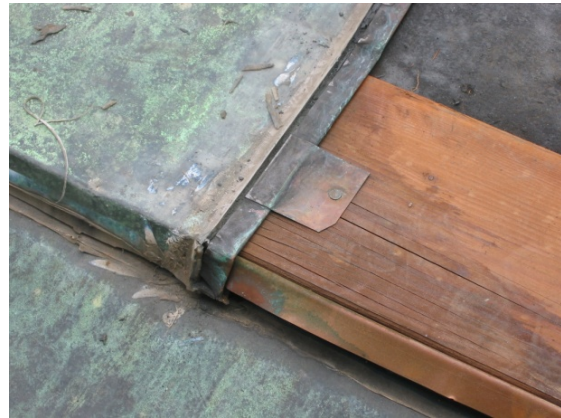
Due to the degree and extent of wood rot and steel framing corrosion, the author determined that water intrusion was a long-term condition not caused by hail and certainly not the result of the one recent hailstorm event alone. Further, hail impact was not evident at the seams and would not have occurred in a consistent manner as revealed by destructive testing.

Figure 7. Copper Seam and Water Staining on Cedar Battens
