Failure Analysis of a Reinforced Concrete Silo

T. Ebisch, M.S., P.E.¹ and R. Chancey, Ph.D., P.E.²

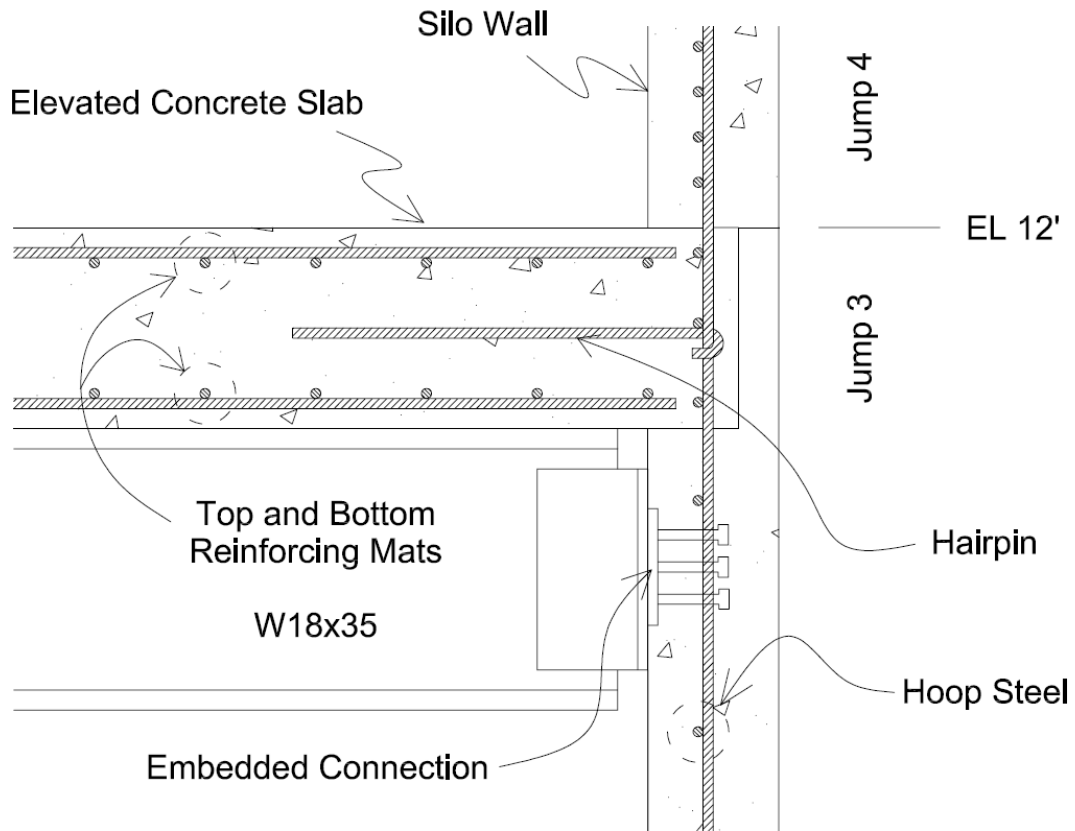
Figure 4. Conceptual section view of the steel framing connection and reinforcing steel at the elevated slab connection to the silo wall

According to the design drawings, the hoop reinforcing was intended to be located inside of the vertical reinforcement in direct conflict with the intent of ACI 313-97, see Figure 4 through Figure 6. While this deficiency was present in the design, numerical analysis was still necessary to determine if the as-designed silo wall would have failed under normal use if properly constructed. To accomplish this, multiple wall locations within Jump 4 were evaluated based loading conditions at the time of failure. Specifically, the silo wall was evaluated as if it was completely full; and using materials properties for the stored material from a lab testing report provided by the owner.

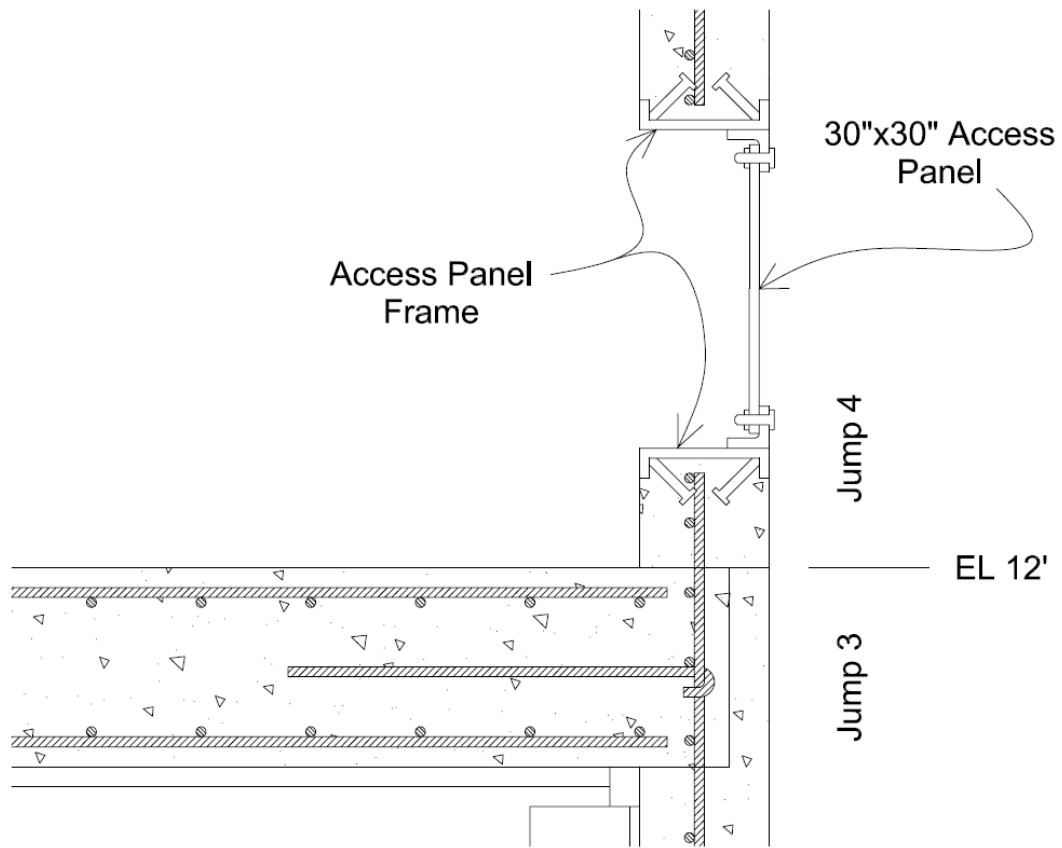
Figure 5. Conceptual section view of the 30"x30" access panel depicted in the design documents

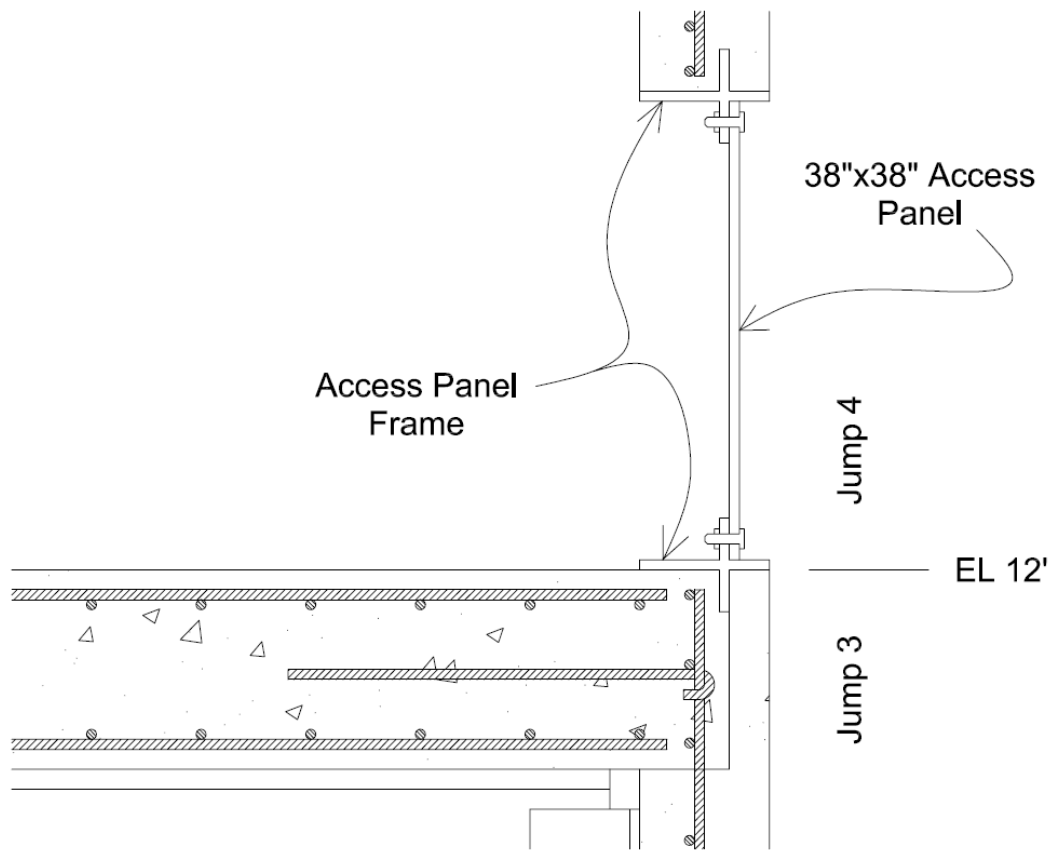
The as-built condition of the silo's access panels varied from that prescribed in the design documents. In lieu of installing the 30"x30" access panels specified in the design drawings, 38"x38" access panels were installed. These larger panels were constructed directly on the top surface of Jump 3 and the elevated slab, effectively replacing the 6 inches of concrete below the designed panel frame. Additionally, the frames of the doors varied from the design documents. The 38" panels included steel frames with embedded steel plates welded around their perimeter, as shown in Figure 6.

Figure 6. Conceptual section view of the 38" x 38" access panels installed during construction

As previously described, the silo was not constructed per the design documents. Specifically, larger access panels that framed into the silo wall differently than depicted on the design drawings were used. Additionally, the portion of the silo wall directly below the access panels and above Jump 3 depicted on the design drawings was deleted (refer to Figure 5 and Figure 6 for comparison).

Based on photographs of the failure, the embedded steel panels welded around the perimeter of the panel frames were cast between the exterior face of the elevated slab and the adjacent unreinforced concrete at the Jump 3 keyway. This condition varies the load path of the pressure exerted on the panels depicted in the design documents by transferring the force on the panel into the unreinforced portion of the silo wall at Jump 3.

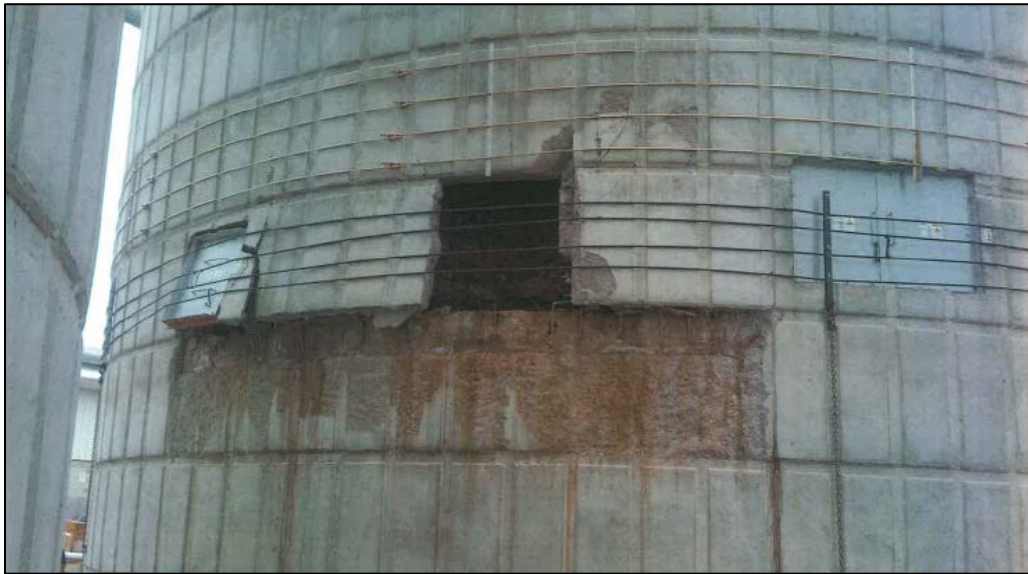
Based on photographic documentation provided to the authors, the failure of the silo wall occurred at Jump 4, just above the top surface of the elevated slab. The distress manifested as an outward displacement of the base of Jump 4 wall, as shown in Figure 7 and Figure 8.

Figure 7. View of silo wall failure at Jump 4

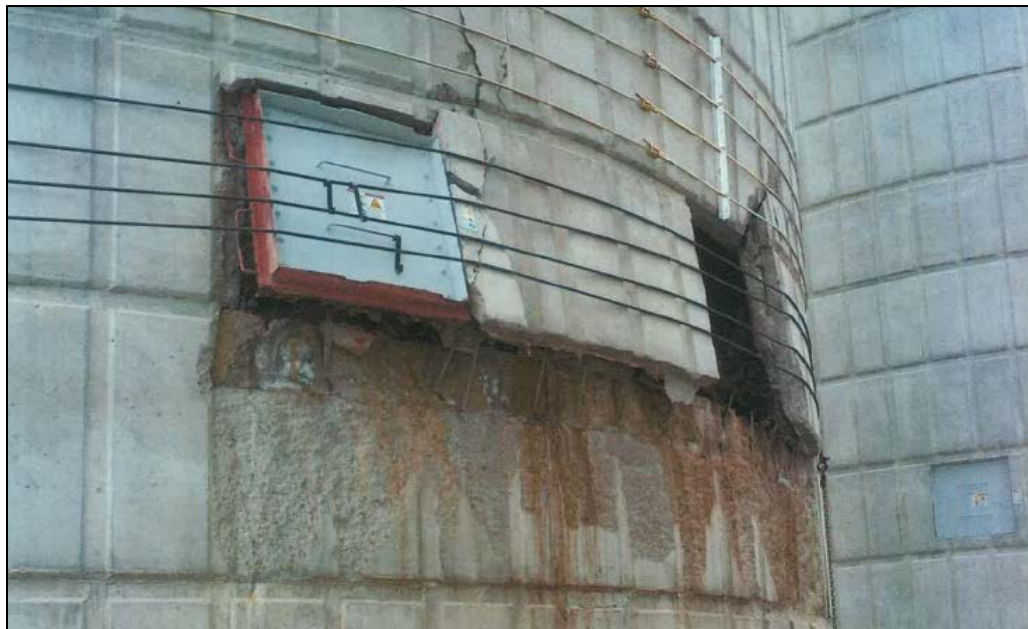
Figure 8. Additional view of silo wall failure at Jump 4

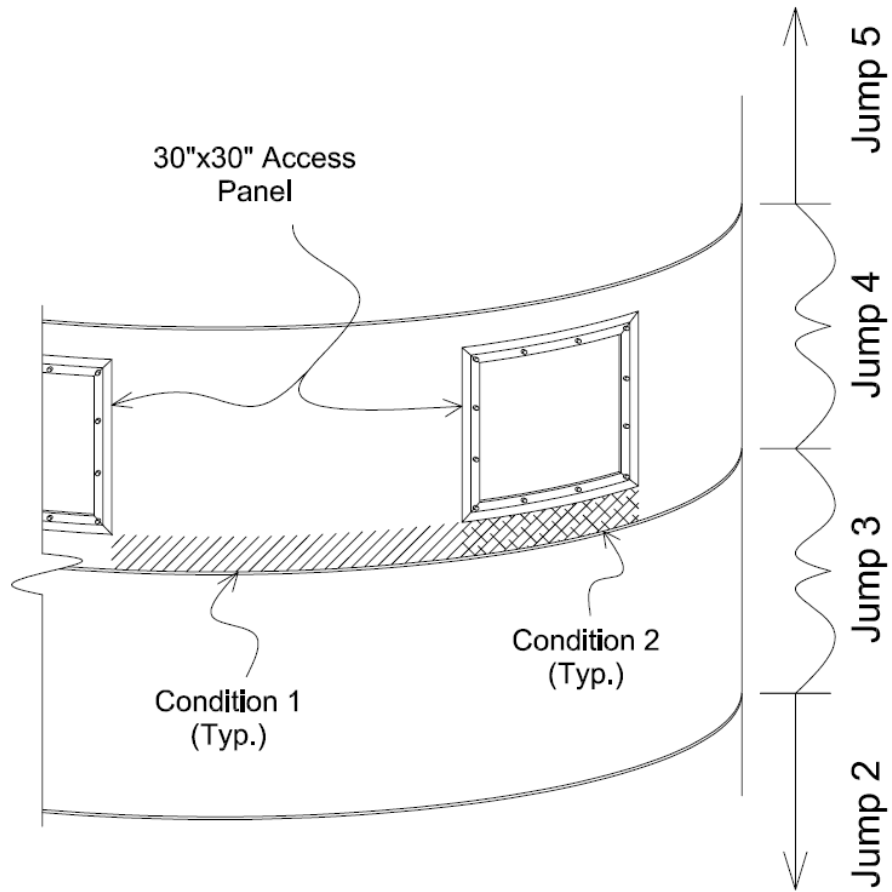
Figure 9. Conceptual view of the as-designed silo exterior indicating Condition 1 and Condition 2 locations

The aforementioned analysis method was applied the portions of the wall section subject to the Condition 1 loading, resulting in a DCR of 0.18 indicating that these portions of the silo wall were not overstressed by design. However, additional forces must be taken into consideration for the portions of this wall section that are directly below access panels and subject to Condition 2 loading.

For the portions of the aforementioned wall section where Condition 2 loading exists are not only subjected to the direct horizontal pressure from the stored material, but also a portion of the transferred horizontal pressure exerted on the adjacent panel. This panel pressure was calculated by determining the geometry of a panel within the silo wall and applying a calculated average horizontal pressure to same. The average pressure was then multiplied by the surface area of a panel and divided by 4 to account for the distribution and flow of forces from the panel into the silo wall. This value was then added to the previously calculated Condition 1 horizontal pressure. The hoop reinforcement was then analyzed using Condition 2 loading, resulting in a DCR of approximately 0.6 indicating that these portions of the silo wall were not overstressed by design.

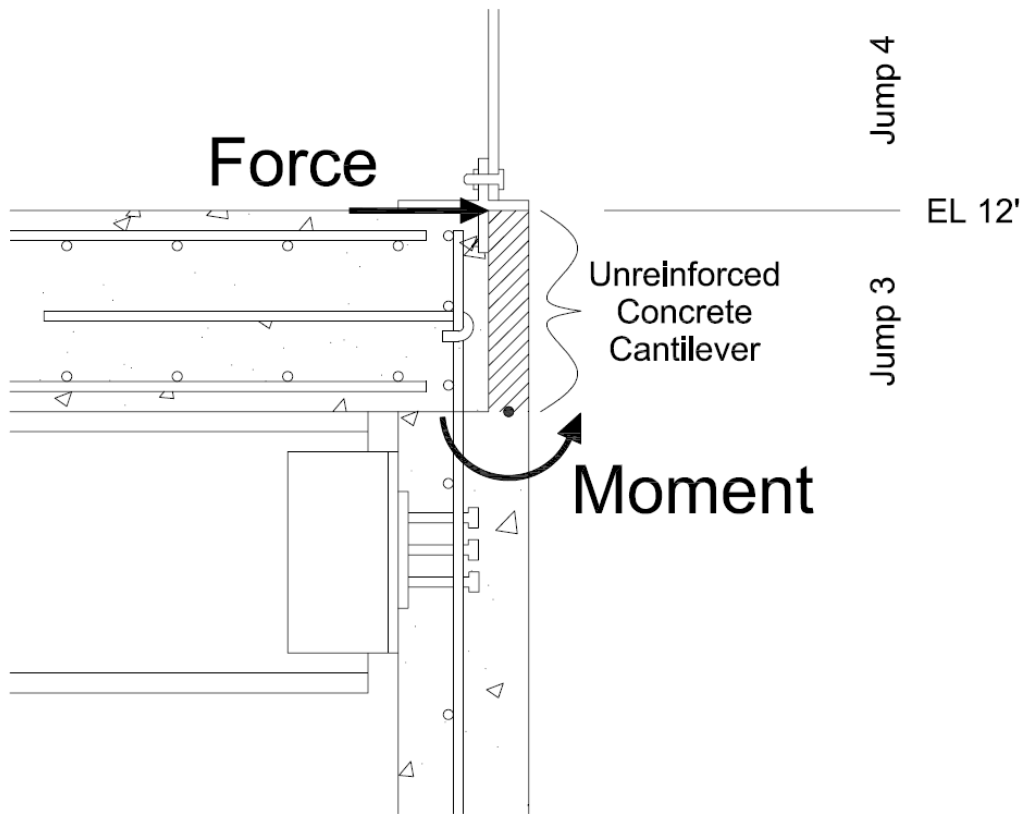
Figure 10. Conceptual illustration of flexural model

The foregoing calculation resulted in a DCR of 1.17 indicating that the unreinforced portion of concrete at the Jump 3 keyway directly below the access panels was overstressed by the load from the panel frame.

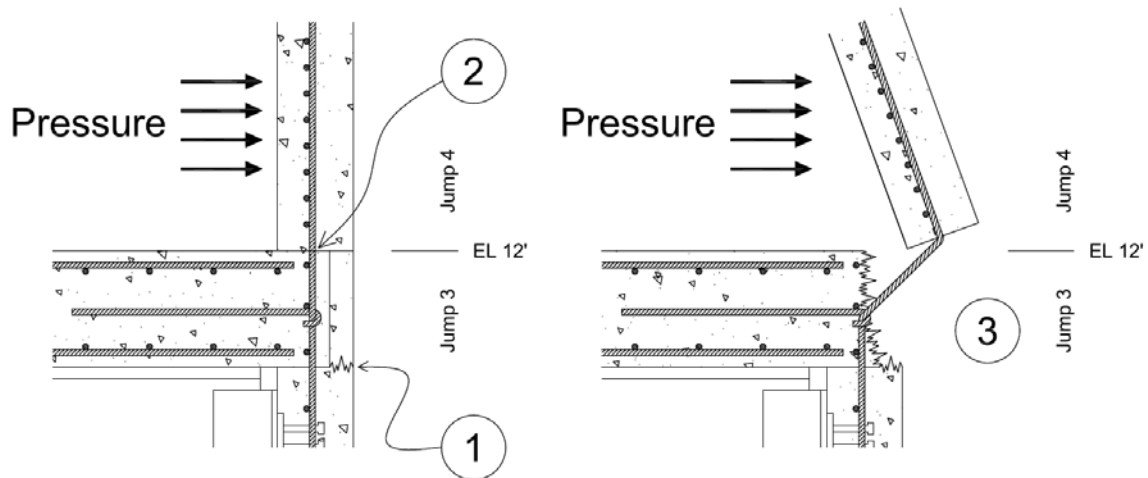
Testing of Hypothesis #3 revealed that by deviating from the design documents, the as-built silo did not provide adequate reinforcing to resist the forces imparted on the silo wall by the stored material. Specifically, the as-built condition of Jump 4 overstressed the silo wall at the Jump 3 keyway, failing the unreinforced portion of the wall in flexure and resulting in failure of the wall. Based on the outcome of Hypothesis #3 calculations, the following failure mechanism, shown in Figure 11, was determined:

1. The unreinforced concrete adjacent to the elevated slab within the keyway at the top of Jump 3 failed in flexure below the silo wall between the panels within Jump 4;
2. The vertical reinforcement at the plane between Jump 3 and Jump 4 was subjected to the entire horizontal pressure from the stored material;
3. The bottom of the silo wall between the access panels at Jump 4 displaced outward at the horizontal plane between Jump 3 and Jump 4.

Figure 11. Conceptual illustration of silo wall failure mechanism

Comparing the results of the authors' numerical analysis to the documented failure conditions, the foregoing failure mechanism corresponds to the distress at the keyway, thus validating the numerical findings.
