This paper was published at the Forensic Engineering 8th Congress, held November 29-December 2, 2018 in Austin, TX. The published version of this paper is available for purchase and download at:

<https://ascelibrary.org/doi/book/10.1061/9780784482018>

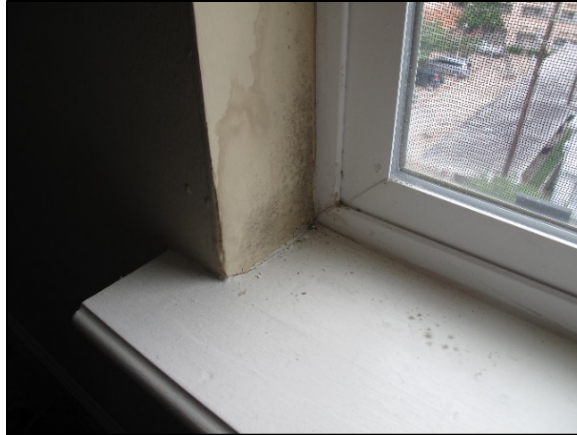
Figure 1: Moisture staining adjacent to window jamb

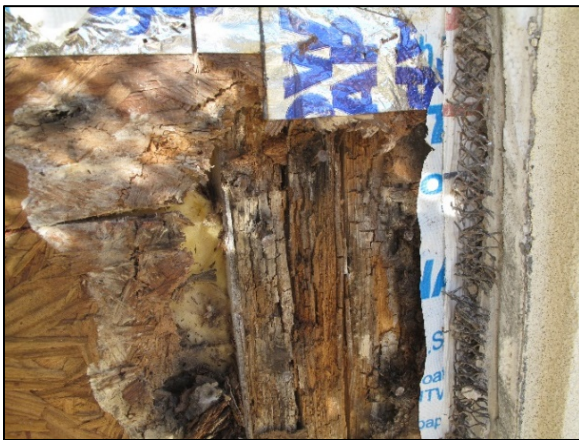
Figure 2: Deteriorated wood framing below a window

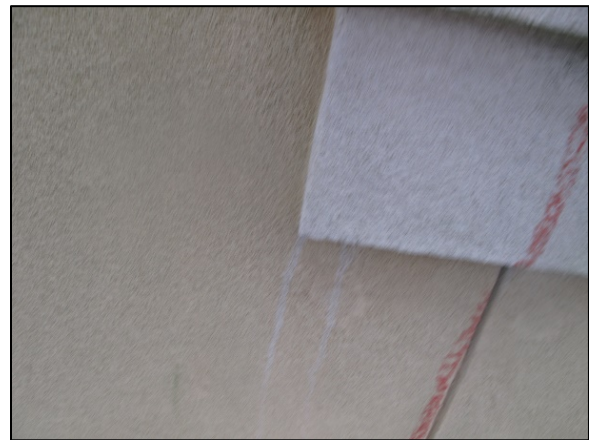
Figure 3: Moisture streaking below EIFS banding with no fracturing of the stucco

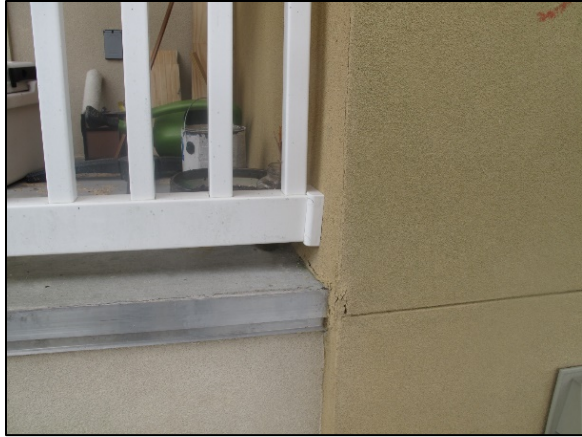
Figure 4: Stucco veneer in contact with concrete topping slab

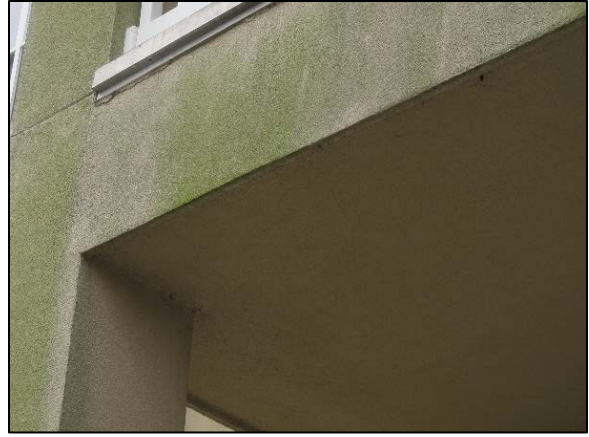
Figure 5: Lack of weeping provisions at soffit transition

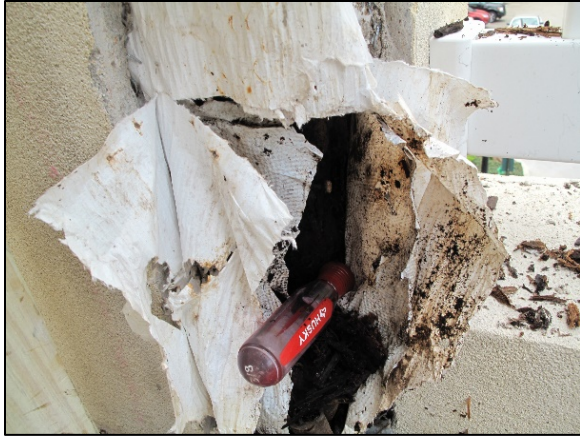
Figure 6: Deterioration of the structural wood framing at balcony column

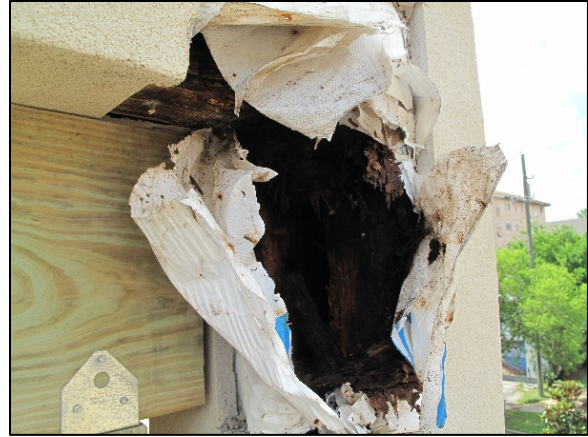
Figure 7: Deterioration of the structural wood framing at balcony column and temporary framing

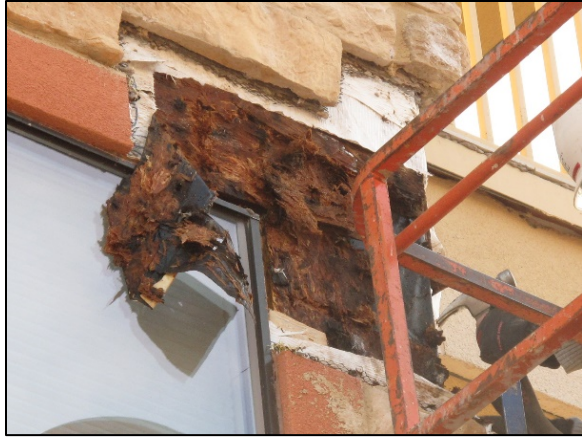
Figure 8: Deterioration of the sheathing at the head and jamb of a window

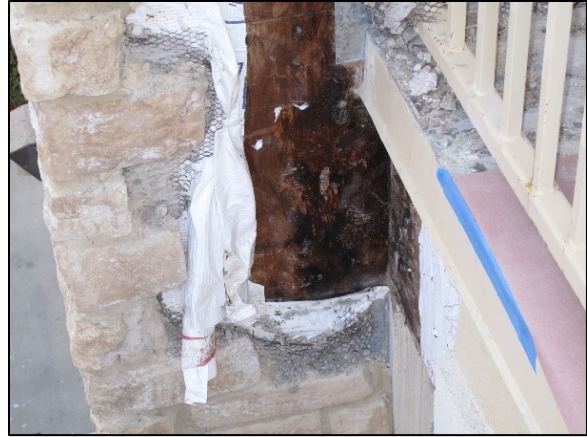
Figure 9: Deterioration of the sheathing at the balcony and wall interface

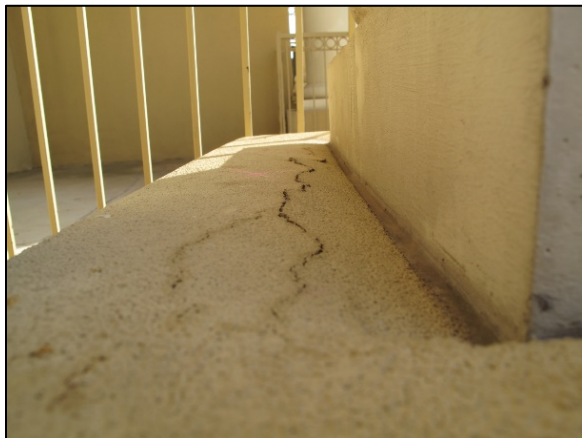
Figure 9: Fractured stucco at a column pedestal

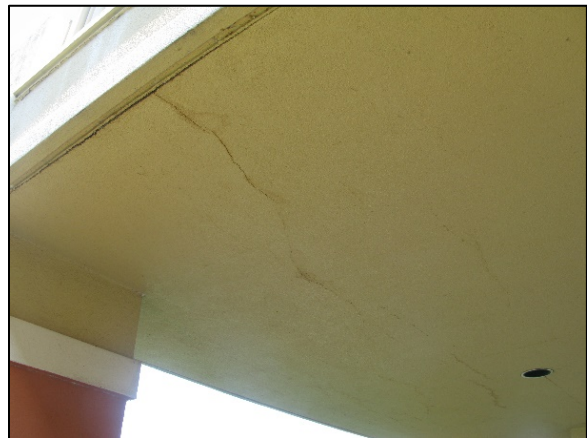
Figure 10: Fractured stucco at a balcony soffit

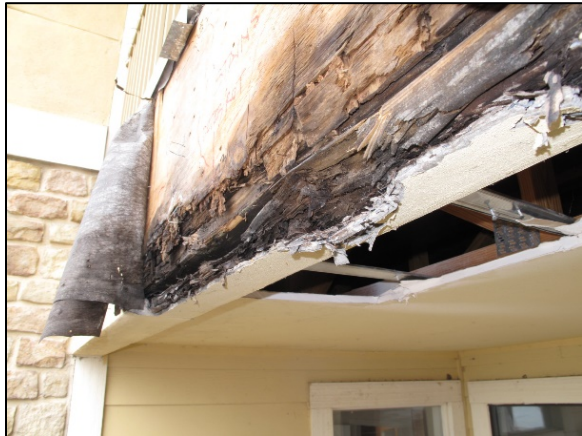
Figure 11: One layer of WRB at deteriorated framing conditions

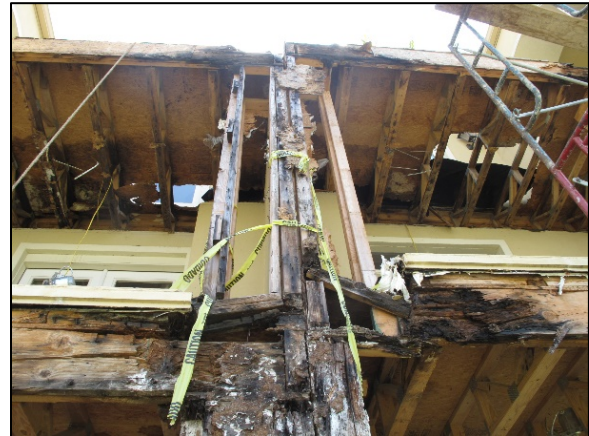
Figure 13: Balcony framing deterioration

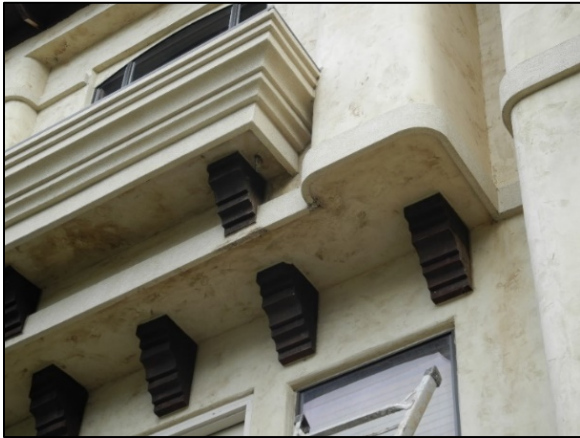
Figure 12: Soffit staining and lack of weeping provisions

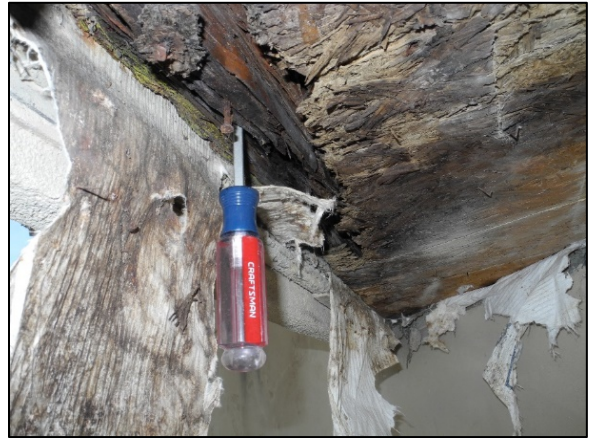
Figure 15: Structural framing deterioration at the soffit condition and one layer of building wrap

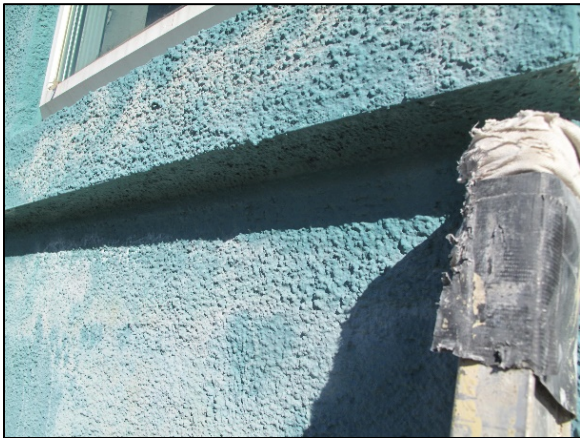
Figure 13: Staining at stucco below a window

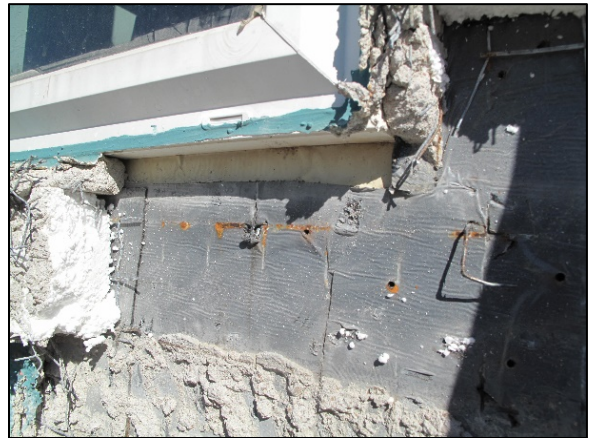
Figure 14: Proper flashing and drainage plane installation
