Analysis of a Fire Riser Failure below a Concrete Slab-on-Grade Foundation

T. Greenberg, B.S., P.E.¹ and T. Ebisch, M.S., P.E.²

ABSTRACT

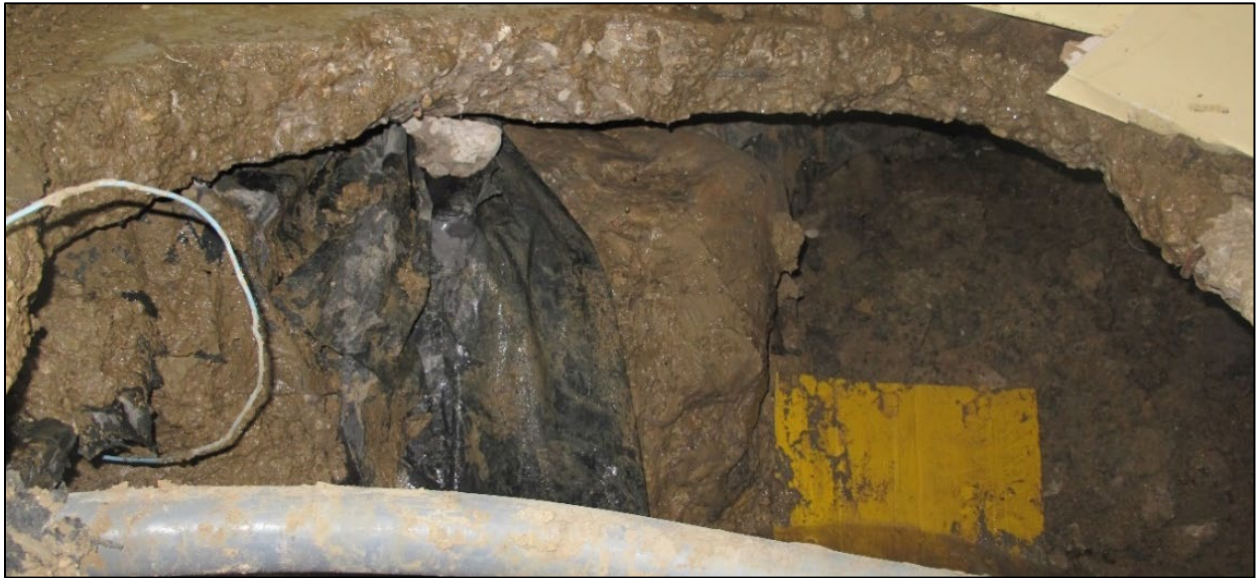
Immediately upon accessing the location of the ruptured fire riser, the upward displacement of the slab was visible. This displacement visibly manifested as a convex feature, or dome, at the slab surface that increased in magnitude with proximity to the fire riser. At the riser, a portion of the concrete slab had previously been removed by others, and a visible void was present below the slab, as shown in Figure 6. Coincident with the vertically displaced portion of the slab were numerous concrete cracks exhibiting an absence of weathering and sharp, angular edges consistent with a recent condition (Figure 7).

Figure 6: Visible void below the concrete slab adjacent to the fire riser

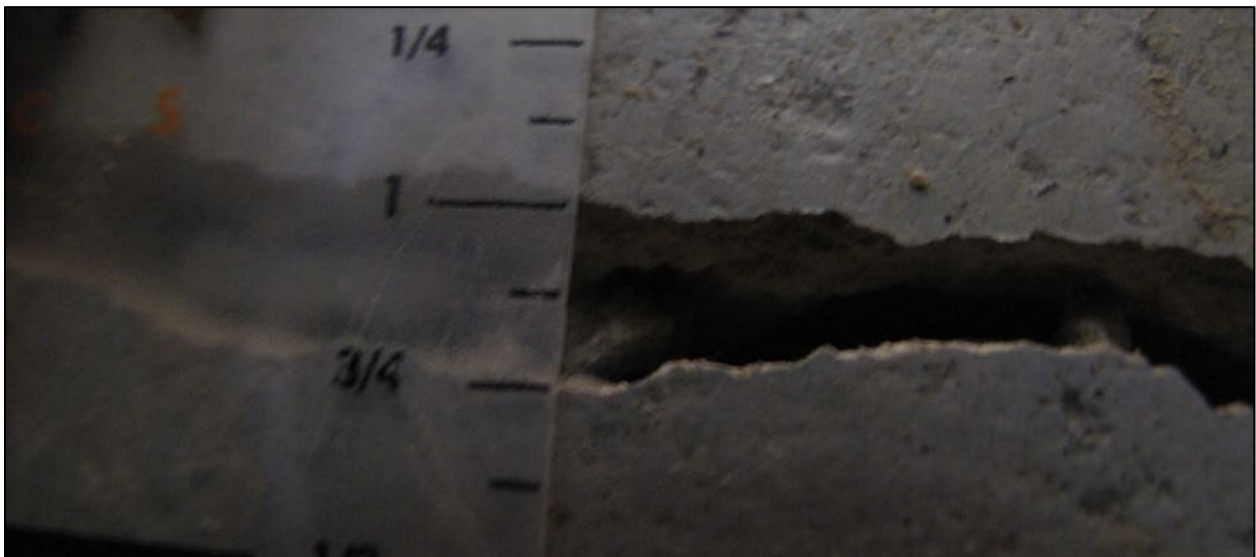
Figure 7: Concrete slab crack with sharp angular edges in close proximity to the fire riser
As is often present in older structures of similar construction, the authors observed numerous other concrete cracks in the slab that exhibited rounded and worn edges (Figure 8). These cracks were typically located farther away from the fire riser and were not indicative of a recent event.

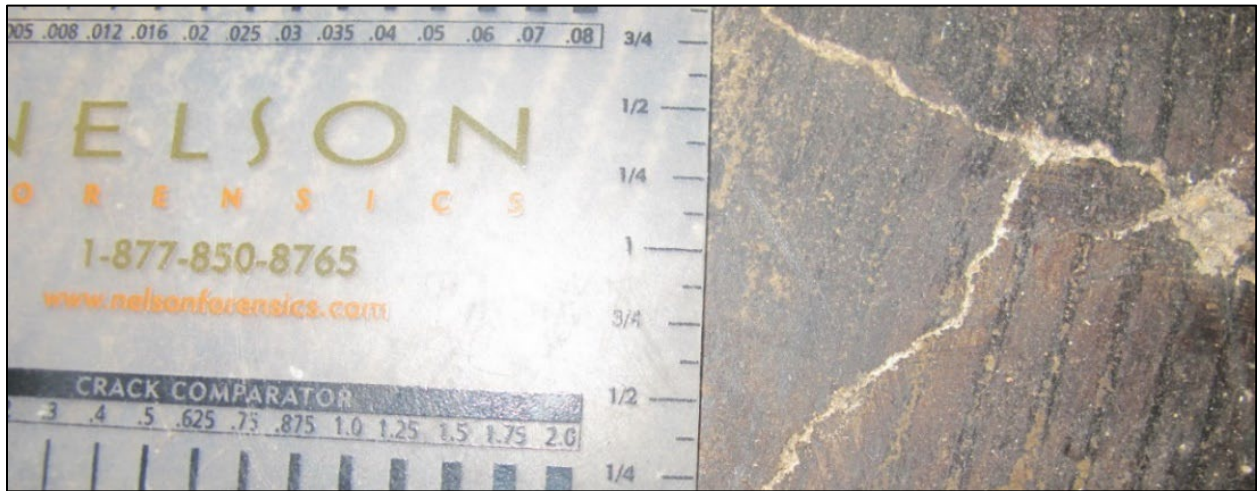
Figure 8: Concrete slab cracks with rounded/weathered edges

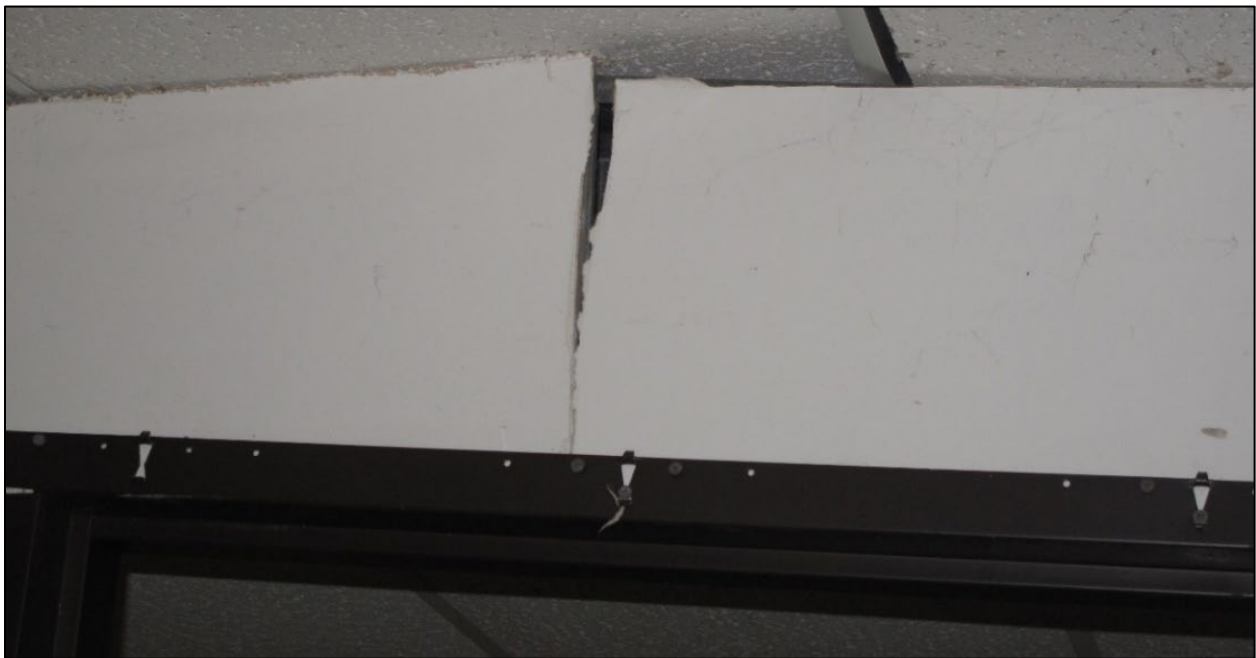
In addition to the concrete slab distress, other observed distress included fractures at the gypsum board wall finishes (Figure 9), displaced and deformed ceiling grids, and buckled floor finishes, all of which are consistent with vertical displacement of the slab during the fire riser rupture. Additionally, this distress occurred in close proximity to the fire riser and further aided in determination of the extent of distress caused by the recent fire riser rupture.

Figure 9: Wall and ceiling distress in close proximity to the fire riser

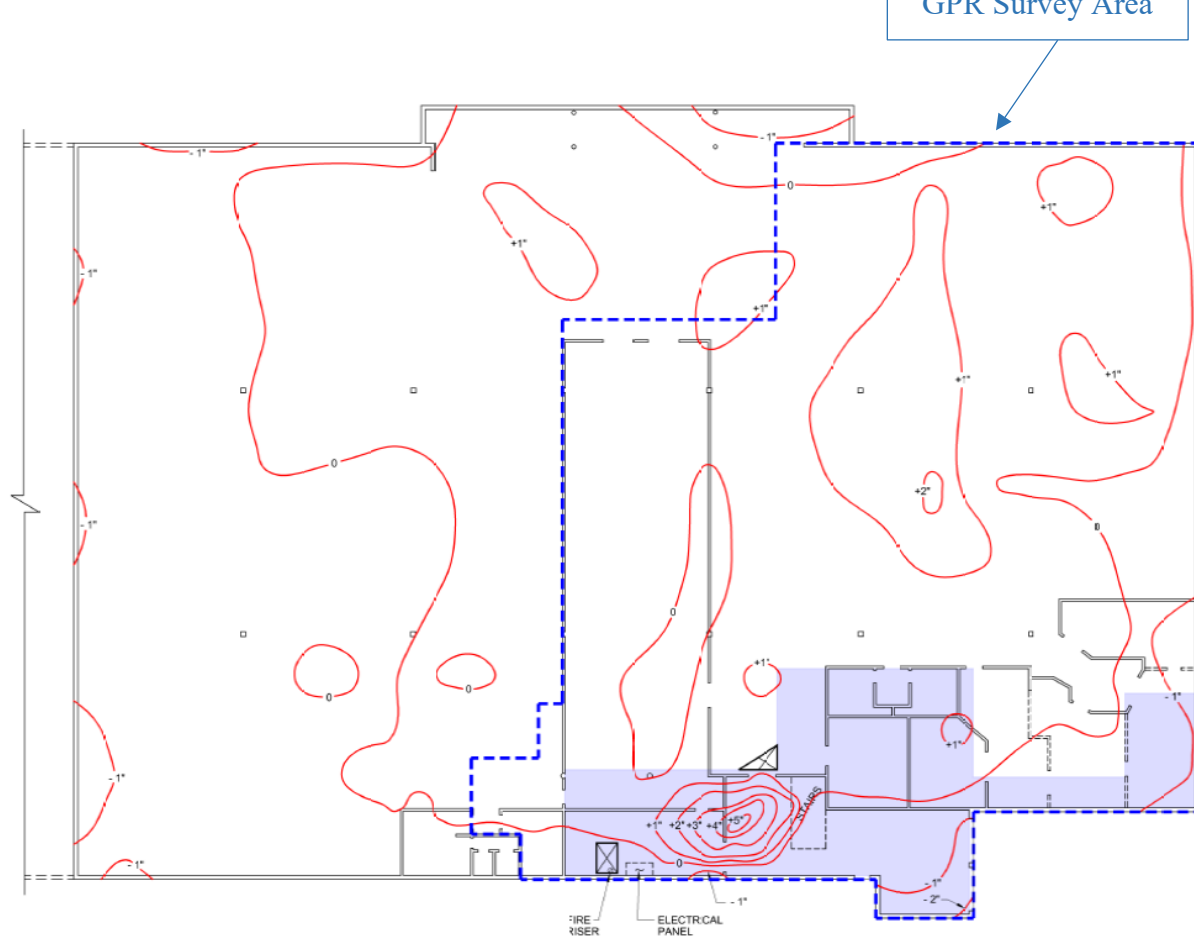
The survey results indicated a discrete upward displacement measuring up to approximately 5" (in relation to the reference point) at the south end of the structure adjacent to the fire riser. This isolated area of upward displacement was further coincident with the locations of the more recent slab cracks. In addition, the survey results identified other areas of upward displacement in other locations of the structure. After reviewing the results of the relative elevation survey, it was determined that the recent rupture did not affect the entire portion of the slab, indicating that only a portion of the slab would need further GPR testing (shown in Figure 10).

Figure 10: Illustration of the topographic contour map resulting from the relative elevation survey and the outline of GPR testing to be performed at the structure.

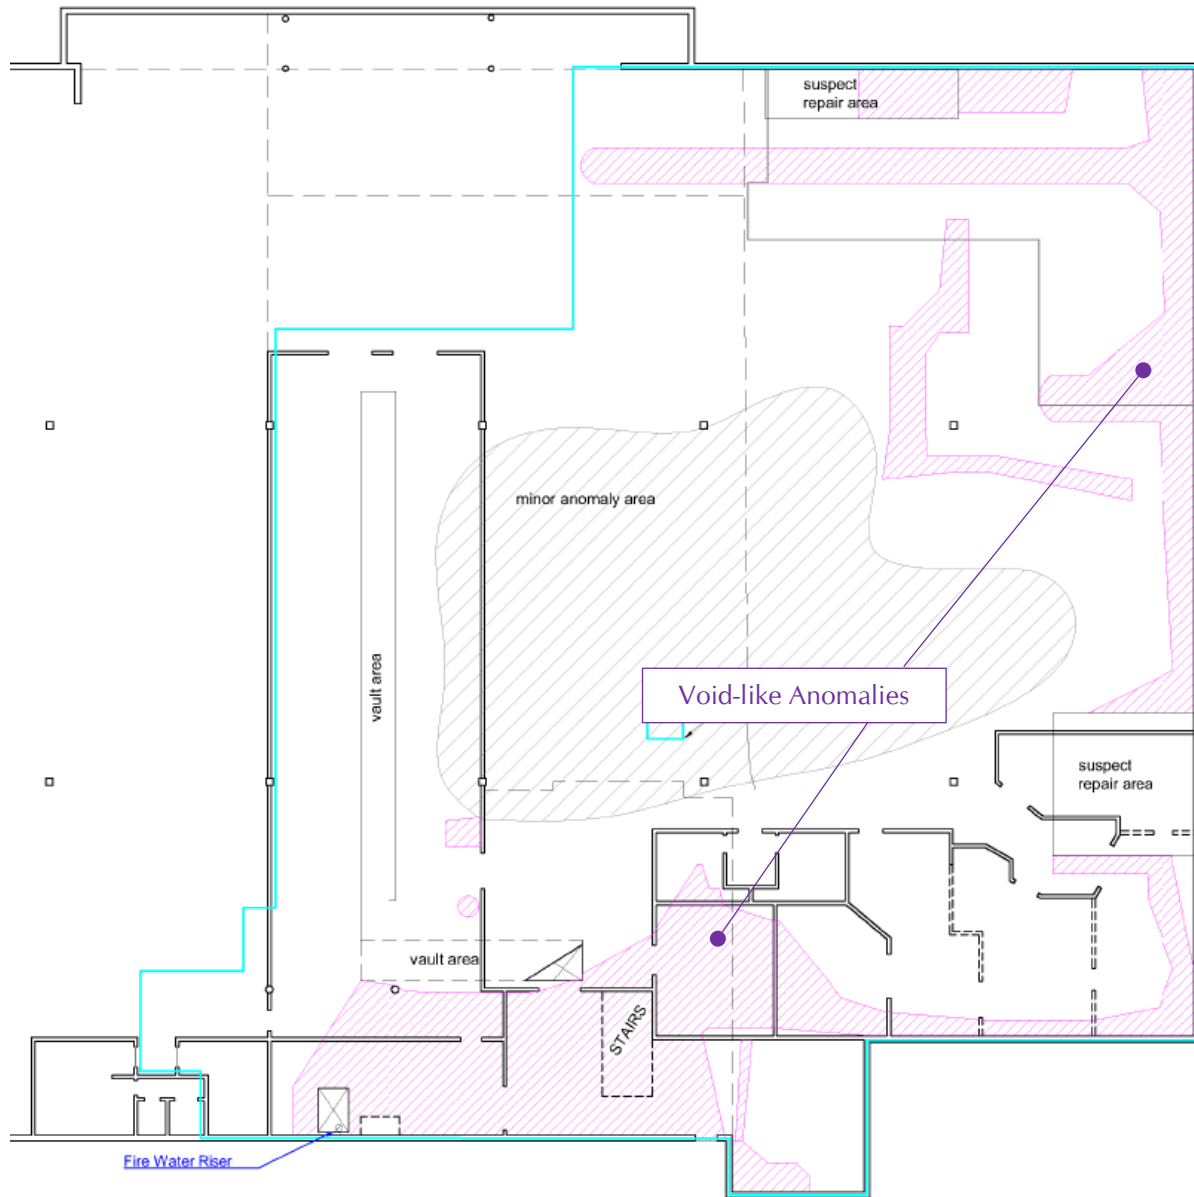
The results of the GPR survey indicated the presence of multiple anomalies that were consistent in pattern and appearance with below-grade voids emanating from the location of the fire riser and progressing towards the northeast portion of the structure. This pattern of void-like anomalies generally correlates with the topographic contour maps produced from the results of the relative elevation survey, as shown in Figure 11.

Figure 11: GPR survey results

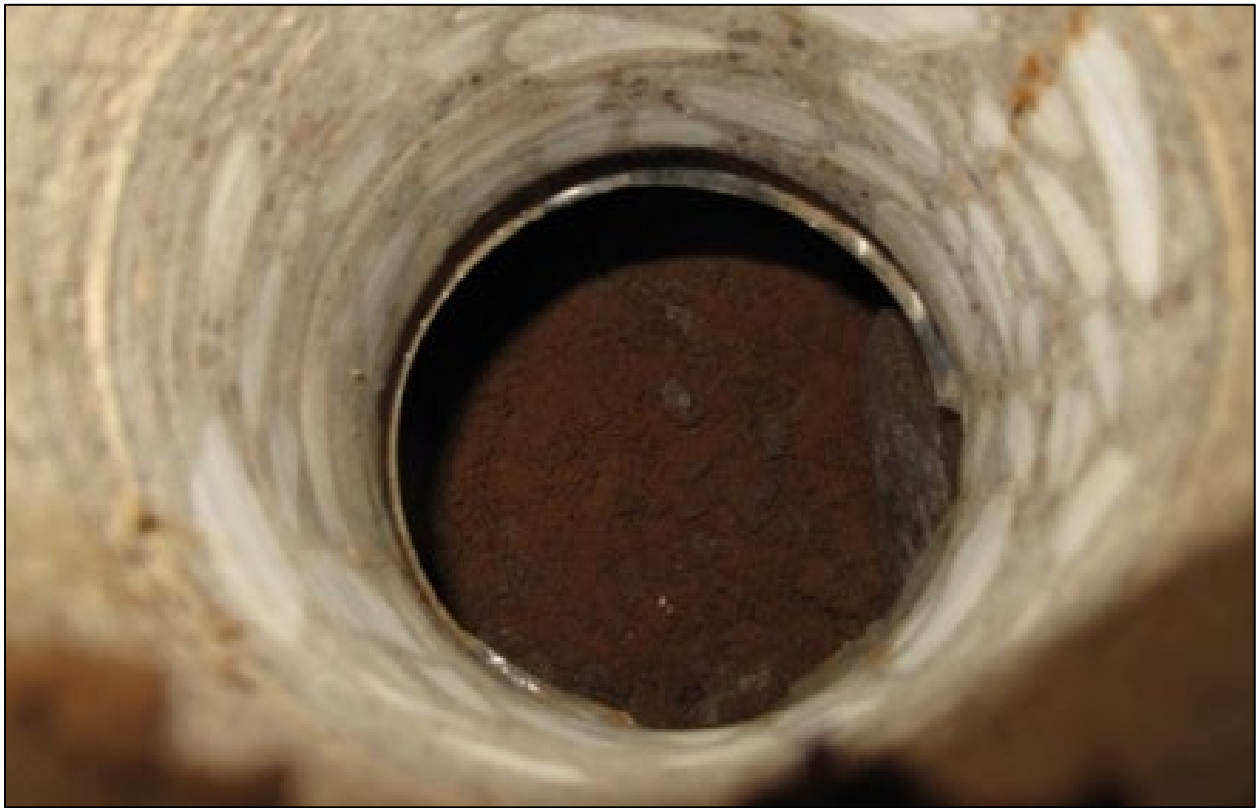
Exploratory concrete coring is necessary to confirm whether the observed anomaly is in fact a below-grade void. Therefore this destructive testing was conducted at multiple locations within the field of the slab. Specifically, 13 cores were extracted from the slab so that the soil-to-slab interface could be visually evaluated at locations both within and outside the areas where anomalies were identified. This testing revealed that seven core locations contained below-slab voids that measured up to 6" in depth as shown in Figure 12 and Figure 13. In addition, the majority of the cores taken within the anomalous regions had measurable voids, further corroborating the results of both the GPR and relative elevation survey.

Figure 13: Representative view at Core 4 with a measurable void of approximately 6"

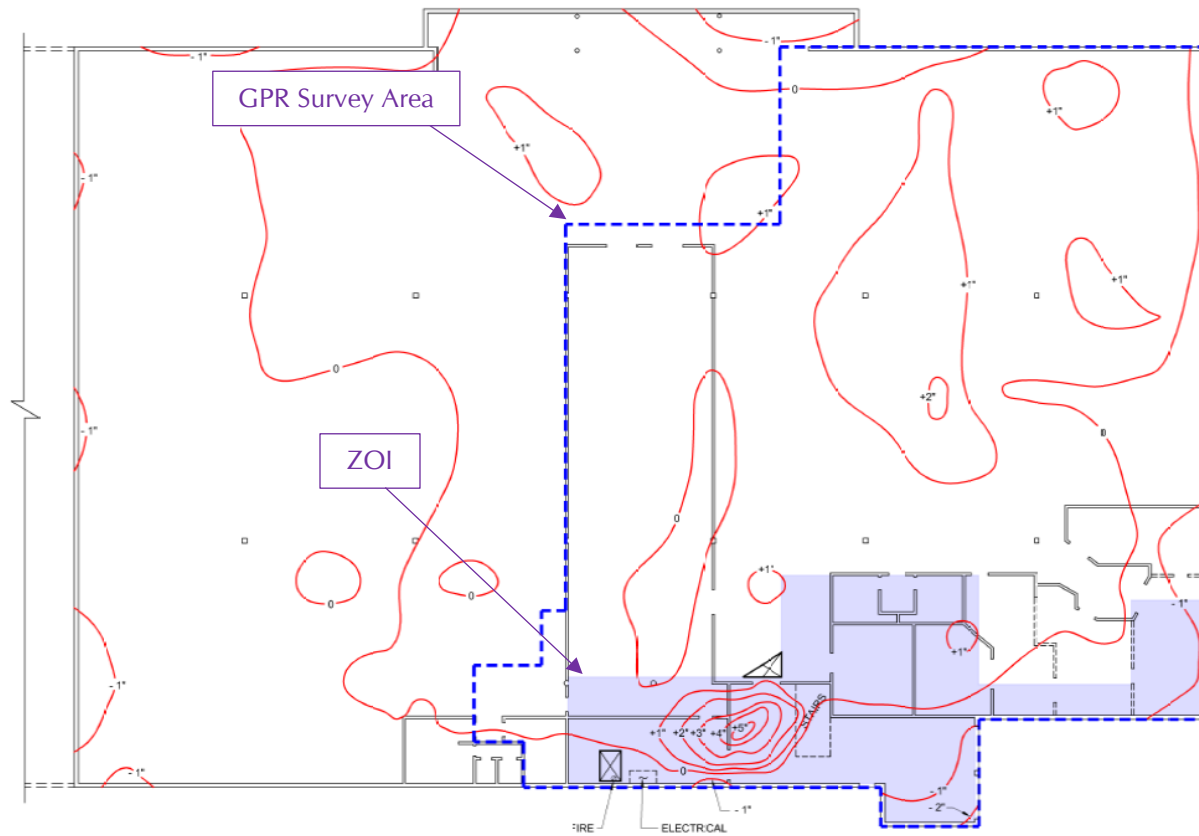
In consideration of the observations, testing performed, and analysis of same, the authors were able to identify the extent of damage caused by the fire riser rupture (i.e., the ZOI) and confirm their hypothesis. The ZOI is shown conceptually in Figure 14.

Figure 14: Outline of Final ZOI

Multiple various options are available for repairing distress to a concrete slab-on-grade; however, the appropriateness of the repair is often defined by site-specific conditions at each location, such as structural configurations or geotechnical conditions. Due to the condition of the concrete slab-on-grade within the ZOI as well as the severity and extent of the below-grade void, the authors elected to recommend complete removal of the concrete slab within the ZOI so that the below-grade soils could be properly reinstated. The authors felt that this was necessary to ensure the long-term performance of the concrete slab moving forward.
