Dating Hail: Investigation and Determination of the Date of Occurrence of Hail Impact Damage

Stewart M. Verhulst, M.S., P.E., RRC, M. ASCE¹

ABSTRACT

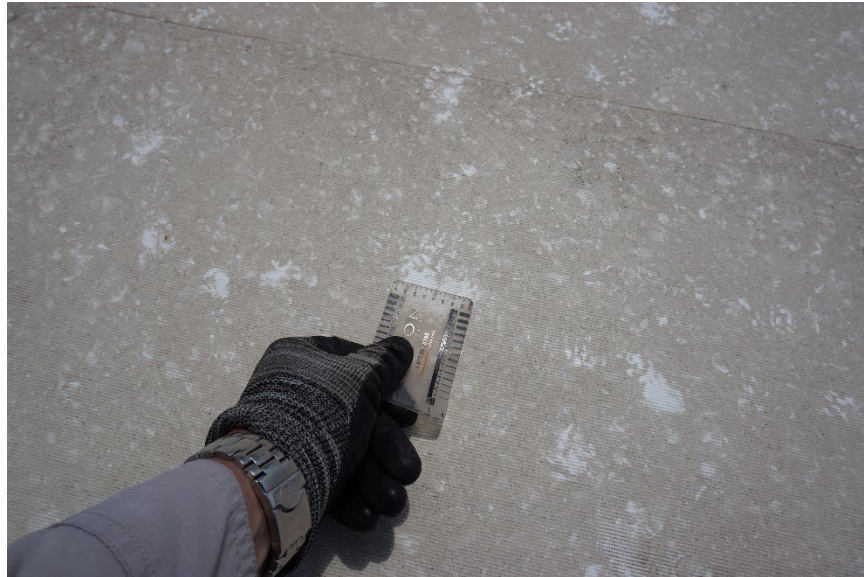
A burnish mark results when an object, such as a hailstone, removes the exterior layer, algae, dirt, oxidation, or film on the surface of a material, leaving a localized area with a different coloration (**Figure 1**). Burnish marks from hail indicate the precise locations of hailstone impacts and provide information regarding the size of the impacting hail and the directionality of the hail, if any. Burnish marks become less distinct (or "fade") over time due to natural weathering of the surface. For this reason, burnish marks often provide the best and most reliable evidence of a recent hail occurrence at a site. The amount of time before burnish marks fade or are no longer visible varies based on the material/surface and the exposure conditions.

Figure 1. Burnish marks on a single-ply roof membrane.

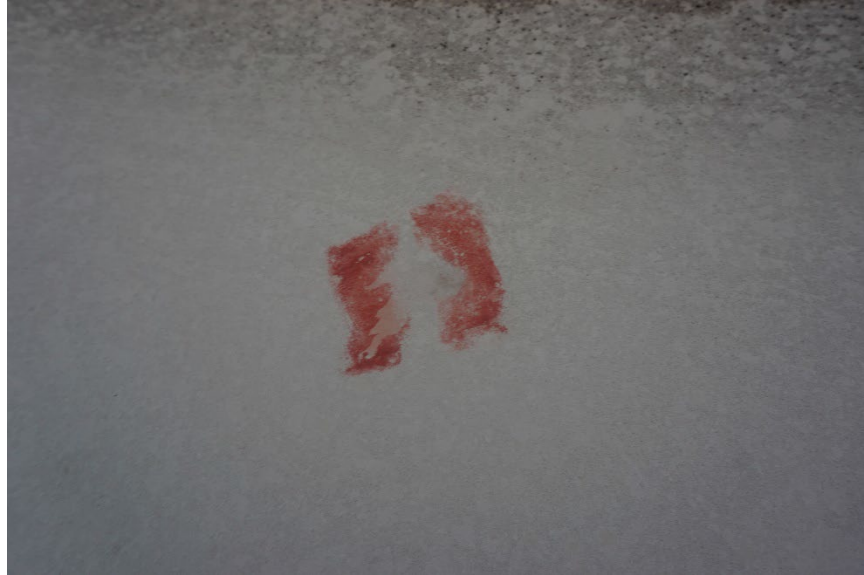
If a surface is prone to both burnish marks and indentations from hail impact, then the presence or absence of burnish marks that coincide with indentations can be used to determine if recent hail has caused indentations. On such a surface, an indentation with a coincident burnish mark is evidence of recent hail, while the lack of a burnish mark at an indentation indicates a previous hail impact, as the burnish mark has faded and is no longer visible (**Figure 2**). This type of information is valuable and illustrates the advantage of visiting a site relatively soon after the hail occurrence.

Figure 2. Burnish marks and indentation on a metal surface. The indentation is not coincident with the burnish marks, indicating that they occurred at different times.

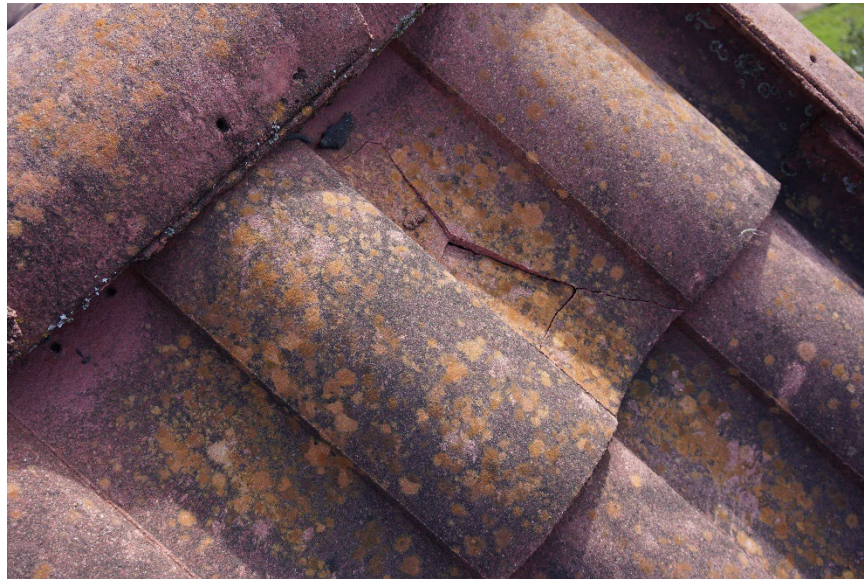
Similarly, the conditions of fractures in brittle materials can provide evidence of the relative age of distress. An example is a fracture in a concrete roof tile. When the fracture occurs, it will have a "fresh" or clean appearance and sharp edges (**Figure 3**). Over time, the fracture will "weather", with the fracture surface typically losing its relatively fresh/clean appearance as the exposed surface becomes stained or discolored. With the passage of sufficient time, the fracture surface often will appear similar in color to the exposed surface of the surrounding roof tiles. Therefore, consideration of the relative weathering characteristics of fracture surfaces can, in some cases, be used in combination with other data to determine the date of occurrence of a hail event with the potential to cause the fracturing, or to at least rule out a certain date or dates.

Figure 3. Fracture at a concrete roof tile. The fracture appears fresh and there is a large burnish mark coincident with the fracture location.

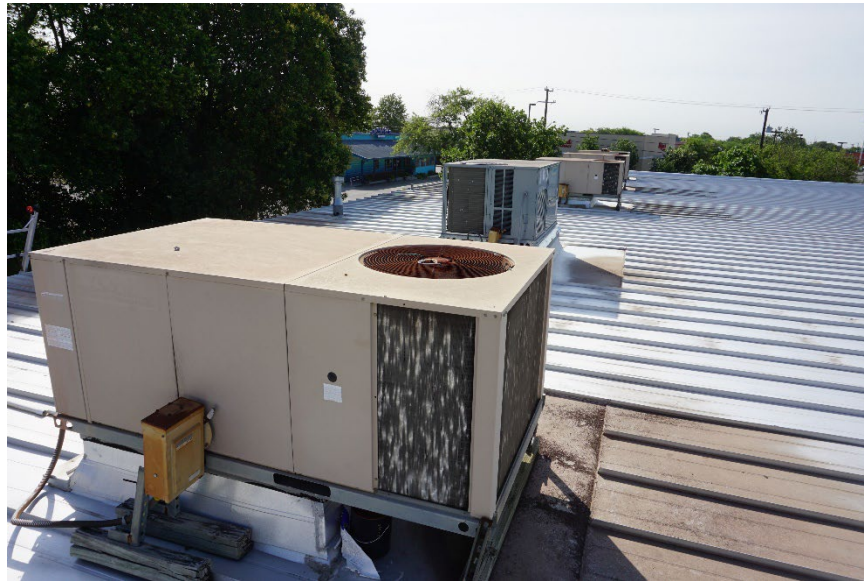
The evaluation of other easily-deformed or damaged materials can also be used to evaluate hail occurrences. One frequent form of hail impact evidence is the deformation of exposed condenser coil fins on HVAC units. Condenser coil fins are relatively malleable and are readily deformed from even minor impact. For buildings that are not newly constructed, it is common to find HVAC units of varying ages. Comparison of the conditions of the HVAC units by age and directional exposure can be used to evaluate the hail history at a given site.

Figure 4. Older unit (foreground) with deformations throughout the coil fins, with a newer unit (in the background) lacking this pattern of deformation.

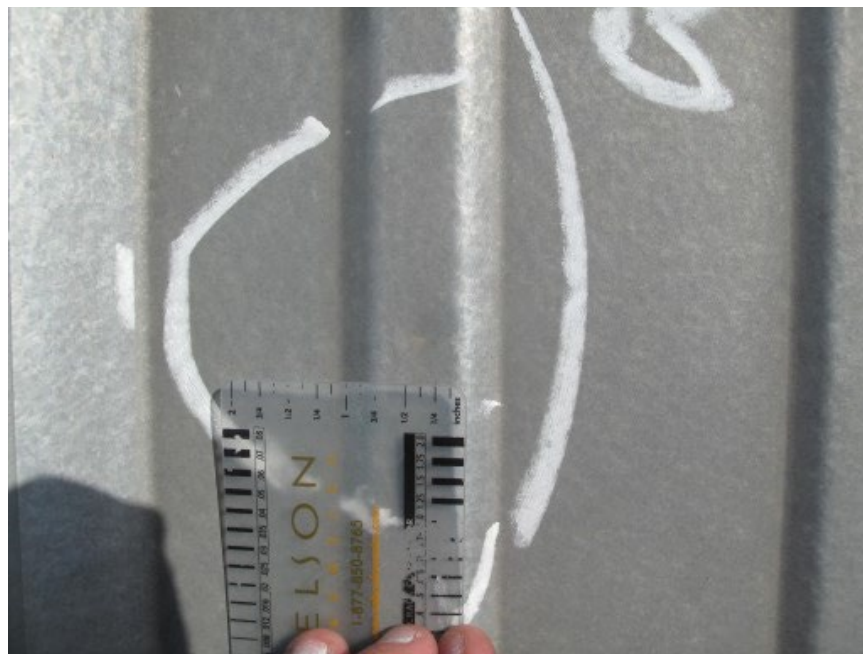
A distinct pattern of indentations consistent with hail impact was present on the roof panels and west wall panels of Buildings 1-11 (**Figure 5**). By contrast, there was no pattern of such indentations at Buildings 12-18. Burnish marks observed throughout the site were approximately 3/8" [1.0 cm] across or less, and these marks were not coincident with the indentations at Buildings 1-11.

Figure 5. Circular indentation in metal panel roofing.

Considering the known ages of the respective buildings, it was determined that the hail that caused indentations in the metal panels at the site had occurred in the time period between 2003 and 2005. The weather data indicated two hail events in the vicinity of the site within that period, both in the spring of 2005. Since the site visit was conducted in 2018, approximately 13 years after these storms, it was not possible to determine which of the two storms contained the indentation-causing hail (or if perhaps both storms did). Nonetheless, the determination of the discrete time period of 2-3 years for this hail was sufficient for the purposes of the investigation.

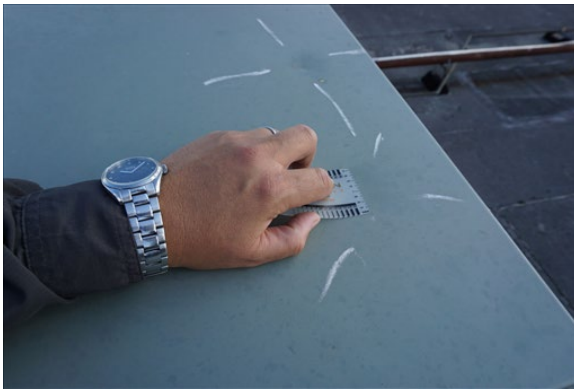
The investigation began in August 2018, just over 4 months from the date of the most recent reported hail event. Several surfaces exhibited large, faded burnish marks measuring up to 2 1/2" [6.4 cm] across and smaller, less faded (i.e., more recent) burnish marks measuring up to 1/2" [1.3 cm] across (**Figures 6 and 7**). The larger and more faded burnish marks typically exhibited a distinct west-to-east orientation, while the smaller and less faded burnish marks had a slight east-to-west orientation or no orientation (i.e., the hail generally fell straight down).

Figure 6. Large, faded burnish mark 2" across with west-to-east directionality.

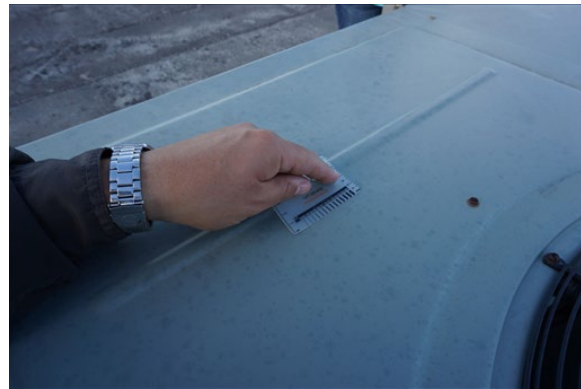
Figure 7. Smaller, less faded burnish marks.

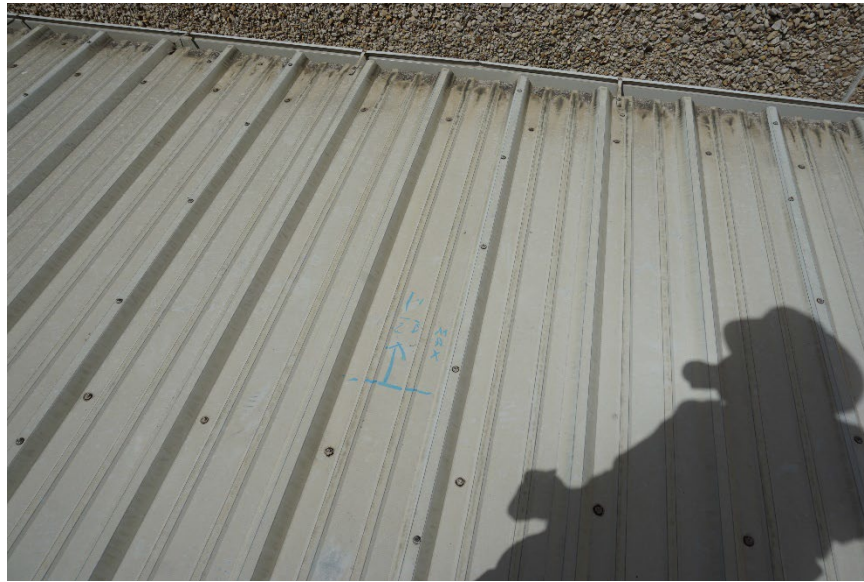
A small building with metal panel roofing was located just to the east of the main building. This smaller building had a lower roof height than the main building and was therefore partially "protected" from directional hail travelling west-to-east. On this roof, large burnish marks were oriented west-to-east and had coincident indentations measuring up to 1 1/2" [3.8 cm] in diameter. There was also a pattern of the smaller burnish marks with no distinct orientation and with no coincident indentations in the metal panels. The larger burnish marks and indentations did not exist at the west-most portion of the roof, closest to the taller main building (**Figure 8**). This provided further evidence of the different orientation and sizing of the two hail events, as the west-most portion of this low metal panel roof was protected from the 2016 hail that fell west-to-east.

Figure 8. Lack of large burnish marks at the west portion of the low metal roof adjacent to the taller main building. The chalk mark denotes 1/2" [1.3cm] maximum burnish mark size at the area along the west side of the roof, close to the adjacent building.

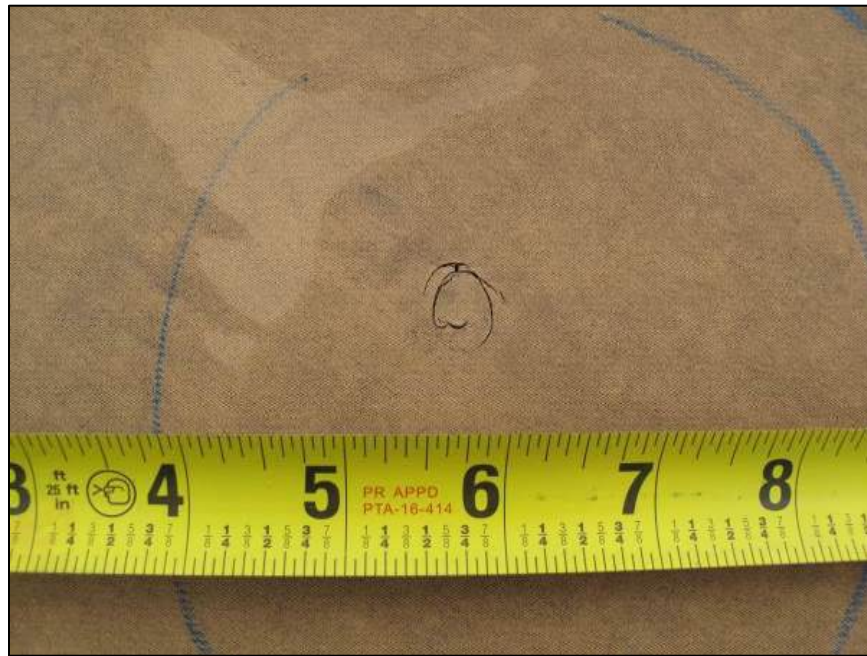
Case Study #3. Multiple buildings owned by a school district, spanning nine (9) campuses, were evaluated for hail impact, including for impact that occurred during a specific time period. The buildings involved in the investigation had a wide variety of common roof coverings, including multiple large roofs covered with single-ply thermoplastic (PVC) membranes. Fractures in the PVC membranes (**Figure 9**) and a pattern of indentations at a portion of the metal roof panels and

Figure 9. Circular fracture in a PVC roof membrane.

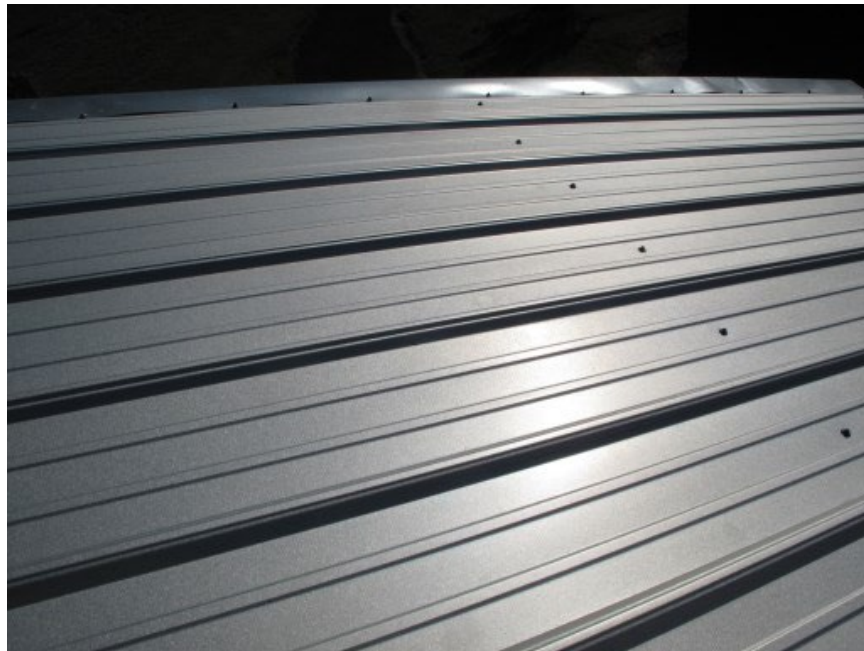
Based on the evaluation of metal appurtenances and surfaces of a known age, it was determined that, while a pattern of indentations consistent with hail impact existed throughout the campuses, items that had been installed as recent as approximately 6-8 years prior to the site visits did not exhibit such indentations. In fact, multiple metal panel roofs that had been installed prior to or during the time period of interest did not have a pattern of circular indentations consistent with hail impact (**Figure 10**). Further evaluation of exposed condenser coil fins throughout the campuses indicated that units manufactured within approximately 10 years prior to the site visit exhibited only relatively small circular deformations, on the order of 1/4" [0.6 cm] in width and smaller. However, older units exhibited significantly larger circular deformations up to 1" [2.5 cm] in width.

Figure 10. Lack of indentations in a metal panel roofing.

Based on the conditions observed throughout the campus sites, it was determined that hail that occurred during or subsequent to the time period of interest (approximately 4-5 years prior to the site visits) was of limited size and was not capable of causing damage to the roof coverings or indentations in the metal panels. This was consistent with the weather data, which indicated limited hail within the time period of interest and larger occurrences of hail prior to that period. Based on careful evaluation of the site conditions, it was determined that the hail that had caused damage to the roof coverings and indentations in the metal roof panels at the campuses had occurred prior to the time period of interest.
