On the Move: Case Studies of Expansive Soils and Foundation Movement

Case Study 1 – Central Texas Office Building

Case Study 2 – Central Texas Entertainment Facility

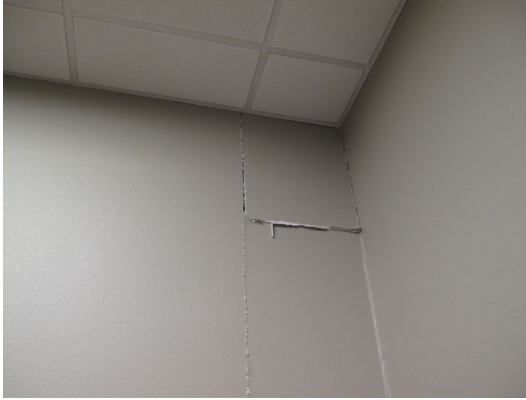
Figure 1: Gypsum board separations and fractures

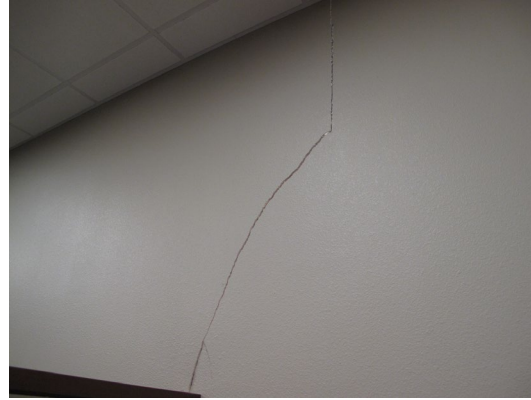
Figure 2: Gypsum board separation and fracture

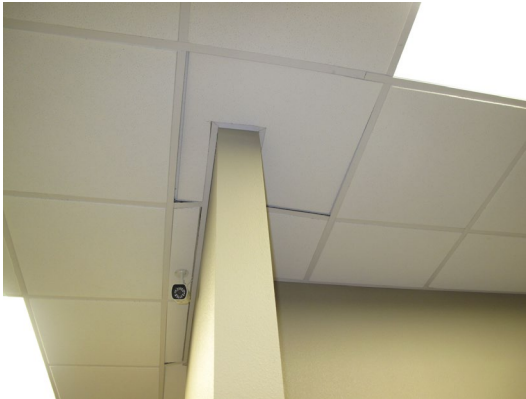
Figure 3: Displaced ceiling panels and displaced/buckled ceiling grid

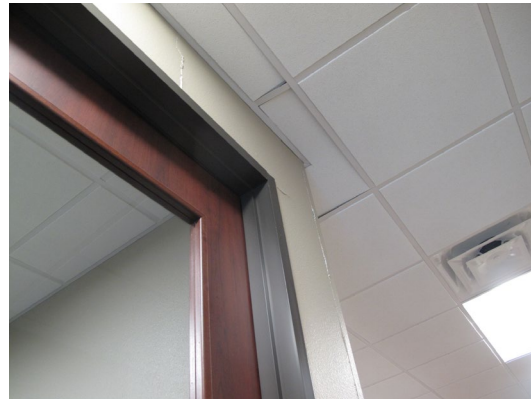
Figure 4: Displaced ceiling panels

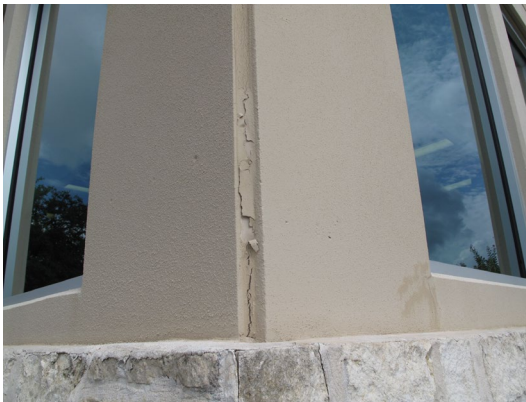
It was reported that a few years after the structure was built, the occupants began to notice distress at interior finishes throughout the building and doors that did not properly open/close. Many of the occupants reported feeling as though there were uneven spots in the floor, and noticed that the chairs at their desks would roll on their own. By the time the authors arrived on site, extensive distress was present at the structure, including fractures and separations at interior finishes throughout the building (**Figures 1 and 2**); displaced acoustical ceiling panels and displaced/buckled ceiling grids (**Figures 3 and 4**); separations at the tilt-up wall panel joints at the exterior walls that extended all the way to the roof (**Figure 5**); and buckled cold-formed steel

Figure 5: Tilt-up wall panel joint separations

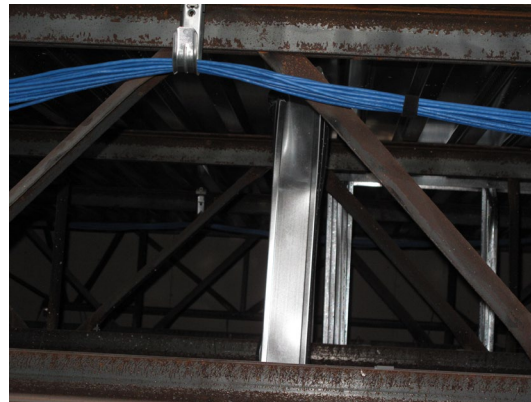
studs at the plenum spaces (**Figure 6**). The extent of distress was consistent with significant differential foundation movement.

Figure 6: Buckled cold-formed steel stud

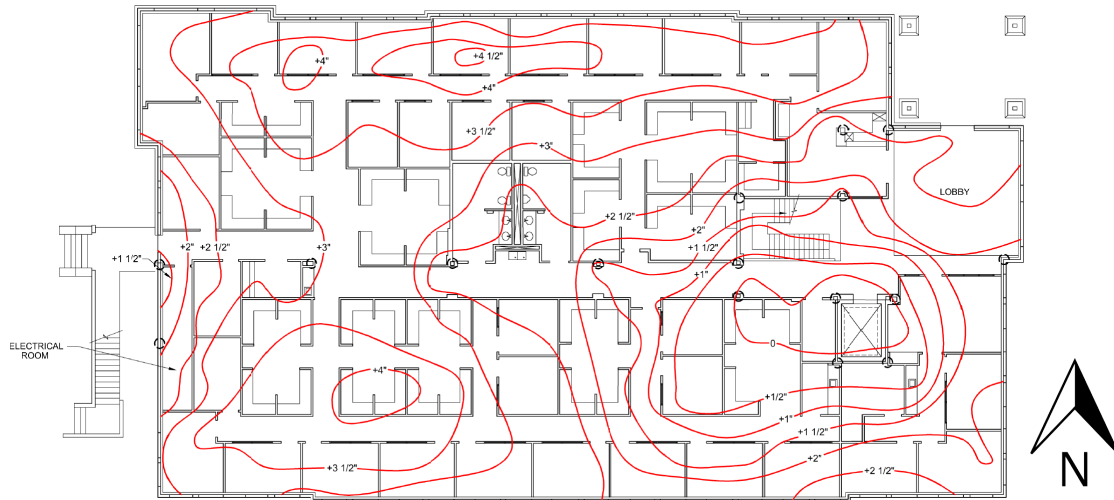
To determine the patterns and extents of the differential foundation movement occurring at the structure, relative elevation surveys of the first and second floors were performed. The results of the surveys indicated that each floor was out-of-level by approximately 5", with relative high

points located at the north portions of both floors and relative low points located in the vicinity of an elevator at the southeast portion of the structure (**Figures 7 and 8**).

Figure 7: Topography of the structure's first floor

In order to determine the mode of foundation movement that had occurred at the structure, an analysis of the topographic maps obtained from the surveys, and the patterns and nature of the distress observed at the structure's components, was conducted. The most severe distress was located at the south portion of the structure, in the vicinity of the stairwell and the elevator, where the most significant angular distortion of the foundation had occurred. The appearance and patterns of this distress indicated that interior finishes had moved upward relative to the low point located near the elevator. The buckling of cold-formed steel studs at the plenum spaces was also consistent with upward movement of the foundation. Based on the measurements and observed conditions, it was determined that the primary mode of foundation movement that had occurred at the structure was differential heave. The patterns of differential foundation movement were also consistent at both floors, and distress was present at structural components, including at the perimeter tilt-up wall panels. This indicated that the foundation movement was

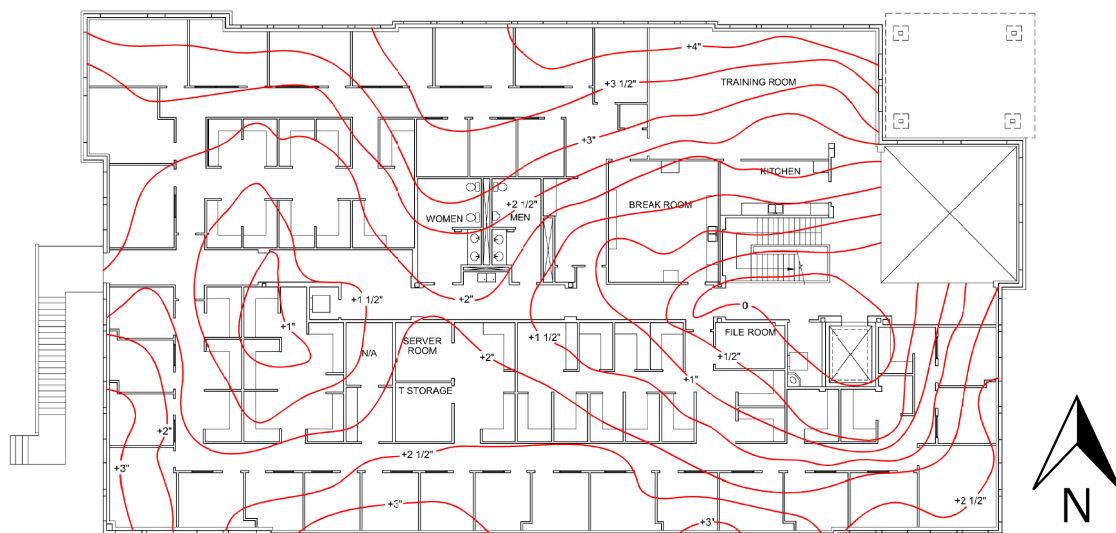
Figure 8: Topography of the structure's second floor

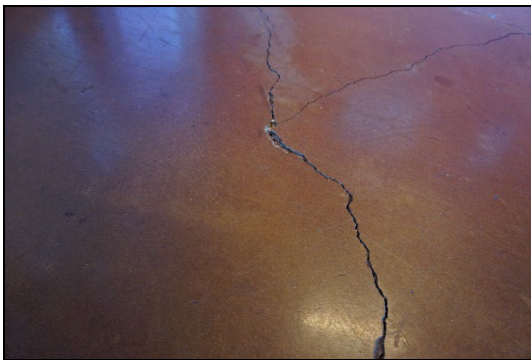
Figure 9: Fractured concrete slab-on-grade exhibiting vertical offsets

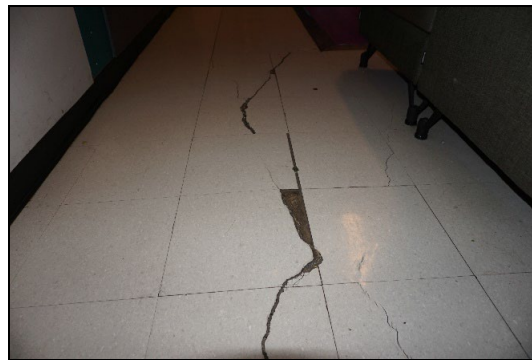
Figure 10: Fractured tile floor; visibly sloping floor

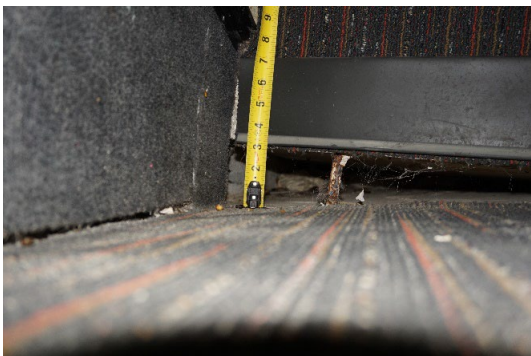
Figure 11: Separation at a movie theater platform riser

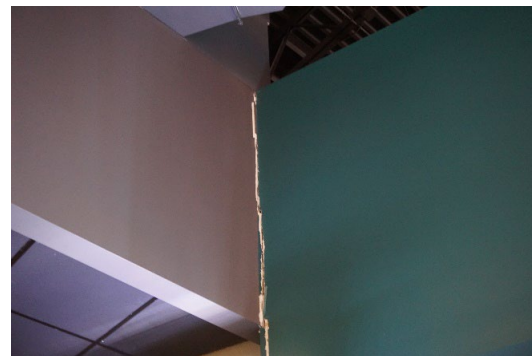
Figure 12: Gypsum board separation at a beam-to-wall interface

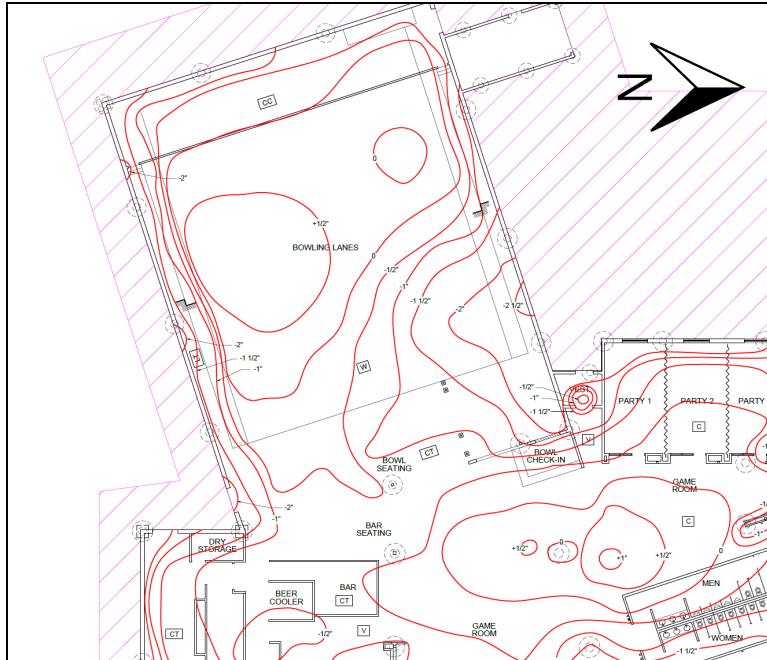
The results of a relative elevation survey of the floor surface indicated distinct areas of higher elevations (i.e., "domes") located at the interior of the foundation, while the relative elevation measurements at the perimeter were relatively consistent (**Figure 13**). Notably, the slope of the floor surface did not exhibit discrete elevation changes, indicating that the interior piers and slab-on-grade had moved (heaved) somewhat synchronously, while the perimeter grade beams experienced much less differential movement and remained relatively flat (i.e., exhibited relatively consistent elevations).

Figure 13: Localized domes in the topography of the facility

Considering the relative elevation survey data obtained by the authors, additional water at the perimeter of the structure due to poor subsurface drainage did not, by itself, account for the significant amount of heave occurring throughout the interior of the building. The pattern of differential movement throughout the foundation system was indicative of a "global" phenomenon. The plumbing systems were tested, with no indication of a leak. Further, the domes at the interior of the structure did not correlate to the locations of plumbing lines. Based on the forensic geotechnical evaluation, it was apparent that groundwater conditions had changed significantly since construction of the building, and that these changes had resulted in an unexpected increase in moisture within the subgrade soils. These significant changes and the severity of the resultant damages begged the question: what caused the groundwater characteristics of the site to change and affect the soils supporting the foundation?
