## **The Rain Must Drain: An Engineering Perspective on a Common Pitfall of Overlay Reroofing**

T. Ebisch, M.S., P.E.<sup>1</sup> and R. Chancey, Ph.D., P.E.<sup>2</sup>

Rehabilitation of commercial roofs is often accomplished by overlaying existing roof coverings with new single-ply membranes. In preparation for this type of recovering, evaluation of the subject building's existing structural system, and analysis of the new roof system's drainage characteristics by properly licensed design professionals, are usually necessary. Often, such evaluation and analysis are also required by municipal authorities having jurisdiction over construction activities to ensure the adequacy of the new systems, their compatibility with the existing structure, and their conformance to applicable building codes. In recent years, and in separate occurrences, operators of a galleria in Oklahoma and a joint retail and service facility in North Texas retained contractors to overlay the existing roofs at the respective buildings with single-ply roof membrane systems. In the months following each reroofing, a portion of each building's roof collapsed during rainfall events. The objective of this paper i

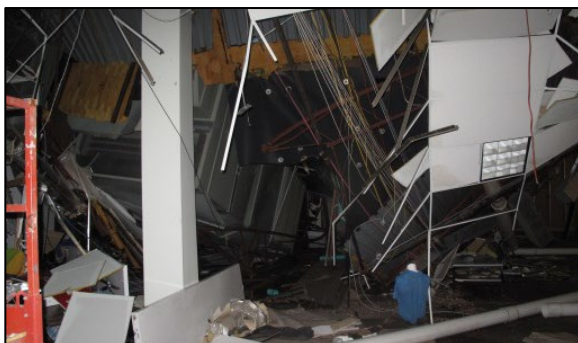
Figure 1. Collapsed portion of galleria roof from the interior of the building

The authors' analysis revealed that the roof drainage system (including both primary and secondary drains) at the galleria was incapable of draining the rainfall which occurred just prior to the time of the collapse. The drainage system was rendered ineffective by the installation of undersized retrofit inserts into the existing roof drains as part of the recent overlay reroofing activities. The retrofit roof drains at the galleria did not comply with the provisions of the applicable building

The deficient roof drainage system resulted in a weight of accumulated water that exceeded the capacity of the roof framing, which analysis showed to have failed due to localized buckling of components of the open-web bar joist system. Such structural deformation was indeed observed during the field investigation, and again the model indicated that the failure would have occurred within minutes of the reported time of the collapse.

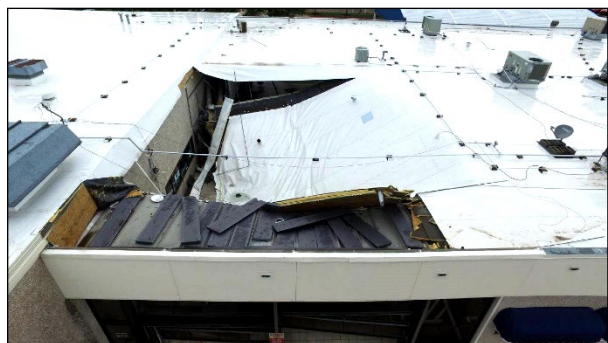
Figure 2. Collapsed portion of service facility roof

The authors' analysis at the service facility revealed that the primary drainage system in place at the time of the collapse was barely capable of draining the reported rainfall without overwhelming the structural capacity of the roof, provided that the drain openings were unobstructed. However, the authors observed pervasive and near-complete blockage of the drains due to debris at the wire mesh inserted into the retrofit drains (refer to Figure 5). This blockage severely restricted the capacity of the already non code-compliant retrofit primary roof drainage system (2015 IBC, 2015 IPC). Recall that the secondary drainage system in this case had been completely abandoned and could not contribute to any drainage from the roof.

When the partial drain blockage in the field was considered, the analysis revealed that the roof drains were incapable of draining the water from the roof before the weight of the accumulated water exceeded the calculated capacity of the roof framing, resulting in structural failure and collapse. The analysis further revealed that the failure initiated as elastic buckling at a critical roof framing member followed by tear-out of the member's bolted connections. Both of these conditions were visible at the time of the site investigation, corroborating the model's validity. Further, the model indicated that the failure would have occurred within minutes of the reported time of the collapse. The foregoing parallels provide evidentiary validation for the analytical methodologies utilized and the results thereof.

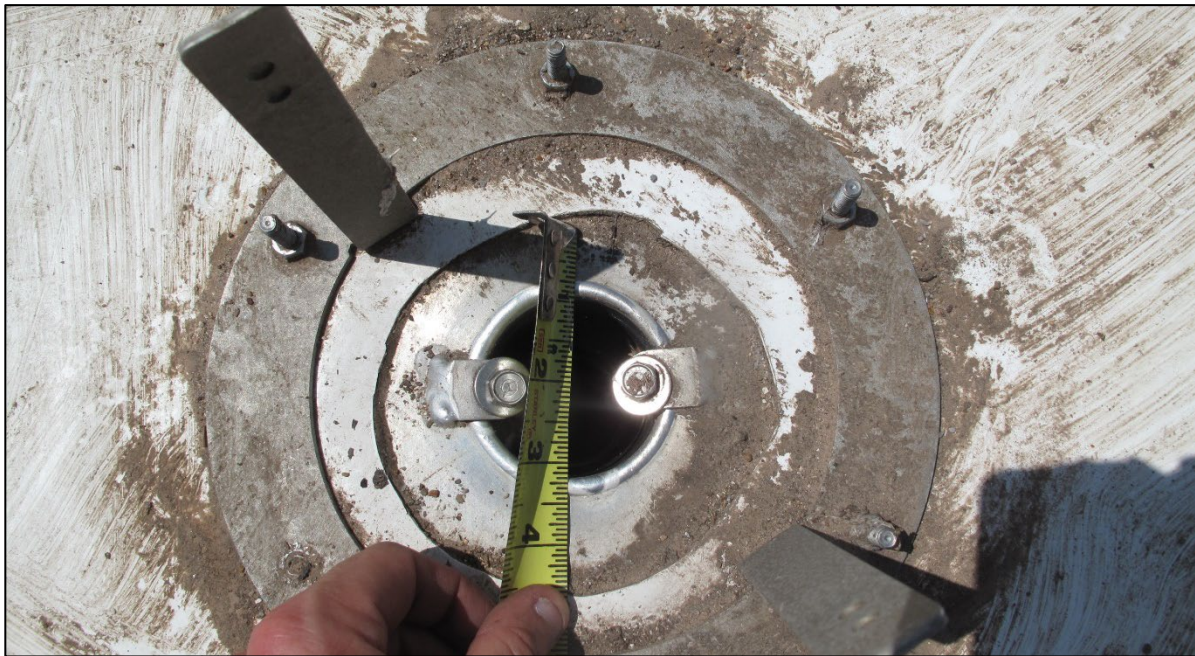
As previously mentioned, the galleria's primary and raised secondary drainage systems *prior to the reroofing* consisted of multiple 11" diameter drain bowls with 6" diameter drain outlets. The authors observed that each of these drains had been modified with a retrofit insert intended for installation into an existing drain bowl with a drastically smaller, 3" diameter outlet. The resulting effective drain inlet opening for each of these inserts measured 2 1/4" in diameter, and even that inlet was obstructed by mounting hardware, as shown in Figure 3. The inlet area of the retrofit drains was thus reduced by over 75% when compared with the pre-existing roof drains.

Figure 3. Modified drain inlet opening at the galleria

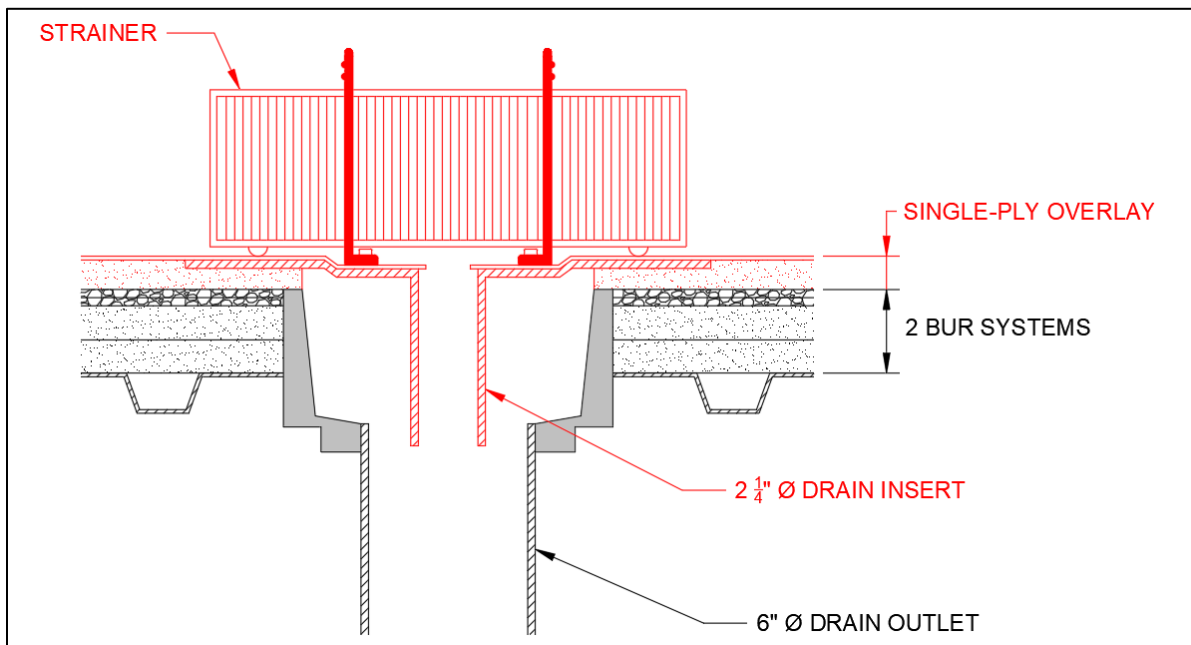
The galleria's roof overlay system was installed over two pre-existing roof systems, which is not only in conflict with the provisions of contemporary building codes (2018 IBC), but is also suggestive of an added dead load which was not likely contemplated in the building's structural design. A conceptual illustration of the modified roof drain configuration at the galleria is presented in Figure 4.

Figure 4. Modified galleria roof drain configuration (roof overlay components in red)

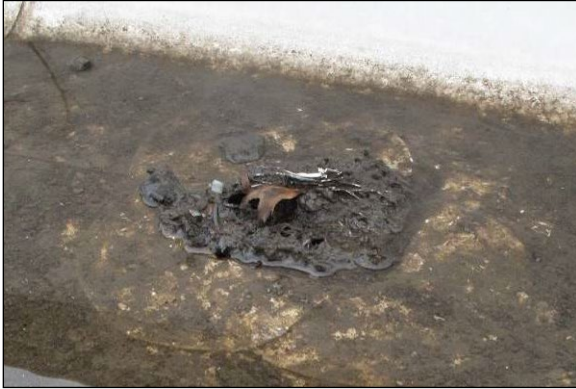
Additionally, the single-ply membrane overlay was flashed into and down the conductor insert, reducing the effective opening size to 3" on each side. A wire mesh strainer was fashioned to press-fit within each opening, further reducing the effective size of the openings. Significant organic growth and debris was observed to be caught on the mesh strainers, further obstructing each of the drains. Figure 5 illustrates the typical condition of the obstructed drains.

Figure 5. Organic growth and debris at a service facility roof drain

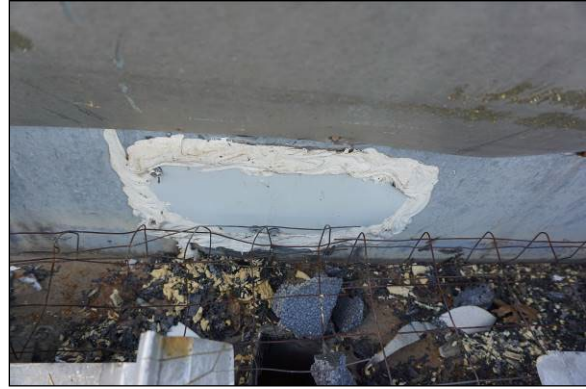
As configured prior to the reroofing, the building's secondary drainage system would have provided for drainage of rainwater if the primary roof drains became obstructed. However, the scuppers comprising the original roof's secondary drainage system were located within the abandoned gutters, below the elevation of the roof overlay surface. The secondary drainage system was abandoned by the obvious installation of metal plates over the inside faces of the scuppers (Figure 6), which was concealed by the roof overlay. No secondary drainage system was installed in place of the abandoned scuppers. Conceptual illustrations of the configuration of the service

Figure 6. Metal plate over inside face of scupper opening

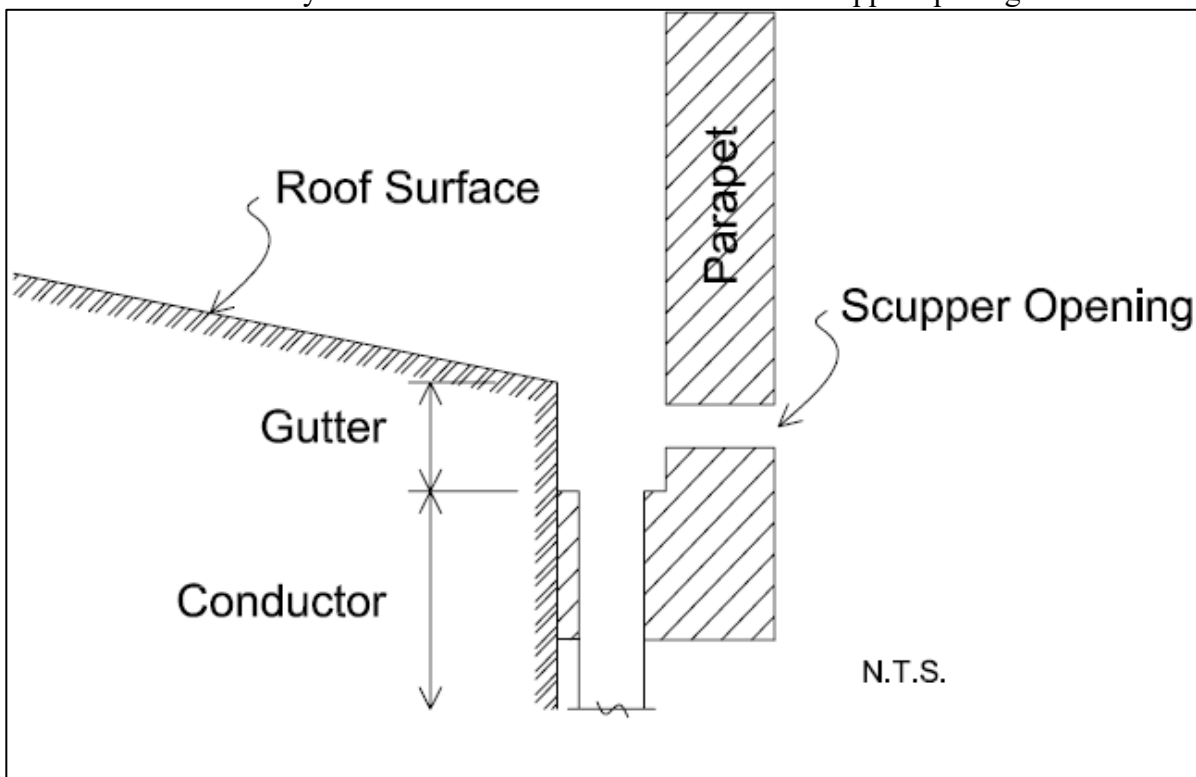
At the service facility, it was similarly evident that the drainage systems had been modified as part of recent reroofing activity. This building's roof *prior to the reroofing* was sloped to drain toward the perimeter parapets, and included 9 x 11" rectangular gutters along the entire length of each of the long sides of the building, just inside of the parapet footprint. The gutters further included multiple 3 1/2" diameter square vertical conductors extending downward from each gutter, each of which discharged at grade. This building also contained a secondary roof drainage system comprised of multiple through-parapet scuppers located at a slightly higher elevation than each downspout conductor. These scuppers would allow drainage from the roof in the event that the primary gutter and downspout system was compromised.

Figure 7. Roof drain configuration at the service facility before overlay installation

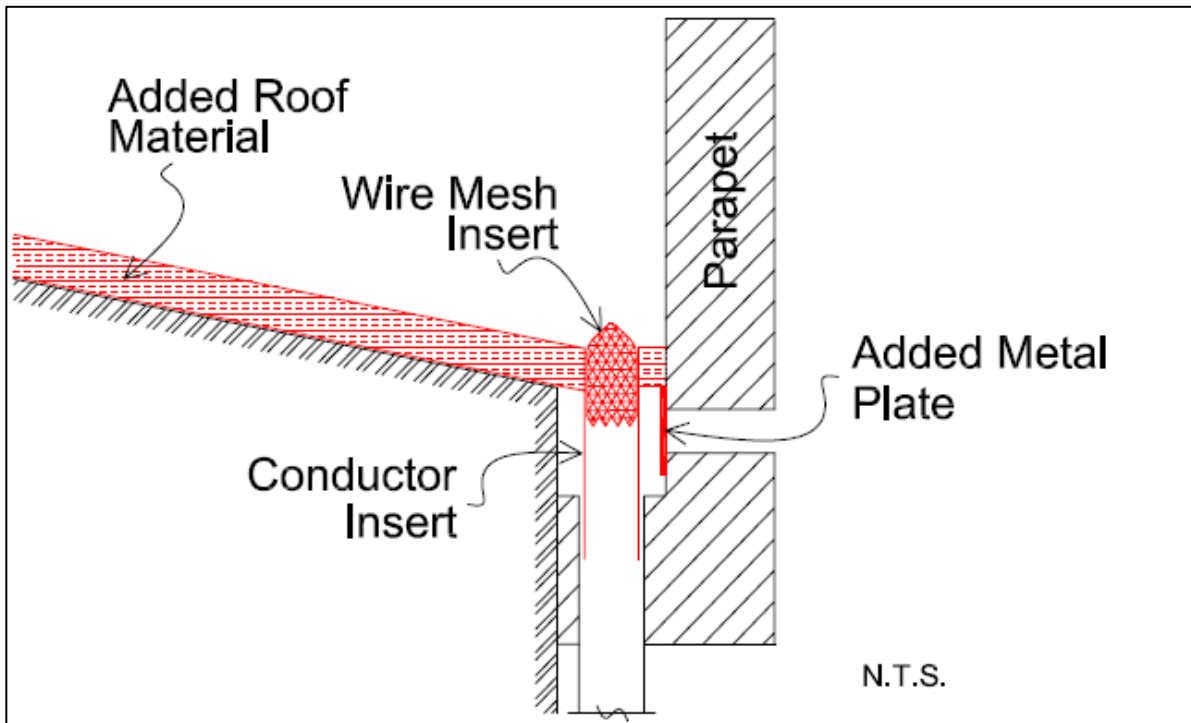
The authors observed that the gutter was bypassed entirely by the installation of square drain inlets at the new roof surface matching the location of each conductor downspout, and that the roof membrane was extended over the gutter itself and up the parapet. To accomplish this, conductor inserts constructed of light-gauge 3 1/4" square metal tubing were inserted into the existing downspout openings, thereby extending each conductor downspout up to the elevation of the new roof overlay.

Figure 8. Modified roof drain configuration at the service facility
