FLASHING OF CURTAINWALL AND STOREFRONT SYSTEMS IN COMMERCIAL APPLICATIONS

DAVID D. CANNON, AIA, NCARB;

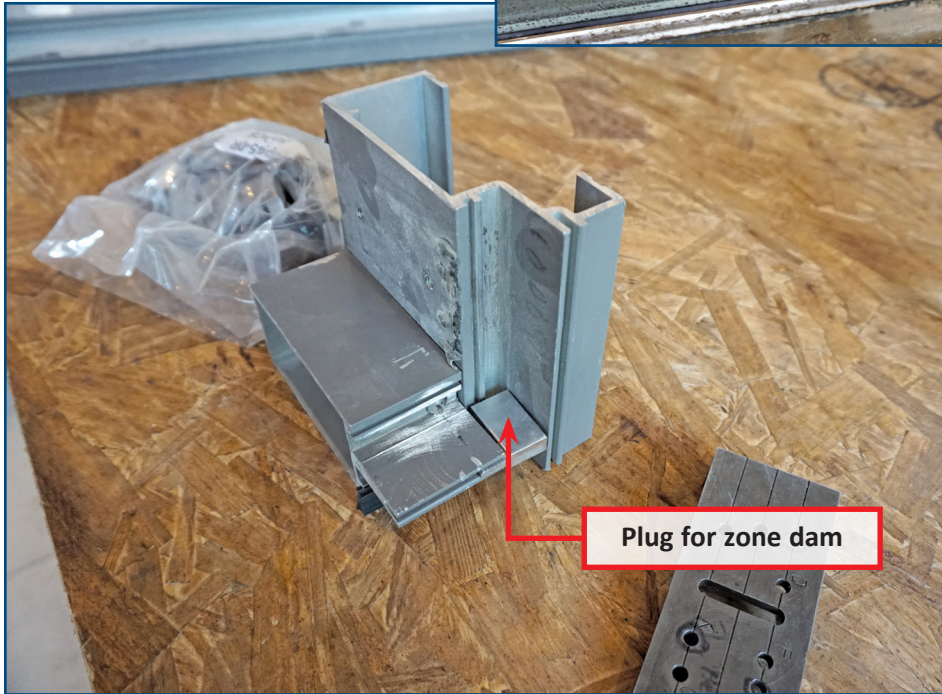
monitoring and repair is required by the building owner to maintain the barrier system performance. Stucco and/or exterior insulating finish systems (EIFS) installed over certain types of wall systems can be constructed as barrier systems, along with various types of masonry, precast concrete panels, and tilt-up concrete construction.

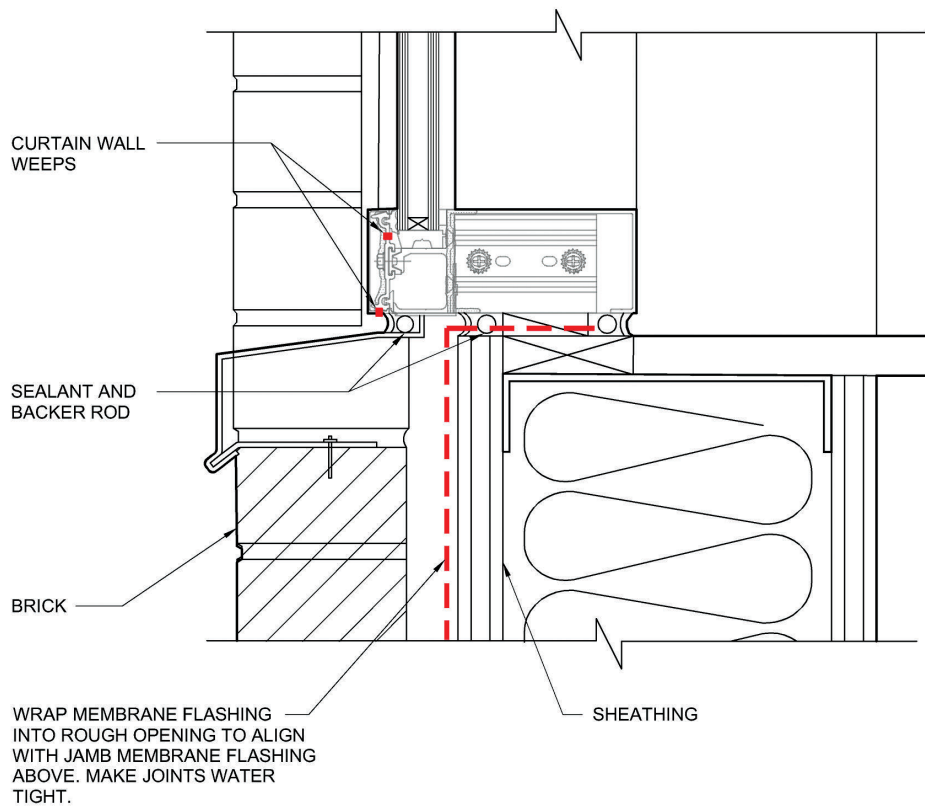
Figure 5 – Typical curtainwall sill section detail.

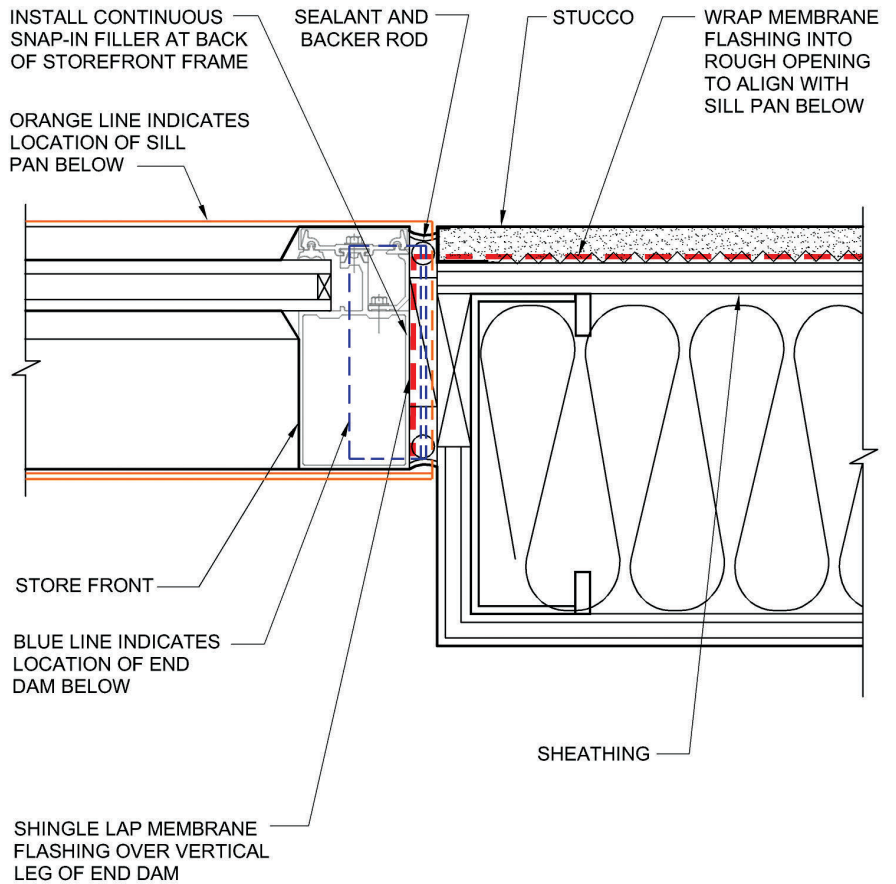
Figure 6 – Typical storefront jamb plan detail.

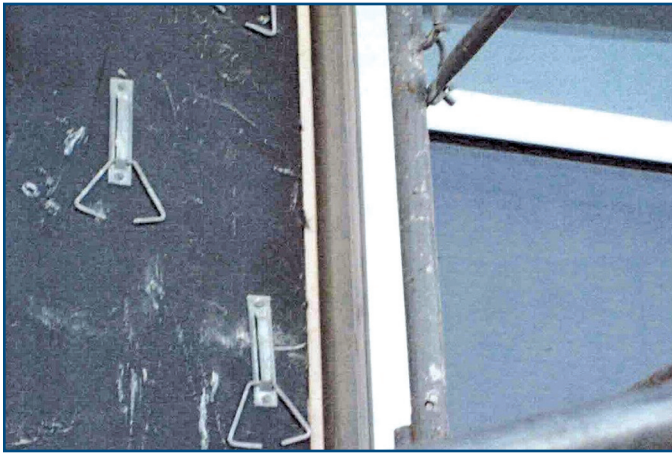
Figure 8 – Missing membrane flashing at curtainwall jamb (photo provided by client).

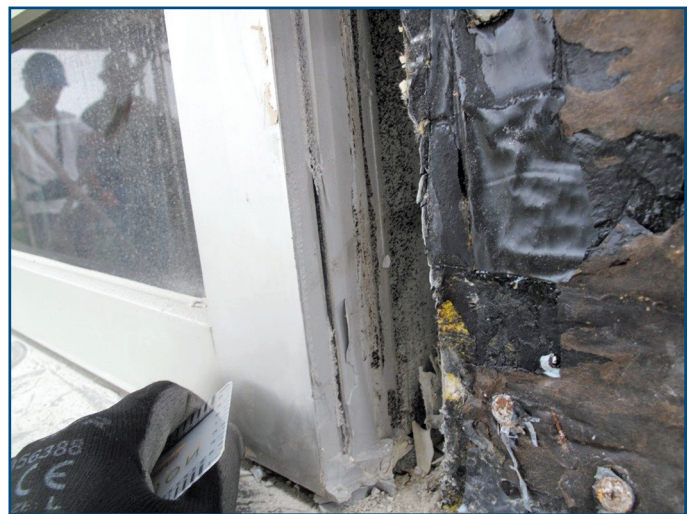
Figure 9 – Large gap at curtainwall jamb and no WRB or flashing wrapped in rough opening.

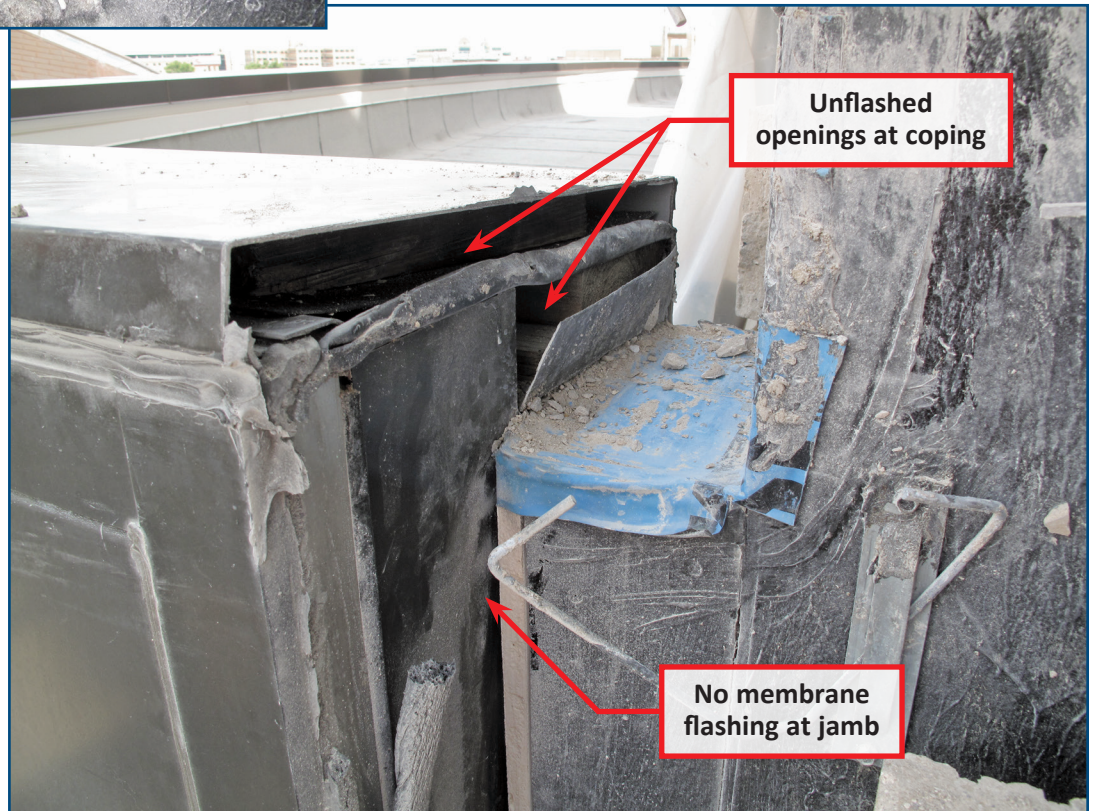
building envelope. These included material transitions, window openings, and roof-to-wall intersections to create a continuous barrier and protect the building against moisture intrusion and air infiltration. Therefore, ongoing moisture intrusion was observed adjacent to curtainwalls throughout the building. Through the removal of exterior finishes, multiple deficiencies in the WRB, flashing, and curtainwalls were noted.

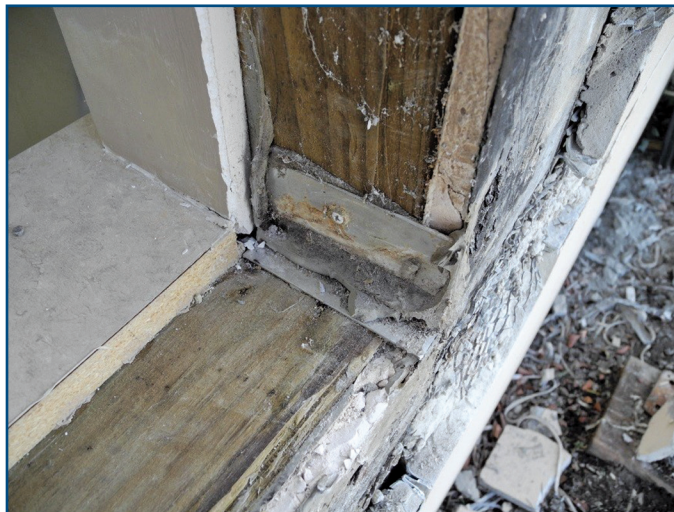
Figure 14 – End dams directly connected to rough opening rather than sill pan. Note the WRB terminating at vertical face of sheathing and not wrapped into rough opening.

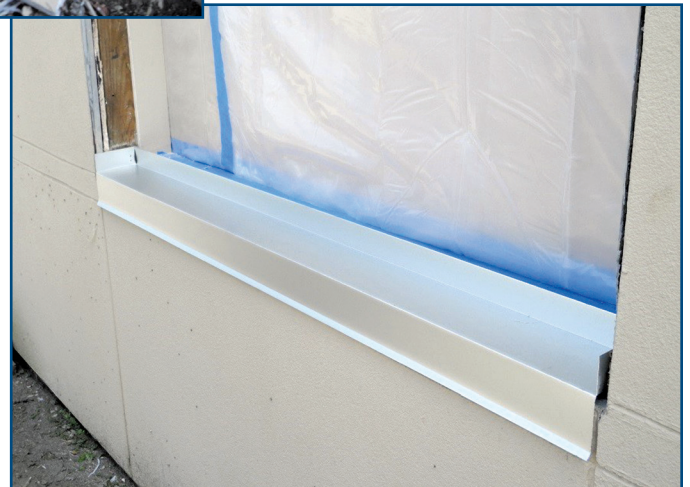
Figure 15 – New custom-built sill pan with integrated end dams.
