Foreseeable Failure: Roof Collapses and Roof Drainage Deficiencies

Stewart M. Verhulst, M.S., P.E., RRC, M. ASCE¹

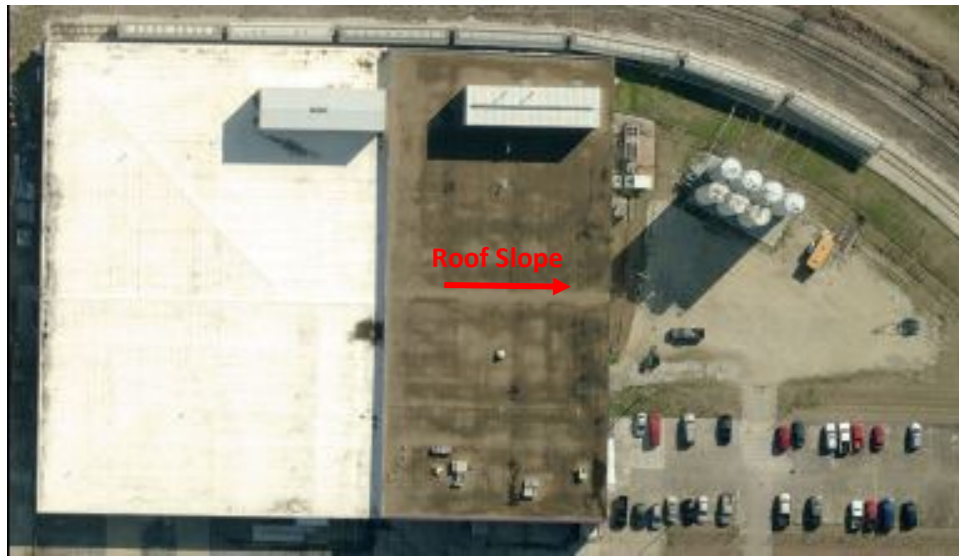
Figure 1. A view of the facility before the construction of the new building addition. The direction of the roof slope is indicated on the subject building.

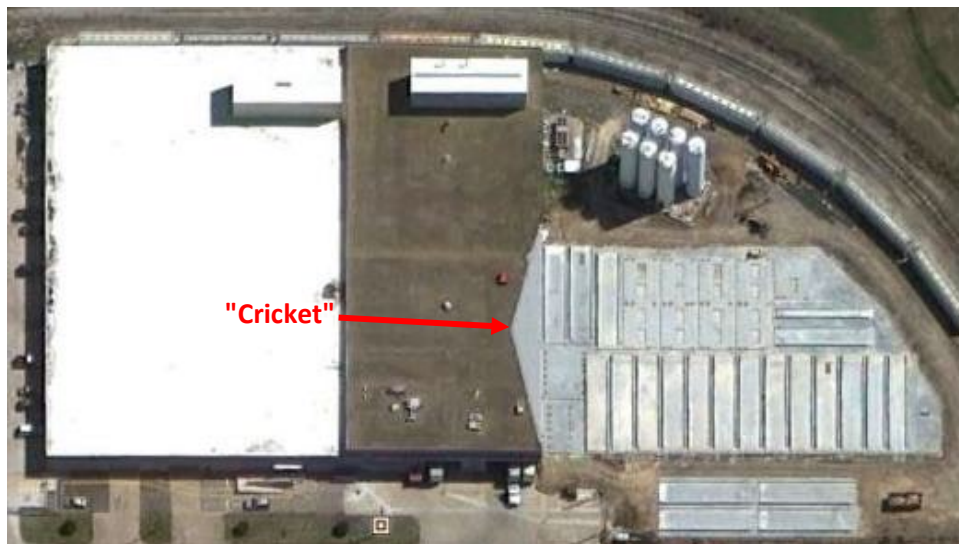
Figure 2. A view of the facility during the construction of the new building addition. Note the drainage "cricket" installed along the drainage edge.

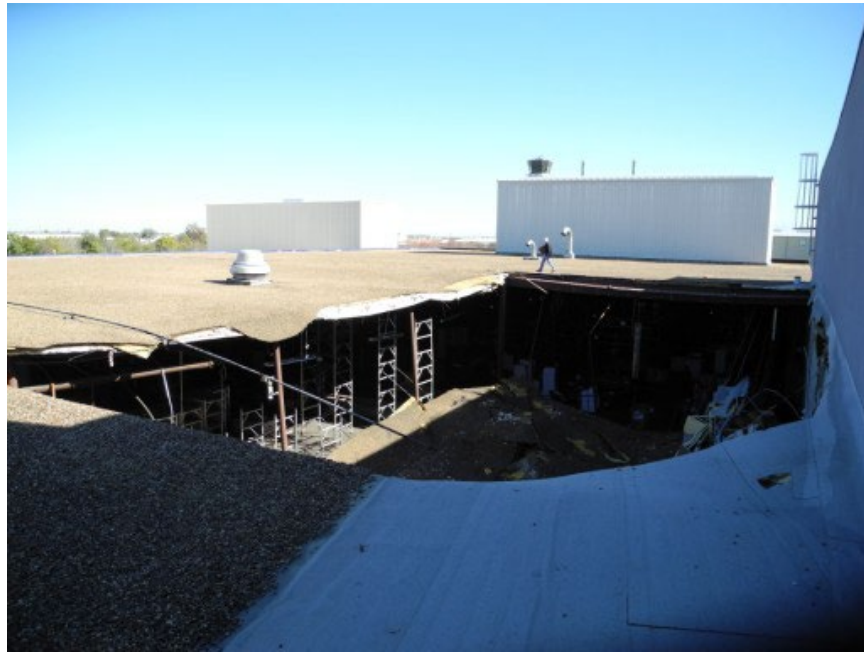
Figure 4. A view of the roof collapse. The new building addition is on the right.

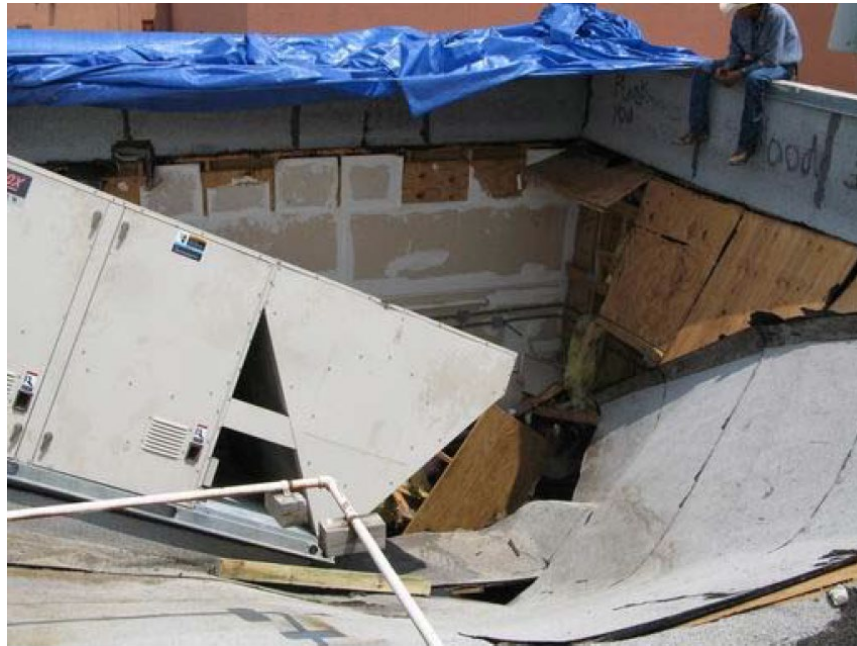
Figure 5. Collapsed roof framing at the building corner above the kitchen.

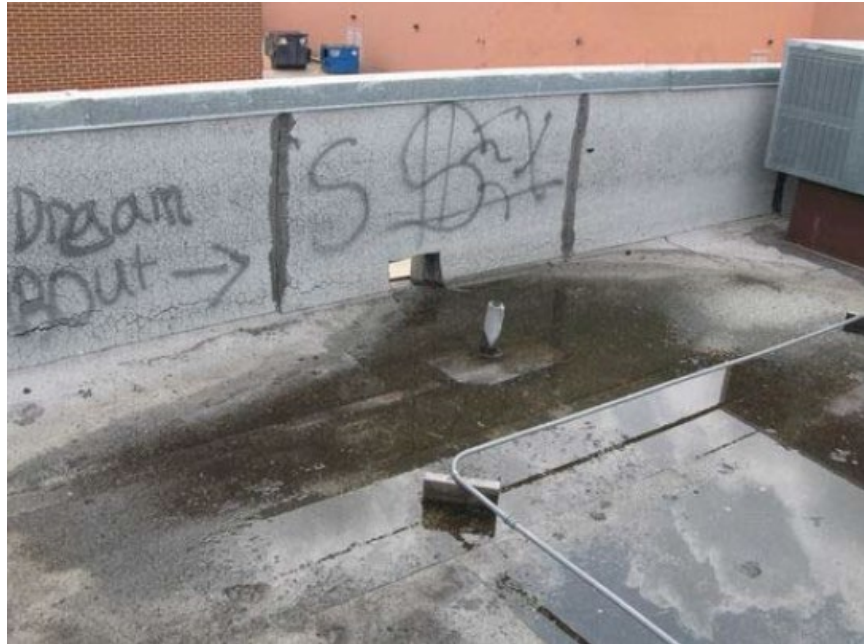
Figure 6. Standing water near the low side of the roof. Note the primary scupper drains and the lack of secondary drains.

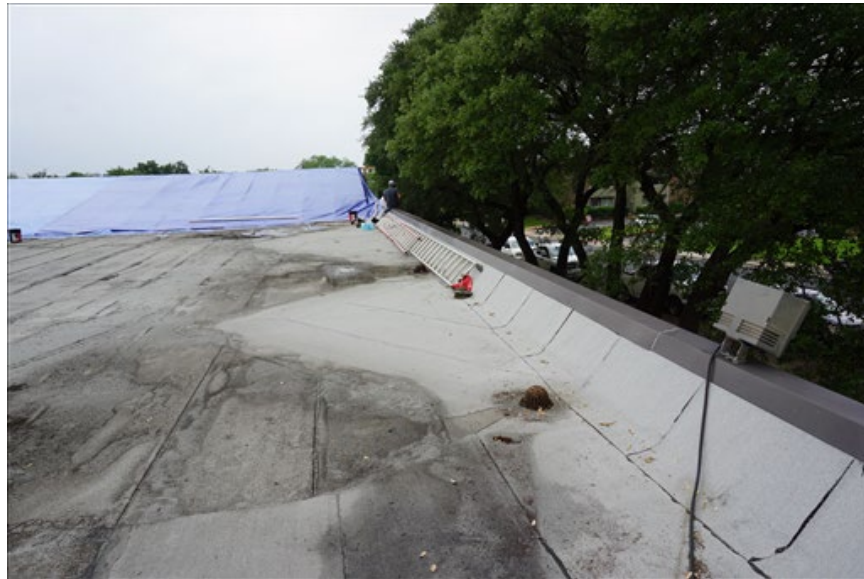
Figure 8. Perimeter roof drains. Note the lack of a secondary drainage system.

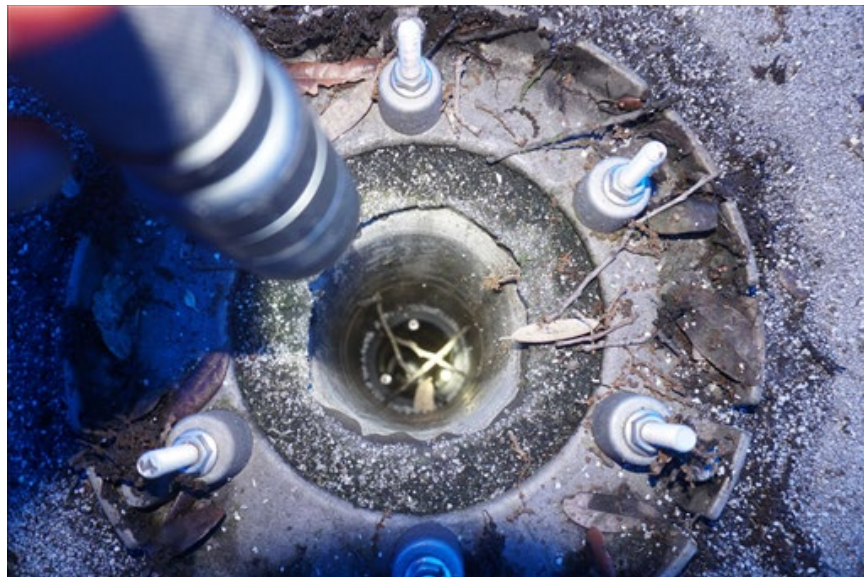
Figure 9. Debris and standing water at the drain pipe of the interior roof drain adjacent to the collapse area.
