Guidelines to Assess Hail Damage to Shingle Roofs

ABSTRACT

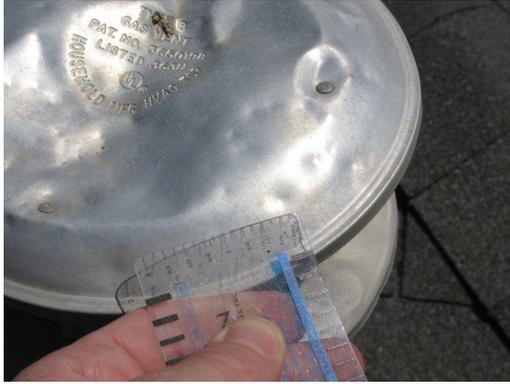
Figure 1. Hail indents on a roof vent cover.

When assessing hail damage to shingle roofs, the roof should be walked thoroughly and a roof plan should be drawn. In addition to evaluating roof shingles for hail damage, roof appurtenances (i.e., vents, any rooftop units/equipment, etc.) should be evaluated. **Figure 1** below shows typical indents due to hail on a roof vent cover. Additionally, the exterior of the structure, including auxiliary structures (i.e., carports), should also be visually evaluated for signs of hail distress. Observed hail distress at both the roof and exterior of the structure should be properly documented.

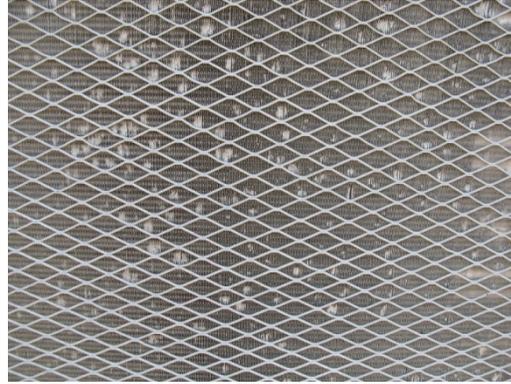
Figure 2. Hail indents in condenser coil fins.

General On-Site Observations. In addition to evaluating the roof, the exterior of the structure should also be evaluated for hail distress. This includes evaluating the exterior finishes of the structure, window assemblies, door assemblies, and auxiliary structures. Any evidence of hail distress, such as burnish marks or indentations in metal materials, should be documented. Additionally, exposed condenser coil fins at air conditioning units are susceptible to impact damage and should be evaluated. **Figures 2** shows typical hail indents in condenser coil fins.

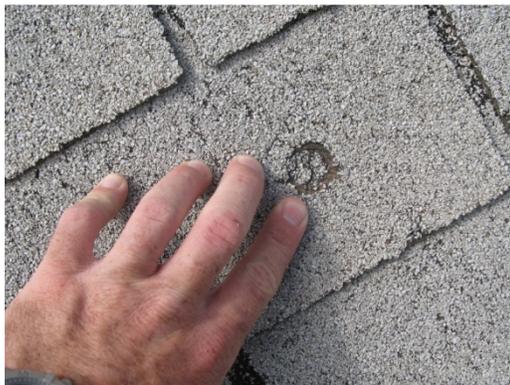
Figure 3. Hail impact mark on a roof shingle.

When evaluating the roof shingles for hail damage, all accessible roof areas should be evaluated. At the accessible roof areas, impact damage to the shingles should be documented. Care should be taken to ensure that the impact damage is consistent with hail. Granule loss on roof coverings can occur from hail impacts; however, granule loss in and of itself does not prove hail damage. Granule loss can also be the result of material and/or installation defects, natural weathering, foot traffic from maintenance, and miscellaneous impact abuse. In the authors' experience, circular areas of granule loss are generally consistent with hail impact damage. For older hail damage, the circular impact marks are typically more clearly defined. Over time, the underlying asphalt at the area of impact shrinks/contracts due to ultraviolet exposure, which creates a distinct circular mark, such as that shown below in **Figure 3**. For newer (or more recent) hail damage, the area of impact will appear bruised similar to that shown below in **Figure 4**.

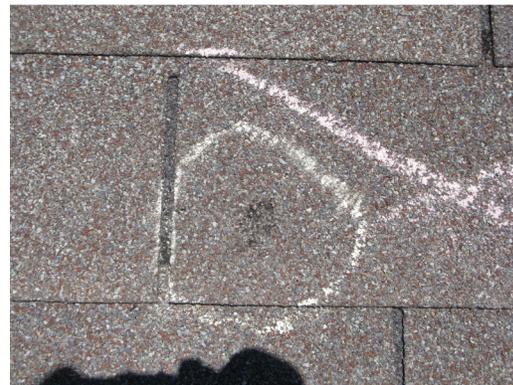
Figure 4. Hail impact mark on a roof shingle.
