Built-up Column Stability in Wood Construction

Design and construction defects related to wood columns in a wood-framed townhome project are presented herein. The subject three-story structures utilized built-up wood columns that depended on gypsum board for stability bracing. The columns did not satisfy the National Design Specification requirements for built-up columns. The proper design of the columns and the implications of using gypsum board for bracing will be discussed.

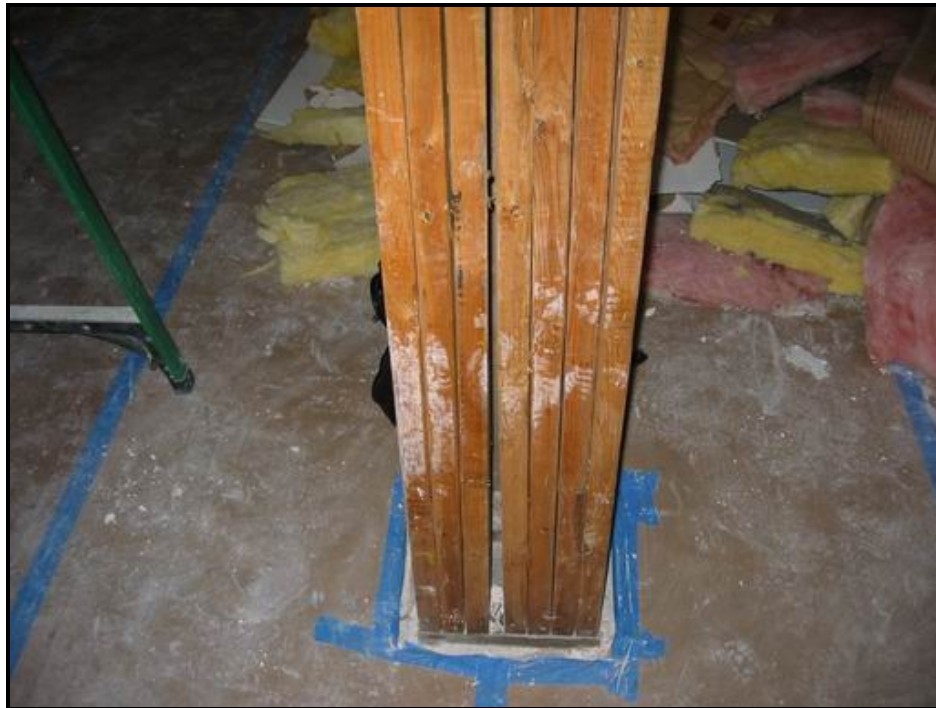
Excessive compressive load on a slender column will cause it to deflect or "bow" perpendicular to the weak axis (Breyer 1993). This deflection causes gaps between the studs of a stud grouping. Such gaps were observed between the studs at heavily-loaded "stud packs" at the subject structures. Column bowing of up to 7/8" (2.22cm) was observed at the subject structures, as measured by the distance between studs at mid-height in comparison with the distance between the studs at the top and bottom, as presented in Figures 2 - 4, below, and on the next page.

Figure 2. Bottom of two adjacent stud groups. The left group exhibits perceptible bowing. Measurement between columns was 1 1/16" at the bottom.

The unsafe conditions created by the insufficient column design necessitated significant column repairs at the subject structures. Inadequate columns were repaired or replaced with "built-up" stud columns (conforming to NDS specifications) or with glulam members. These repairs were necessarily invasive, and required relocation of the unit owners. Significant shoring was required to perform the column repairs. Additionally, some of the columns proved difficult to access and required the removal of architectural features. **The cost of the repair work far exceeded the cost of providing proper column support during construction.**

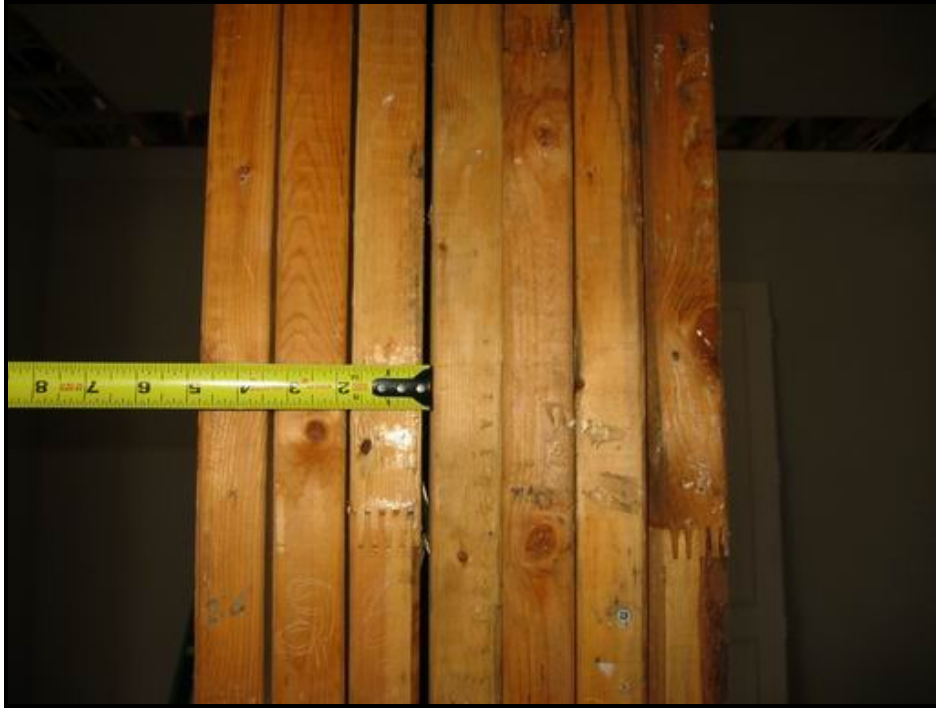
**Figure 3. Measurement at mid-height of columns is 3/16".
The studs have displaced laterally and are also separated individually.**

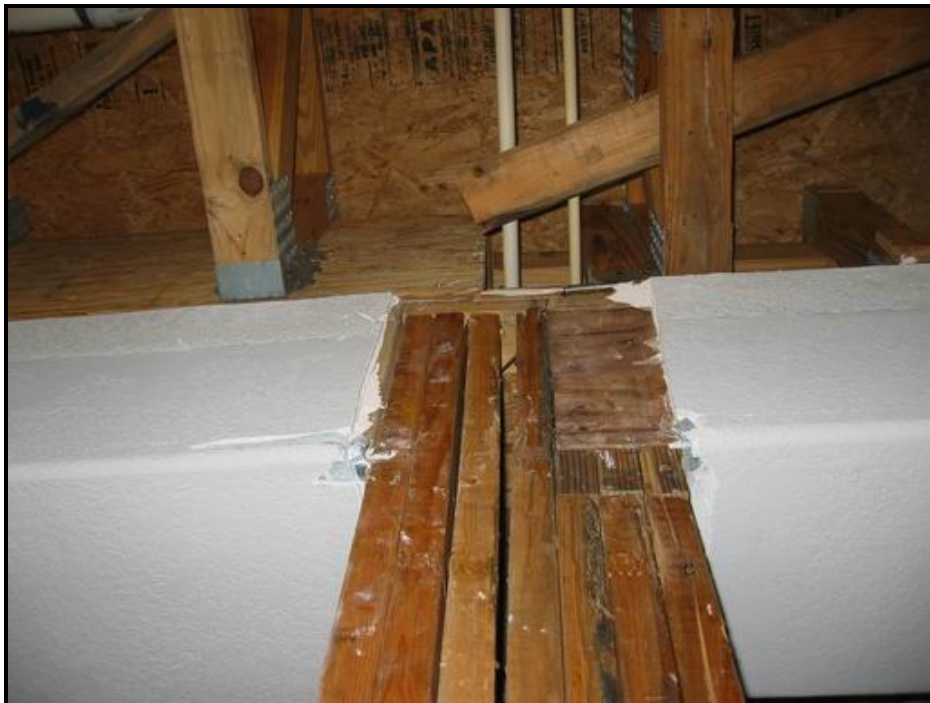
Figure 4. Top of columns. Distance between columns same as at base.

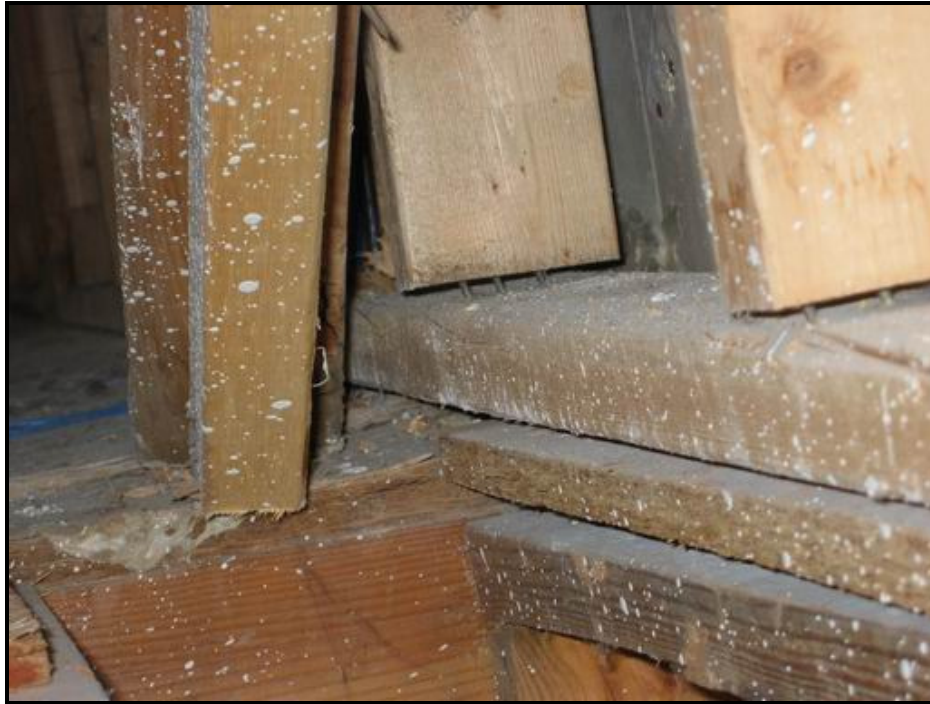
Evidence of downward column deflection was observed due to bowing of the column under load. At one attic space, a heavily-loaded beam had separated more than 1" (2.54cm) from the framing at the attic, as shown in Figure 5, below. Despite the observed column failures, it should be noted that the structure had likely not been subjected to the full design load at the time that these conditions were observed.

Figure 5. Separation of framing at attic level above a heavily-loaded column.

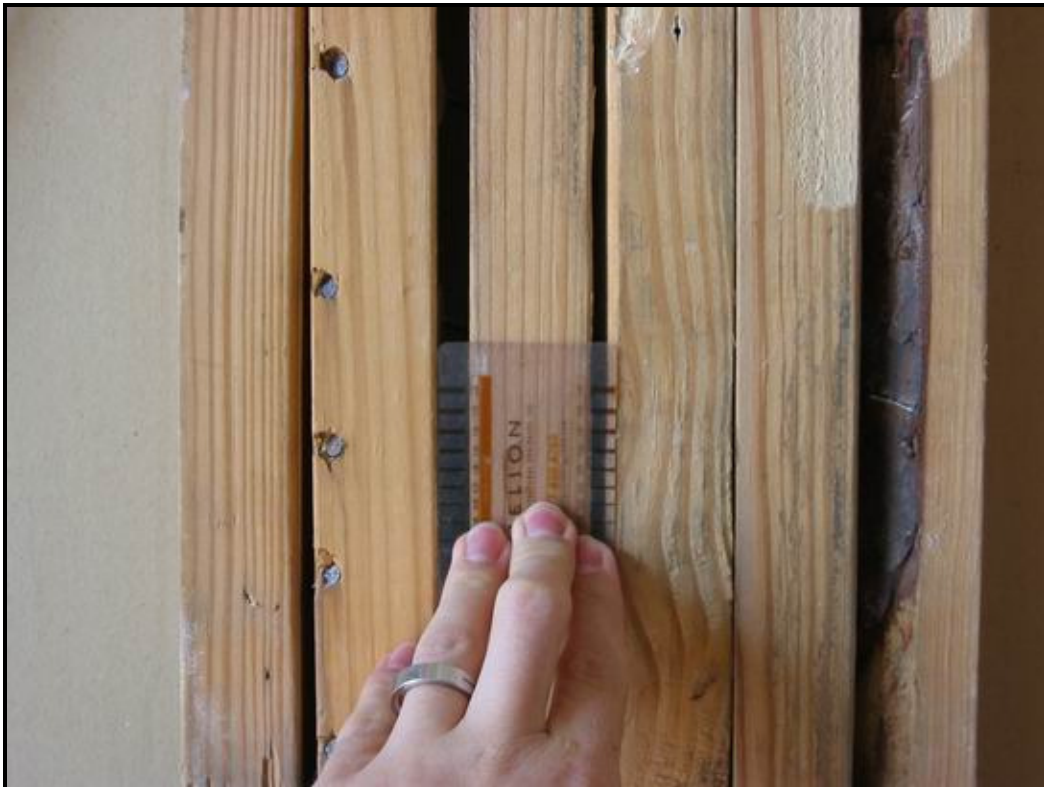
- Neither gypsum board nor paneling is a permanent brace. During future remodeling either could be removed, and the column would then have no allowable axial load capacity. That is not a risk that either the design engineer or the owner should accept.
- If gypsum board were to become water saturated, perhaps due to a roof or plumbing leak, the gypsum board would have little or no bracing capacity.
- It is very difficult to verify during construction that the nailing into the individual laminations was in accordance with the design, e.g. some nails might be driven into the interface or nearer to the edge of the lumber than permitted by the NDS. For example, Figure 6, on the next page, shows nails

at the edge of one of the studs at the subject condominium project when only a single line of nails was used.

Figure 6. Nails attached near the edge of a stud in a "stud pack".

1. Two or more studs that are required to carry a greater load than permissible using a single stud should be designed as a built-up column.
2. Gypsum board or other wall paneling is not to be considered as bracing for more than one stud in a group. Also, these materials should not be considered as bracing for columns (solid or built-up) with a design load greater than the capacity of one stud.
3. Built-up columns should be called out on Structural Drawings and be detailed in accordance with NDS requirements.
