## **A Case Study on the Collapse of Industrial Storage Racks**

A forensic case study of failure of industrial storage racks is presented herein. This case study will highlight forensic investigation methodology, industrial storage rack installation guidelines; and how a combination of improper installation, maintenance, and operational procedures led to a catastrophic failure of a warehouse storage rack system. Methodology for, and results of, structural analysis of the subject rack system is presented. The authors will demonstrate that current installation guidelines do not provide for adequate stability of storage rack systems and propose that a change from guidelines to prescriptive requirements will provide a safer environment for building occupants and protect against costly property damage and business interruptions due to storage rack collapses.

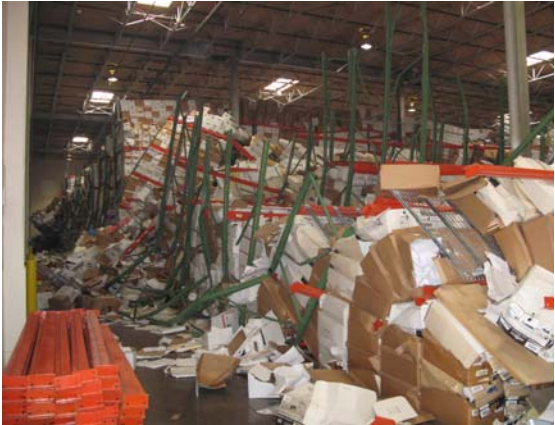
In the early morning hours of July 5, 2007 a motion detector for the security system of a warehouse in Carrollton, Texas was triggered by the collapse of more than half of the industrial storage racks installed in the building (**Figure 1** and **Figure 2**). The collapse occurred approximately 30 minutes prior to the warehouse being operational for the day.

**Figure 1:** Collapsed Storage Racks

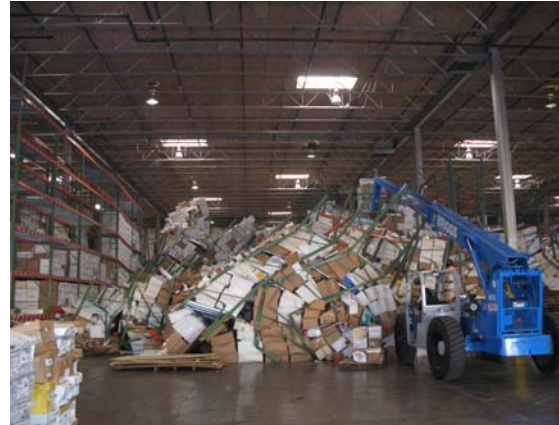
**Figure 2:** Collapsed Storage Racks

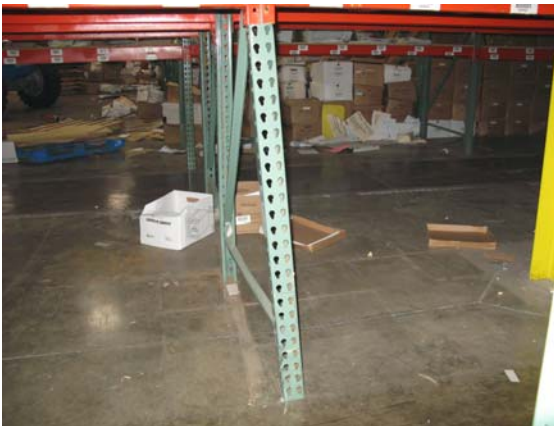
The authors observed that many of the columns were out of plumb from vertical *below the first beam of the racks* (**Figure 4** and **Figure 5**). However, column sections above the first beam appeared approximately plumb. Plumbness measurements were taken with a Stanley® SmartTool™, which is a four-foot level instrument, on the bottommost column sections (between the floor and the first beam) of the racks that were still standing at the south side of the warehouse. A reading of 90.0° indicates that the column is true and plumb with the vertical, whereas each 0.1° difference from 90.0° is equivalent to slightly more than 1/12" change over four feet from the vertical (i.e. 89.7° is approximately 1/4" out-of-plumb over four feet).

Of the 58 columns on which plumbness measurements were recorded by the authors, 44 (approximately 76%) were not in compliance with the ANSI/RMI standard for plumbness. Ten of the measured members were out of plumb more than 0.8" in 4' feet, which extrapolated to 2" in 10'. The most severely leaning member was out of plumb 6.2" in 4', or 15.7" in 10'.

**Figure 4: Out-of-plumb Column**

- ❑ Safeguards were not in place to protect the subject storage rack system from impact damage by equipment. Rack columns were out of plumb as a result of equipment impact.
- ❑ The failure to positively anchor column bases to the floor allowed column bases to be displaced, allowing for eccentricities, or out-of-plumbness, of the columns. Many column sections of the frames that remained standing were out of plumb and did not meet the provisions of the ANSI/RMI standard for plumbness.
- ❑ Out-of-plumb column sections caused eccentricities more severe than that which the frames were designed to resist. These eccentricities, combined with the absence of backties, caused the collapse of the racks.

It is the authors' opinion that industrial storage racks are structural systems which affect the safety and welfare of the public; and thus should be designed by a licensed and qualified structural engineer based on prescriptive requirements. The design engineer should provide for positive anchorage of the rack bases to the building foundation, and ensure adequate bracing for lateral stability. A structural analysis should be conducted for the global geometry of each rack installation to ensure adequate strength and stability of the configuration to be installed. Furthermore, protection of the bases of rack systems must be provided to prevent impact damage.

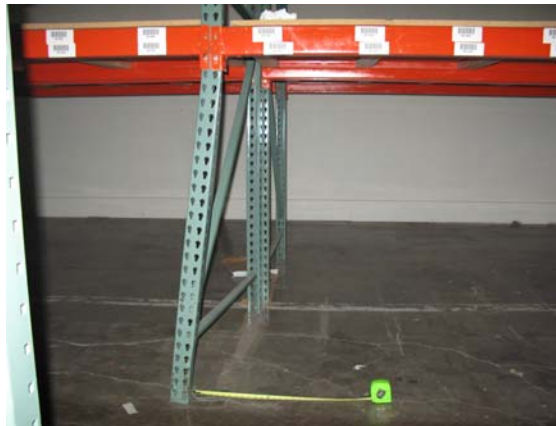
**Figure 5: Out-of-plumb Column**
