Case Study: Failure at an Abutting Lower Roof due to Snowdrift

Jed B. Larsen, M.E., A.M.ASCE¹
Marco A. DeLeon, M.E., P.E., M.ASCE²
Deepak Ahuja, M.S., P.E., M.ASCE³

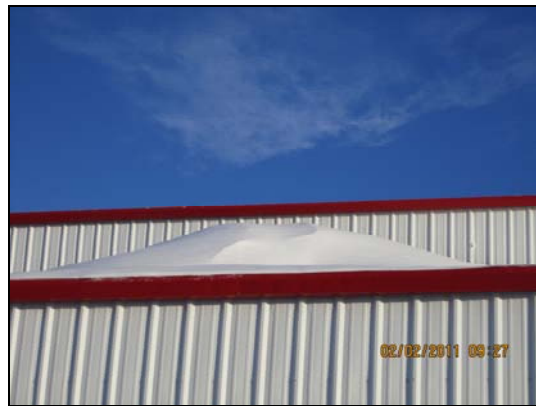
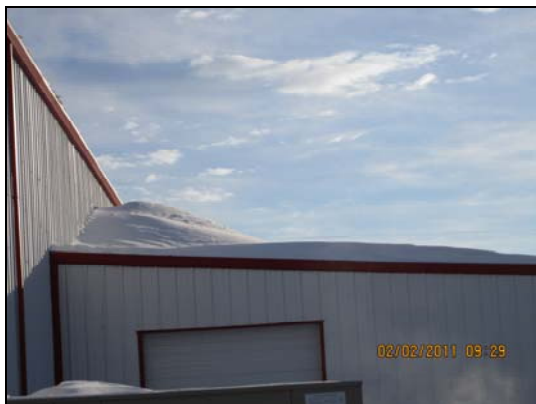
Only the southern, abutting lower roof structure experienced a partial roof collapse during the storm event (**Figure 1**). Photographs of the total snowdrift height at the southern lower roof structure were taken the morning after the storm event (**Figures 3 and 4**). As a result of the snowdrift, the southern lower roof deck was sagging throughout and had pulled away from the upper roof structure (**Figure 5**). The distance between the elevation of the lower and upper roof at this location was 12'.

The upper crest of the snowdrift measured approximately 10' from the projected surface of the lower roof (sagging in the lower roof deck would result in additional drift height, which was not included in the measured 10' drift height). The snowdrift accumulation at the southern lower roof resulted in several failed secondary framing members (Z-purlins), excessive deflection of the metal roof deck/framing, and

Figure 3: Snowdrift geometry/height at southern lower roof

Figure 4: Snowdrift geometry/height at southern lower roof

However, the maximum observed height of snowpack from the storm event on the southern lower roof was measured as approximately 10 feet from the lower roof surface (possibly greater if roof deck deflection is taken into account), which is approximately 2.2 times higher than the predicted design snow height. Therefore, based on the site-specific design snow density (15.3 pcf as presented in the previous section), the total snow surcharge on the southern lower roof framing could have been up to approximately 2.2 times higher than the minimum, code-required design snow loads.

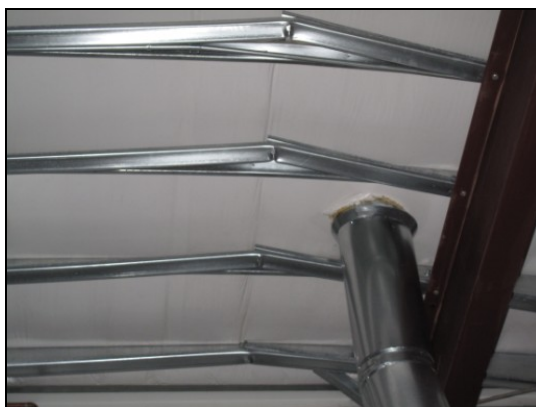
Figure 6: Failed Z-purlins

damage to a portion of the metal roof deck (**Figure 6**). The authors observed that bolts were missing at several of the roof purlins at the purlin splice connections (**Figure 7**).

The authors' load calculations revealed that the purlin design at the partially collapsed lower roof structure was marginally inadequate for the required design snow loads per the 2003 IBC. Structural analysis revealed that the failed purlins were less than 10% overstressed for code-required vertical loads and the deflection of select purlins exceeded the allowable code limits for serviceability. The as-built conditions noted in the field indicated construction deficiencies, including missing bolts at Z-purlin to Z-purlin lap connections, which would further reduce the load carrying capacity of the as-built members.
