The Roof Drainage Epidemic

ABSTRACT

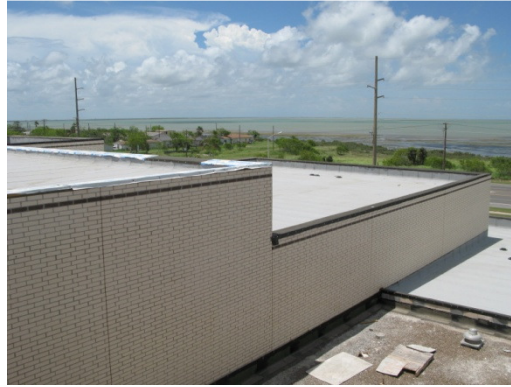
subject structure was a multi-level low-sloped roof with multiple roof areas that were bounded by parapet walls. **Figure 1** is an overall view of several roof areas at the subject structure. Roofing types included modified bitumen roofing (both smooth and granule surfaced) and built-up roofing with gravel ballast. The roof drain systems throughout consisted of primary roof drains and associated secondary scuppers along the roof edges.

Figure 1. General view of a portion of the school roof.

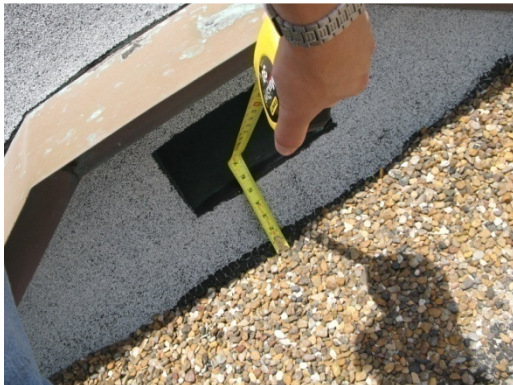
It was observed during our investigation that several of the scuppers were located approximately 4" to 7" above the adjacent roof drains. **Figures 2 and 3** are examples of two of the scuppers that were measured during our site visit. Previous building codes (dating back at least to the 1997 Uniform Building Code [UBC]) required that the secondary drain system be located 2" above the primary drains (ICBO, 1997). The requirements of the more recent IBC are based on the design of the roof structure and differ from the UBC prescriptive requirements. Regardless, it has been our experience that the 4" to 7" distance between the scuppers and primary drainage at the high school roof was too high. In our opinion, this condition was potentially unsafe if the roof structures were not designed for the hydrostatic loading from water accumulation to these heights. Additionally, the significant amount of water allowed to pond on the roof due to the location of the scuppers provided a condition conducive to significant water intrusion and accelerated roof deterioration.

Figure 2. Scupper is located approximately 5" above the roof surface.

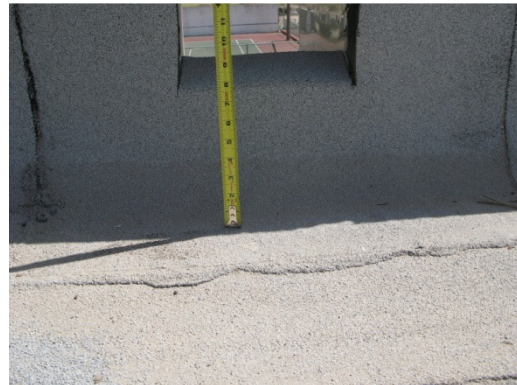
Figure 3. Additional scupper located 7" above the roof surface.

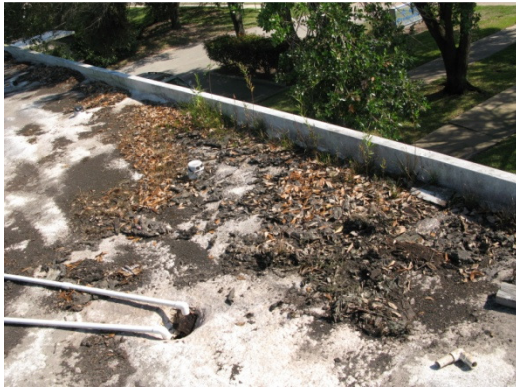
There was a significant amount of debris along the south end of the roof around the scuppers. **Figures 4 and 5** below depict the debris build-up at the subject roof. The debris was obstructing the roof drainage. Vegetation was observed growing from the debris, indicating a long-term condition. Additionally, staining was observed at the roof consistent with previous standing water, and unevenness at the foam roof surface, which created several localized low spots for standing water. These conditions resulted in poor roof drainage, which contributed to roof failure and water intrusion at the building interior. Proper maintenance at the roof level would have prevented the significant debris build-up and provided conditions favorable for proper drainage.

Figure 4. Debris build-up at roof.

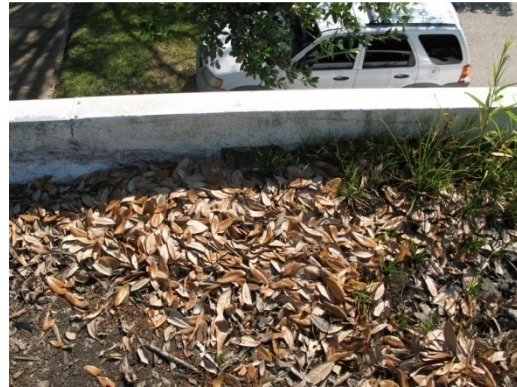
Figure 5. Debris build-up around scupper.

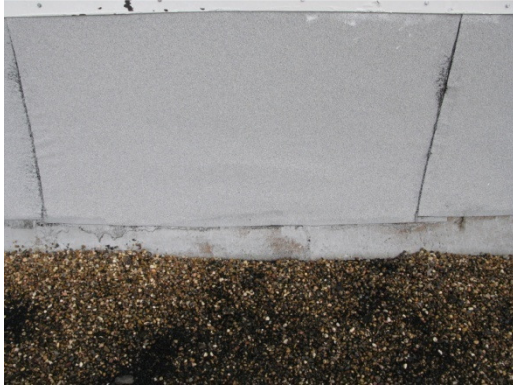
It was observed during our investigation that the roof surface around several of the drains had been patched; however, the strainers at most of these drains were missing. It was also observed that the overflow scuppers along the north parapet wall had been flashed over by a modified bitumen membrane repair, thus eliminating the overflow drain system. This created a potentially unsafe condition at the roof: if the primary drain system was to become impeded (more likely due to the lack of strainers), there would be no secondary means by which the roof could drain, which would create

conditions conducive to a roof collapse. **Figure 6** shows an area at the roof where the overflow scupper had been patched over and **Figure 7** shows the same scupper as viewed from the exterior of the structure.

Figure 6. Patched over overflow scupper.

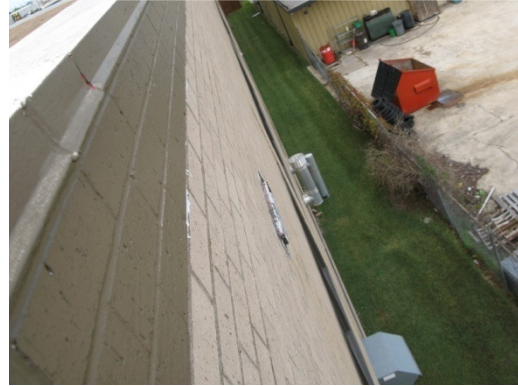
Figure 7. Non-functional scupper viewed from exterior.

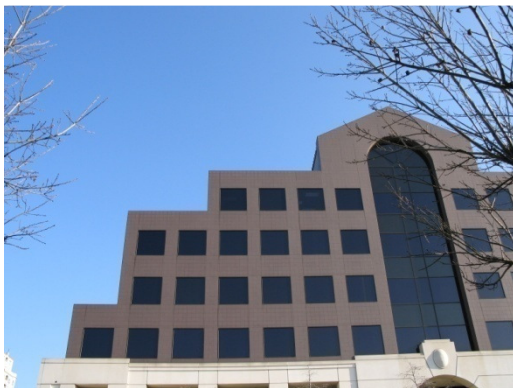
Inadequate drain covers. The subject building in our fourth case study was a multi-story office building with recessed roofs at the three top-most floor levels, as shown in **Figure 8**. The recessed roofs consisted of rectangular gravel ballasted built-up roofs with perimeter parapet walls at three edges. The fourth edge consisted of a building exterior wall with windows over a low curb wall. An overall view of one of the recessed roofs can be seen in **Figure 9**. Drainage for each roof consisted of two pairs of primary and secondary drains. Drainage for roofs cascaded down from upper to immediately lower roofs. Therefore the bottom-most recessed roof received the drainage from all upper roof areas.

Figure 8. Recessed cascading roofs.

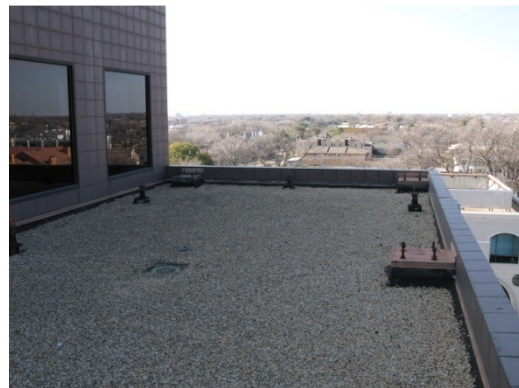
Figure 9. Ballasted built-up roof.

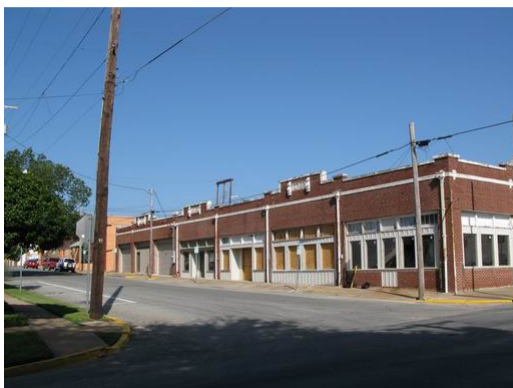
Modified drainage. The subject building in our fifth case study was a nearly 100 year old retail strip-mall building. It had original wood truss roof construction with multiple layers of roofing membranes. The roof profile was unusual and consisted of low-sloped roof sections with gable-style cross-sections in an apparent attempt to direct water to the sides of the roof. Thru-wall scuppers were located on a high parapet wall at the downward slope of the roof. An overall view of the building can be seen in **Figure 11**. The roof partially collapsed during a storm event, as shown in **Figure 12**. Fortunately, there were no injuries.

Figure 11. Strip mall.

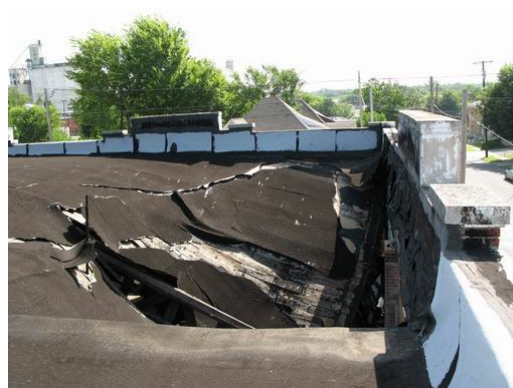
Figure 12. Partial roof collapse.

The cause of the collapse was determined as improper drainage. The roof drain system was modified upon the numerous re-roofing applications performed on the structure over the years. As **Figures 13 and 14** show, at some time the drain system changed from interior roof drains to exterior scuppers. The new scuppers became undersized due to the numerous re-roofing layers that reduced the available scupper cross-sectional drainage area and also by a reduction in size of the downspouts located on the exterior walls. Clearly, the original drain system was changed substantially and resulted in the partial collapse of the roof.

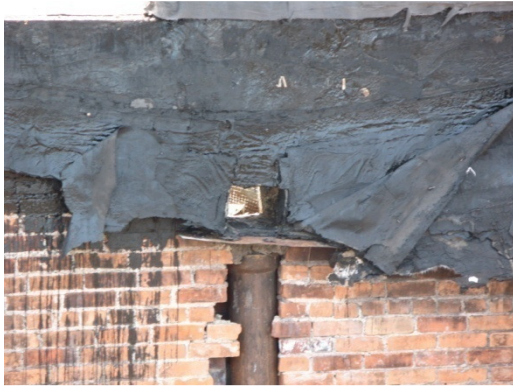
Figure 13. Modified drainage – scupper above sealed-over drain.

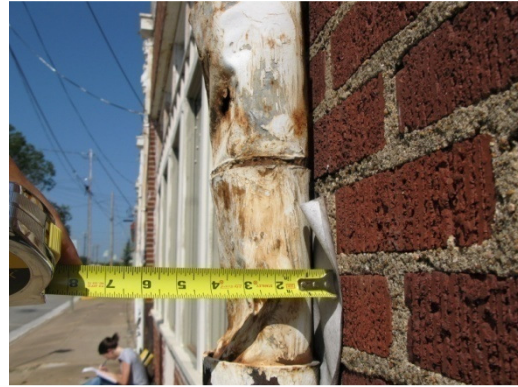
Figure 14. Reduction in downspout cross-section.
