## **Causation of Near-Surface ASR at Concrete Slabs-on-Grade**

Ryan D. Kalina, M.S., P.E., M. ASCE,<sup>1</sup> Ryan T. Chancey, Ph.D., P.E., M. ASCE,<sup>2</sup> and Stewart M. Verhulst, M.S., P.E., M. ASCE<sup>3</sup>

### **ABSTRACT**

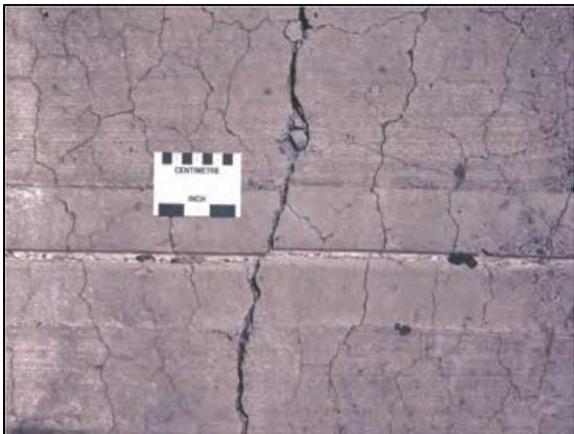
**Figure 1:** Traditional ASR map cracking.

When the proper conditions are present in a concrete mixture, ASR will occur throughout the entire concrete member and takes several years to initiate, typically on the order of 10 or more years. Map cracking (i.e., widespread cracking throughout the concrete member, including at the surface) will occur, resulting in loss of strength, as well as unsightliness and serviceability concerns. This particular mechanism will be referred to herein as "traditional ASR." **Figure 1** depicts map cracking on a concrete member affected by traditional ASR (Thomas, et al. 2011).

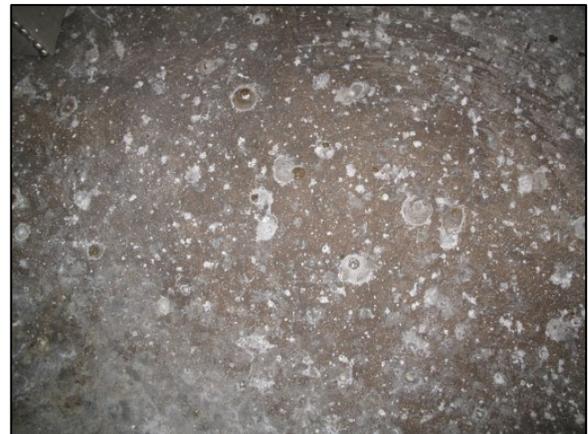
**Figure 2:** Gel exudations and white residue from NSASR at concrete slab surface.

Another type of ASR encountered in concrete slab-on-grade foundation systems in the central Texas region is near-surface ASR (NSASR). NSASR differs from traditional ASR in that the reaction occurs relatively quickly in comparison to traditional ASR, occurs only near the top (exposed) surface of the concrete slab, gel is extruded at the top surface of the slab, and it does not result in map cracking. **Figure 2** depicts gel exudations and white residue resulting from NSASR at the top surface of a concrete slab.

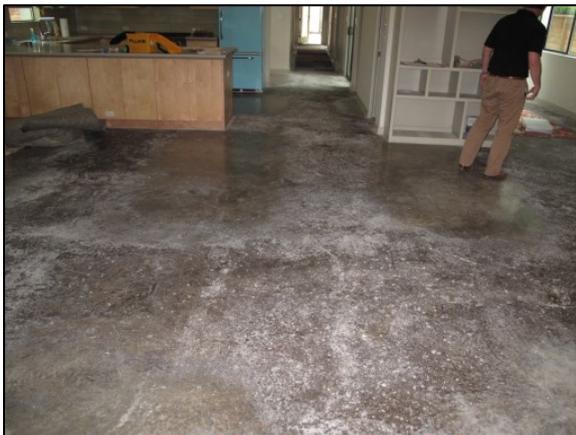
**Figure 3:** Gel exudations at concrete slab surface at interior – note the checkered pattern.

The intended flooring at the building was exposed concrete (i.e., no floor finishes) and gel exudations reportedly began appearing at the top surface of the foundation approximately 17 months after the slab was poured. During the investigation, gel exudations and white residue were observed at the top surface of the slab in a checkered pattern (**Figure 3**) at the interior of the building, and at the back patio (**Figure 4**), which was exposed to the elements. The gel was opaque and brown in color, surrounded by white residue (**Figure 5** and **Figure 6**). The texture of the gel varied between viscous/deformable to hard/brittle.

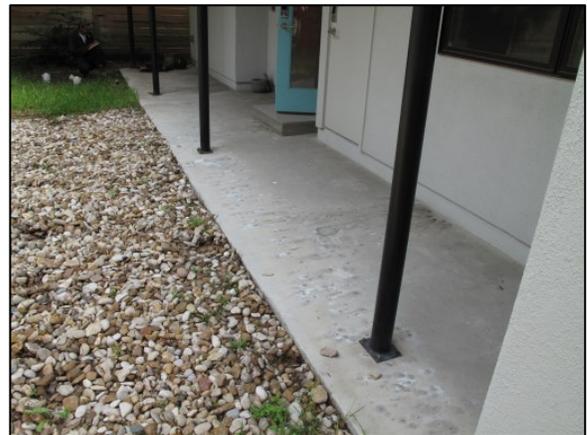
**Figure 4:** Gel exudations at concrete slab surface at back patio – note the checkered pattern.

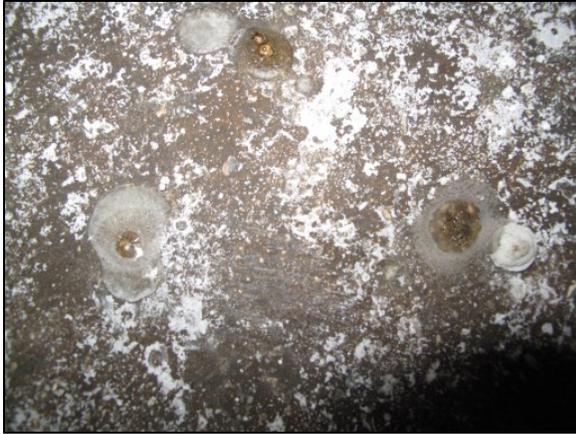
**Figure 5:** Close-up view of gel exudations and surrounding white residue.

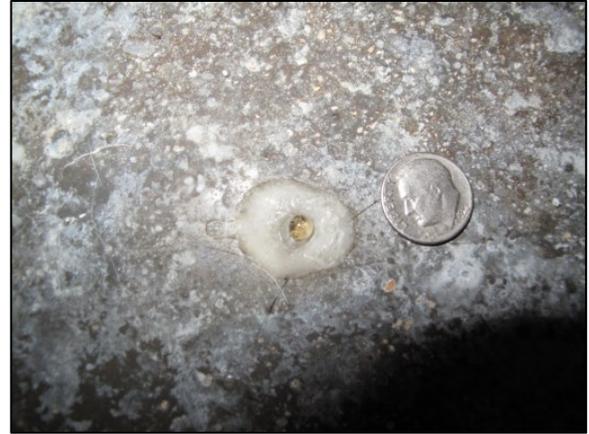
**Figure 6:** Close-up view of gel exudations and surrounding white residue.

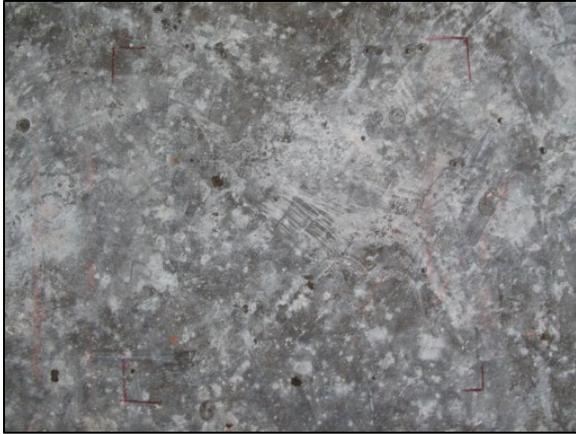
**Figure 7:** New gel formation after seven days. Note that the slab was wiped clean of gel seven days prior.

**Gel Removal and Monitoring.** Two locations exhibiting NSASR were chosen for gel removal in which a 12" by 12" area with gel was wiped clean. Seven days later, the areas were evaluated for the presence of new gel formation. At each of the locations, new gel formation had occurred and had not yet formed a hard outer layer. **Figure 7** and **Figure 8** depict the new gel formation within these areas.

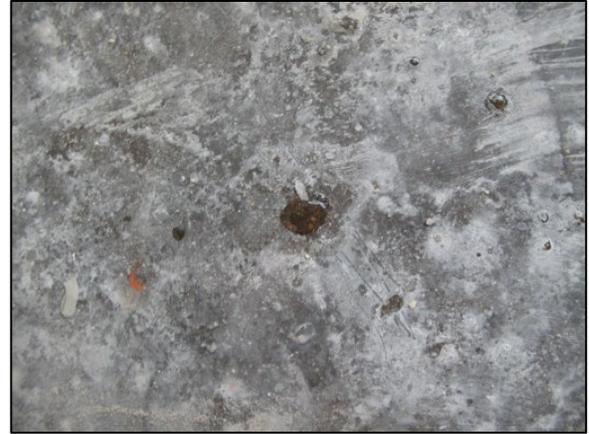
**Figure 8:** Close-up view of new gel formation with no hard outer layer.

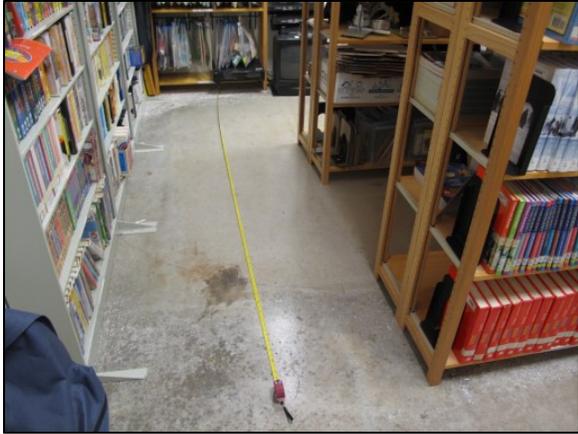
**Figure 9:** Gel exudations at concrete slab surface – note the checkered pattern.

The intended flooring at the building was exposed concrete. It was reported by the owners that gel exudations began appearing at the top surface of the foundation in a checkered pattern approximately 6 months after the foundation was poured. Due to the presence of the gel, vinyl composition tile (VCT) was placed on the concrete throughout the building with the exception of isolated rooms where the concrete remained exposed. During the investigation, gel exudations were observed at the top surface of the slab in a checkered pattern (**Figure 9**) at the exposed portions of the foundation. The gel was opaque and brown in color, surrounded by white residue (**Figure 10**). The texture of the gel varied between viscous/deformable to hard/brittle. Distress to the VCT in the form of cracking, pitting, and/or ridging (i.e., raised portions) were also observed in a checkered pattern (**Figure 11**). Upon removal of the VCT, the tiles exhibiting distress were debonded from the slab and were brittle (**Figure 12**). The surrounding tiles with no distress present were bonded well to the slab, and were flexible and sound upon removal.

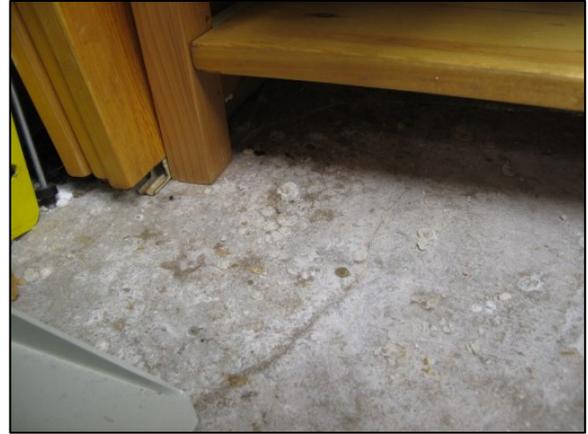
**Figure 10:** Close-up view of gel exudations and surrounding white residue.

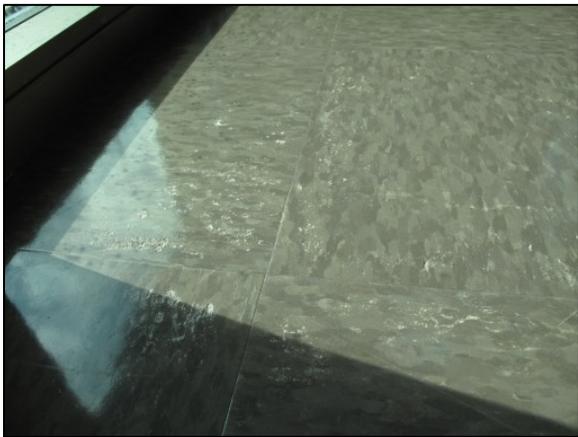
**Figure 11:** Pitting at VCT.

- VCT flooring was installed throughout most of the building as a result of the presence of gel/residue, and distress then manifested at the VCT in the form of cracking, pitting, ridging, and debonding.
- The distress was present within the vicinity of the grade beams, and not within the fields of the slab.
- A vapor barrier was present within the fields of the slab, and was specified to be terminated at the sides of the grade beams.
- In-situ RH testing revealed a correlation between elevated concrete RH and the distress manifestation.
- Analytical elemental testing on gel samples revealed that the gel contained elevated levels of sodium and potassium cations, consistent with alkalis present in ASR.
- The levels of the fluid pH at areas exhibiting gel/residue was elevated, indicating that the pore solution within the concrete at the near-surface region was also elevated.

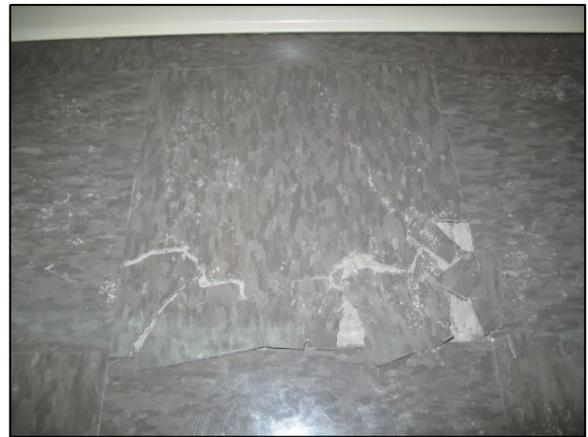
**Figure 12:** Brittleness of VCT.

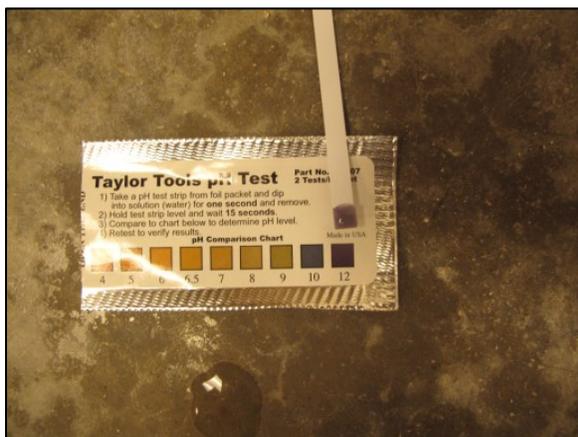
**Figure 13:** Elevated level of fluid pH at area exhibiting gel/residue.

**pH Level Testing.** pH level testing was performed at the exposed concrete surface in general accordance with ASTM standard, F710 *Standard Practice for Preparing Concrete Floors to Receive Resilient Flooring* (ASTM 2017). Testing was performed at areas exhibiting gel/residue and areas with no gel/residue. Distilled water was placed on the concrete surface for 60 seconds prior to absorption of the test fluid onto pH paper strips. The color of the strips changes based on the level of pH and is compared to a pH color chart. The levels of the fluid pH obtained at areas exhibiting gel/residue ranged between 10 and 12, indicating an elevated level of pH of the fluid (**Figure 13**). The levels of the fluid pH obtained at areas with no gel/residue ranged between 4 and 5, indicating a minimal level of pH of the fluid (**Figure 14**).

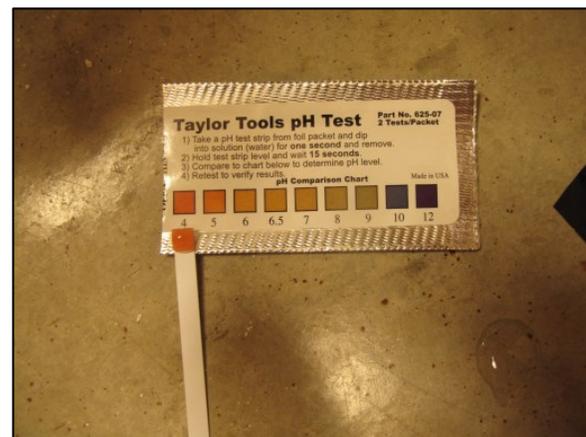
**Figure 14:** Minimal level of fluid pH at area with no gel/residue.

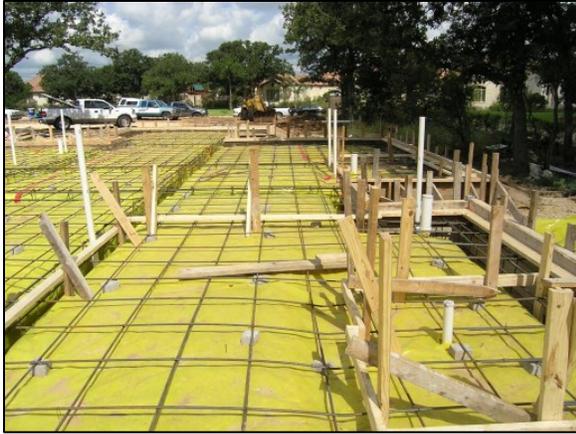
**Figure 15:** Vapor barrier at the slab portions of the foundation (image included with permission).

The main differentiator for Case Study 3 versus the prior two case studies is the presence of a continuous vapor barrier below the grade beams (**Figure 15** and **Figure 16**), which was not present at the buildings in Case Studies 1 and 2. Information regarding construction/design documentation and photographs were provided to the authors by the structural engineer of record for the project.

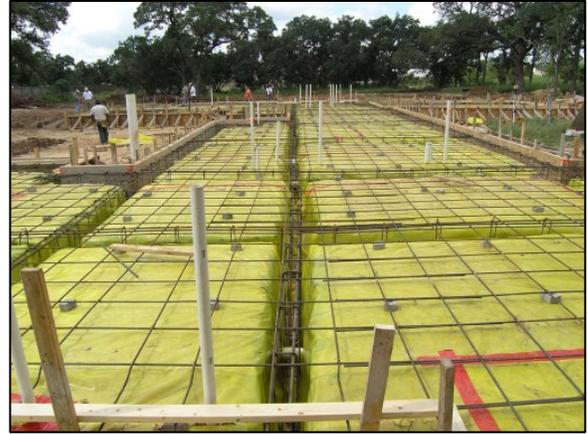
**Figure 16:** Vapor barrier at the slab portions and grade beams of the foundation (image included with permission).

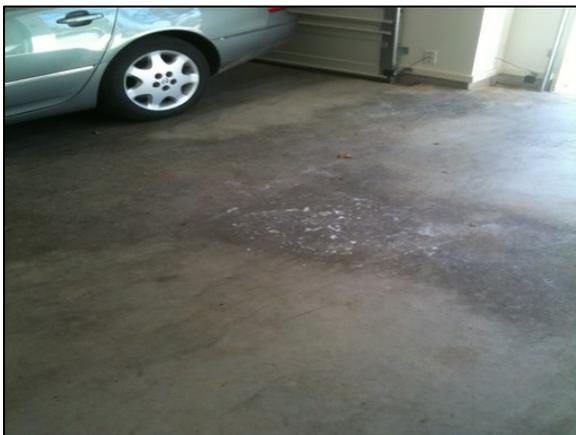
**Figure 17:** White residue and discoloration at concrete slab surface – note the checkered pattern (image included with permission).

The intended flooring at the building was a polyurethane coating at the interior and exposed concrete in the garage. It was reported that pitting of the coating, and gel exudations, white residue, and discoloration began appearing at the top surface of the foundation in the garage in a checkered pattern (**Figure 17** and **Figure 18**) approximately 12 months after the foundation was poured.

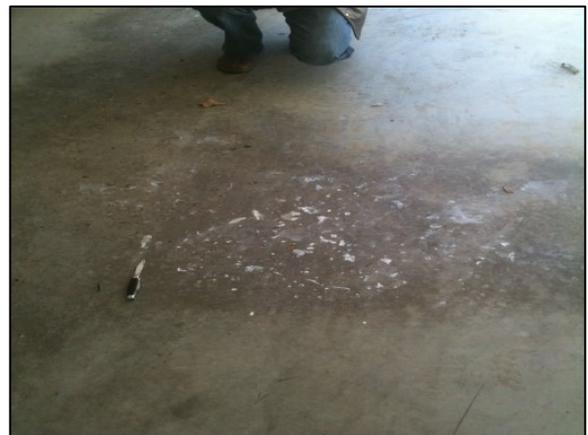
**Figure 18:** Close-up view of white residue at concrete slab surface (image included with permission).
