## **Hidden from View: Investigating Masonry Veneer Anchorage**

### **ABSTRACT**

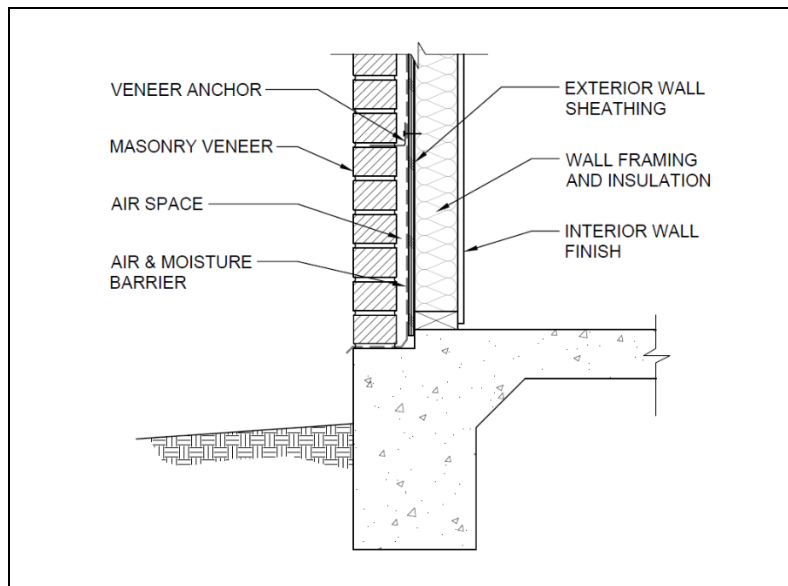
Figure 1: Typical Cavity Wall Components

The discussion presented herein focuses on the attachment of anchored masonry veneer systems used in modern cavity wall construction. The typical components of a cavity wall are shown in Figure 1, and consist of: cladding (e.g., masonry veneer), air space (drainage cavity), air and moisture barrier (drainage plane), exterior sheathing, framing and insulation, and interior wall finishes.

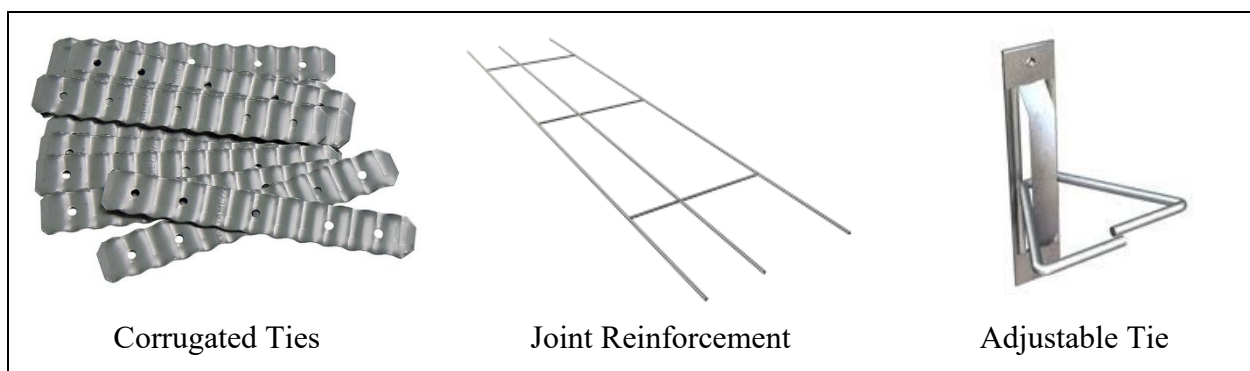
Figure 2: Common Masonry Veneer Anchors.

Lateral loads on masonry veneer systems utilized in cavity wall construction are transmitted to the underlying structure primarily through the masonry veneer anchors. These anchors may consist of a single element (i.e., “box” ties, “Z” ties, and corrugated ties) commonly referred to as “unit ties”, continuous horizontal joint reinforcement, and adjustable ties with multiple components. There are a multitude of veneer anchor types for various applications. Common examples of veneer anchors are shown in Figure 2 for illustrative purposes.

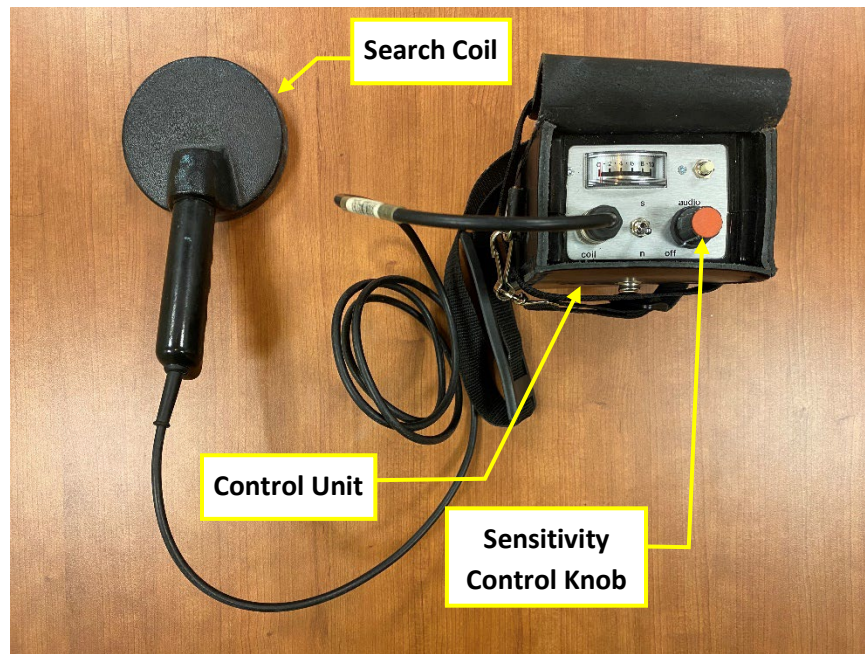
Figure 3: Overview of the Imp Wall-Tie Locator.

**Survey Methodology.** The non-destructive veneer anchor survey process is similar to methodologies utilized to determine the locations of reinforcing bars in concrete. The surveys discussed herein were performed using an Imp Wall-Tie Locator, manufactured by Protoval®; however, various similar devices are available. The Imp Wall-Tie Locator uses magnetic pulse induction from a wire coil to detect metal veneer anchors embedded in the mortar beds of the veneer. The device includes a hand-held search coil that attaches to a control unit carried by the operator (Figure 3). The sensitivity of the device can be adjusted on the control unit to detect anchors at a range of depths. The operator receives an auditory alert when the presence of a veneer anchor (or other metallic object) is detected.

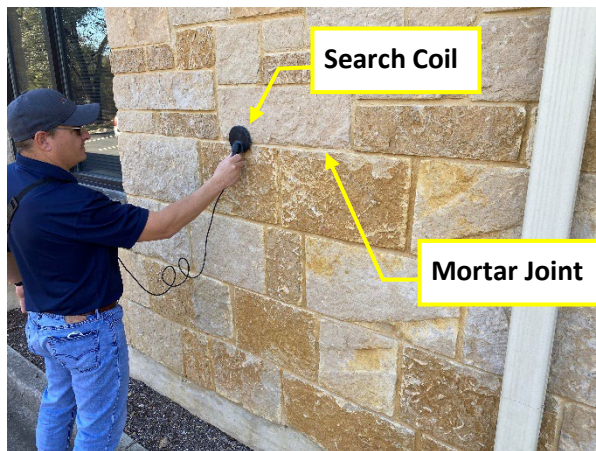
Figure 4: Overview of non-destructive survey in progress.

The survey methodology consists of selecting survey areas at accessible portions of the veneer, determining the veneer anchor locations by traversing all mortar joints within the survey area with the search coil, and marking the locations of detected anchors with tape, chalk, or other means (Figure 4 and Figure 5). The size of each survey area, the number of veneer anchors detected, and the locations of the detected veneer anchors is then documented.

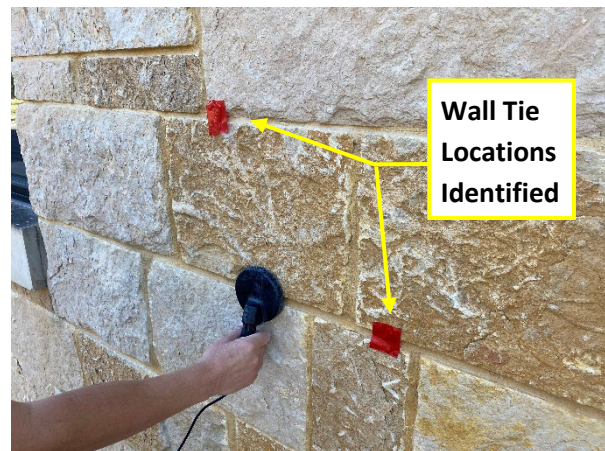
Figure 5: Wall tie locations marked within survey area.

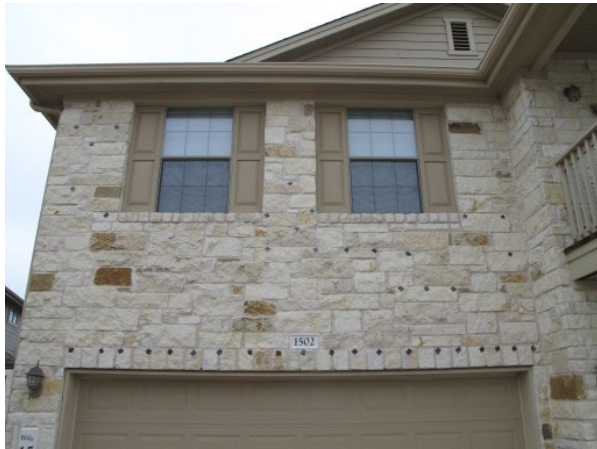
Figure 6: Overview of typical survey area at stone masonry veneer.

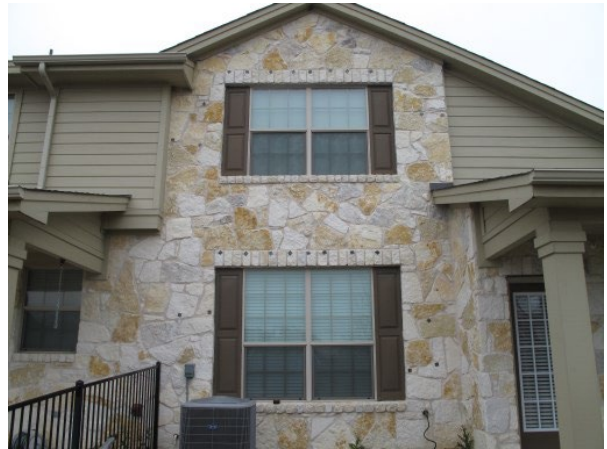
Figure 7: Overview of typical survey area at stone masonry veneer.

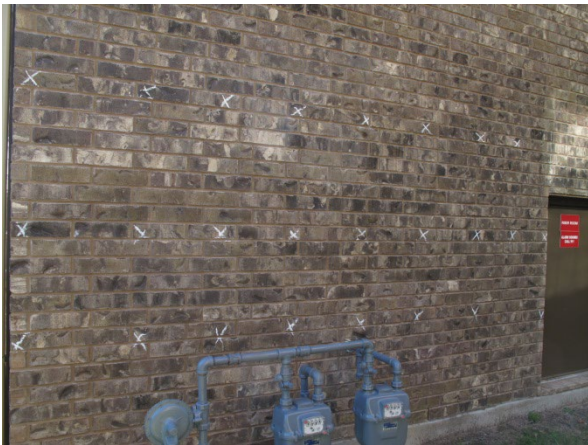
Figure 8: Overview of typical survey area at brick masonry veneer (anchors denoted with chalk "x" markings).

The surveys at this property also indicated a distinct difference in the anchor densities based on veneer type: less than 60% of the required anchors were installed at the surveyed stone veneer, while approximately 94% of the required anchors were installed at the surveyed brick veneer. The anchors for the brick veneer were also more evenly distributed, and more closely complied with code-prescribed spacing requirements (Figures 8 and 9).

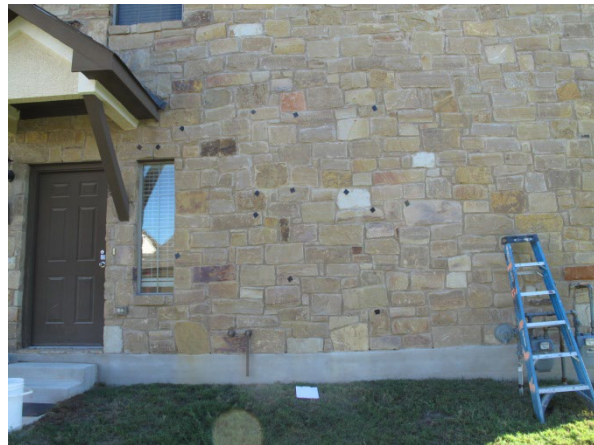
Figure 9: Overview of typical survey area at stone masonry veneer.

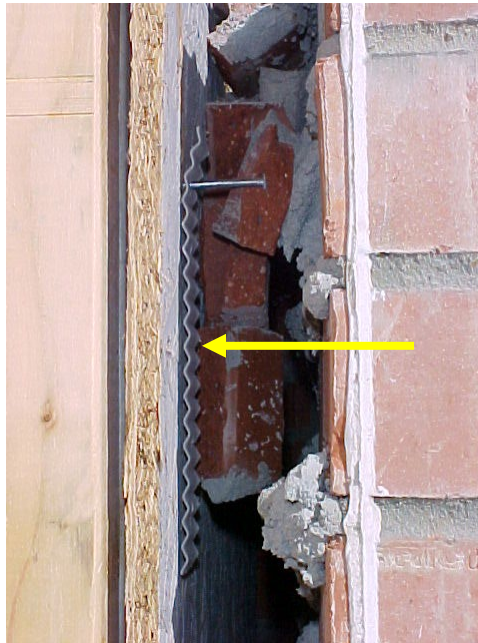
Figure 10: Veneer anchor that was detected during a survey but not anchored into the veneer.

In some cases, veneer anchors that are not properly embedded within the veneer (Figure 10) can be identified based on the difference in auditory feedback on different sensitivity settings.

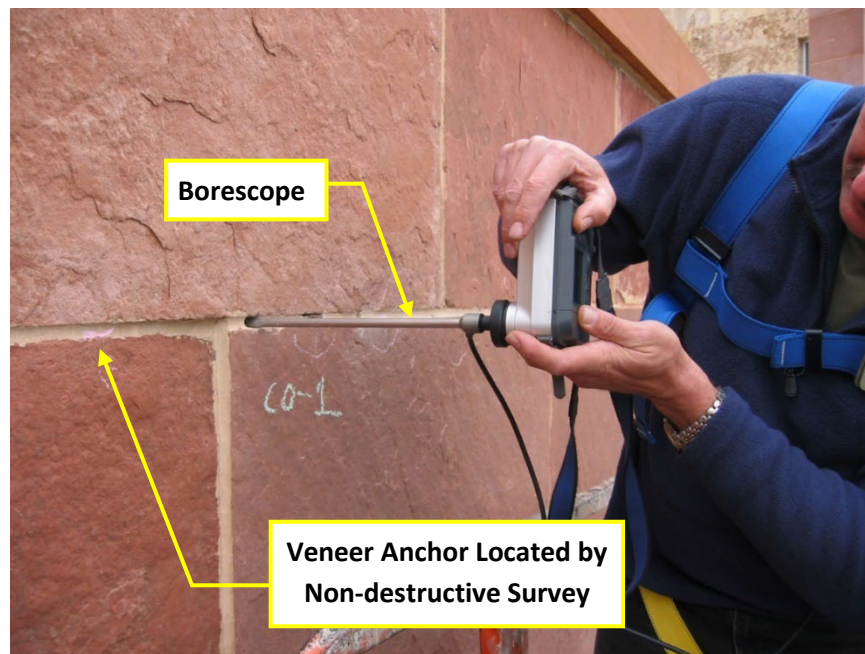
Figure 11: Evaluation of veneer anchor with borescope.

The borescope destructive testing method involves drilling a hole into the mortar joint or masonry unit at the area(s) to be evaluated and inserting a scope into the drilled hole in order to observe the conditions within the veneer cavity. Evaluations with a borescope are generally limited to a visual assessment. A camera attachment can be used on the scope to document the conditions observed (Figure 11).

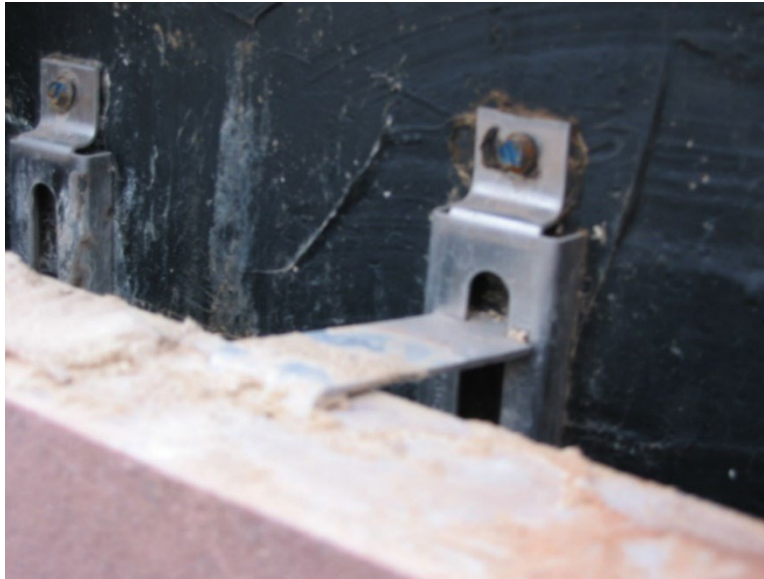
Figure 12. Tie installed such that it restrains vertical movement of the veneer.

Figure 12 shows an example of an anchor exposed with limited veneer removal. This revealed that the stainless steel anchor had been installed with a mild steel fastener (which had started to corrode) and that the installation was such that the anchor was restraining further vertical movement of the veneer.

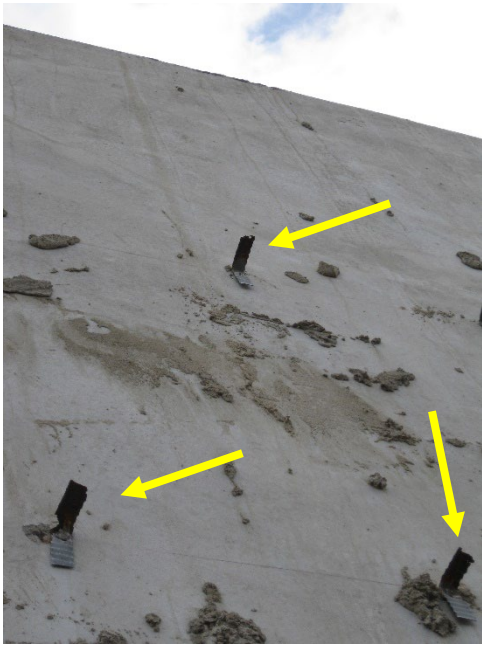
Figure 13. Corroded and failed veneer anchors at a collapsed veneer wall.

The corrosion deterioration of veneer anchors, or of the framing supporting the veneer (such as steel stud framing), is a topic worthy of extensive and detailed discussion beyond the scope of this document. However, a brief discussion is warranted herein due to the severity of the problems that can result from veneer anchor corrosion. The corrosion deterioration of veneer anchors within a cavity wall is typically not visible and often goes unrecognized until a failure occurs. Figures 13 and 14 depict conditions observed after a portion of a veneer wall collapsed at a school campus building. Veneer anchors had corroded through their cross section within the wall cavity. However, the deteriorated condition of the anchors was not known prior to the collapse, which occurred suddenly. It should be noted that this structure was not located in a coastal area.

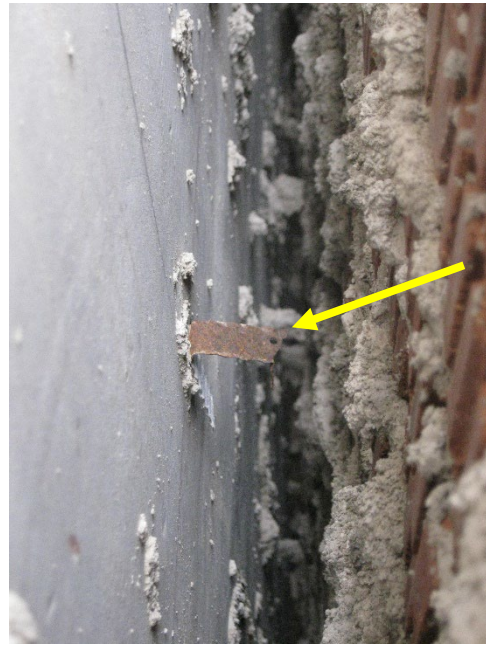
Figure 14. Corroded and failed veneer anchor at a portion of the wall that had not yet collapsed.

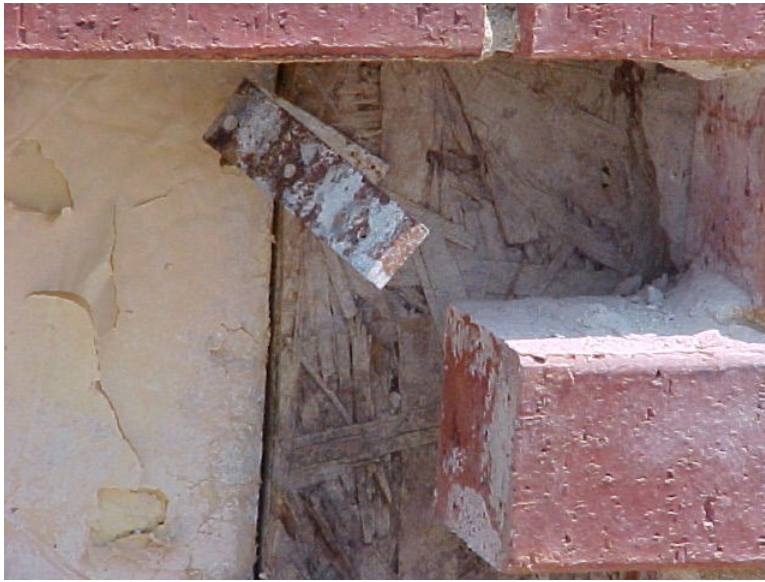
Figure 15. Veneer anchor corrosion at a structure less than one-year of age.

Awareness of the potential for veneer anchor corrosion has increased over time and with changing construction methods related to veneer walls (BIA 2003). The authors have observed veneer anchor corrosion to varying degrees and have observed the beginning stages of base steel corrosion in veneer anchors very early in their service lives, even in non-coastal locations. The authors have also observed base steel corrosion at galvanized veneer anchors in buildings one-year of age and less (Figure 15).
