Case Studies of the Cause and Origin of Fungal Growth in Residential and Commercial Structures

Stewart M. Verhulst, M.S., P.E.¹
Erik L. Nelson, Ph.D., P.E., M.ASCE²
Deepak Ahuja, M.S., P.E., M.ASCE³
Halet G. Poovey, Sc.D., C.I.H.⁴

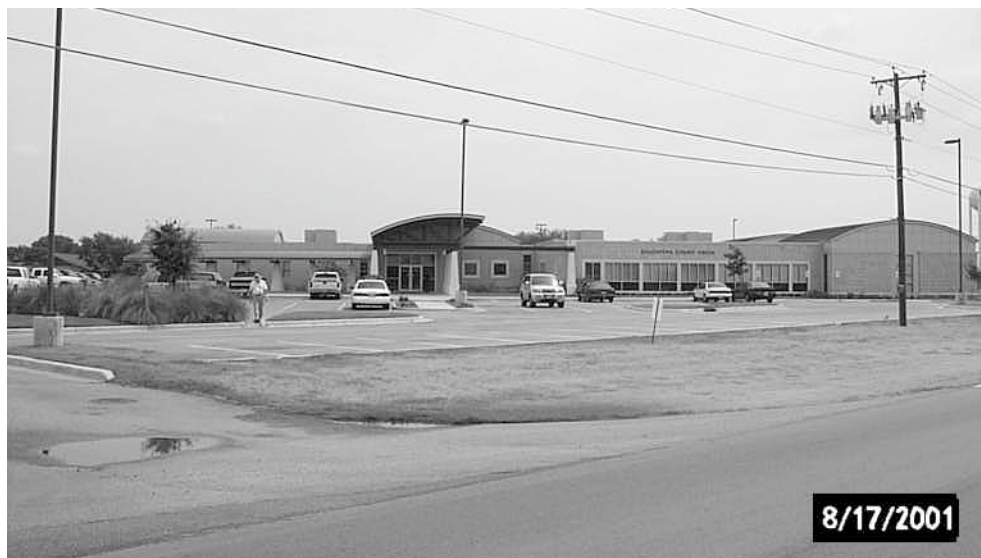
Figure 3. Front elevation of structure.

Weep holes: In the specifications, weep holes were specified to be spaced at 24" on-center. This differed with the Architectural Plans, which specified weep holes at 48" on-center. The actual number of weep holes at the structure perimeter was less than either of these requirements and was in fact only 29% of the weep holes required in the specifications. Also, of the weep holes that were present, approximately 63% were blocked with mortar from the wall cavity. Therefore, considering the unblocked weep holes only, the weep capacity of the wall system was about 11% of the amount specified.

Masonry veneers, such as the veneer in this case study, are not intended to be waterproof and require cavity drainage for moisture which penetrates to the back side of the veneer. Weep holes are therefore necessary in cavity wall construction to allow water to escape the cavity.

Mortar Blockage: The observation of blocked weep holes indicate a likelihood of mortar droppings in the wall cavity. The presence of mortar droppings and blockage of weep holes create a condition whereby the wall cavity cannot drain or ventilate properly. This condition is conducive to water damage at the interior building materials (Beall, 1993). For susceptible building materials, this condition is therefore conducive to fungal growth at the interior.

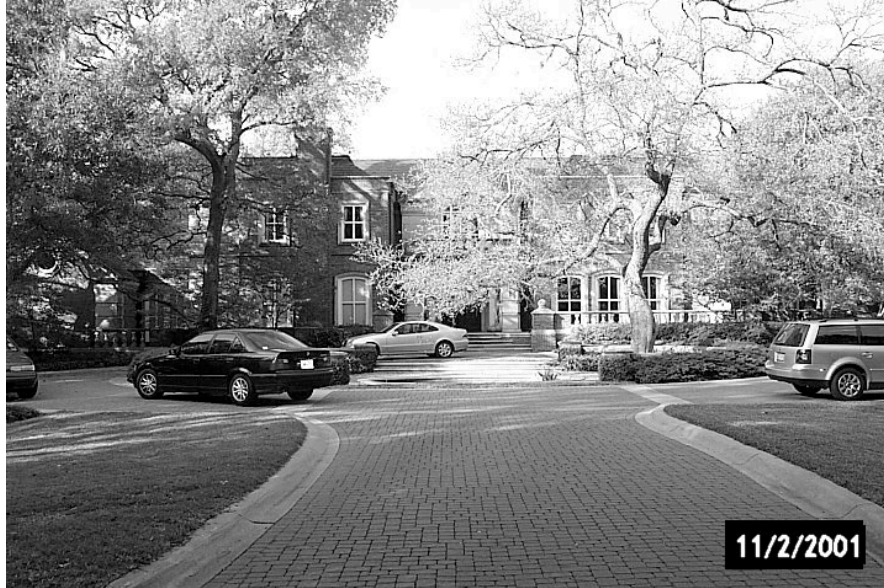
Figure 5. Front view of residence.

Case Study Background: The homeowners reported visible mold at various locations throughout the residence. During a visual assessment, possible fungal growth was observed in the wine cellar, at the kitchen ceiling, in a bedroom, the game room, the family room, the garage, at several supply air vents and at the crawl space. No direct crawl space ventilation was provided for this structure.

Water Intrusion: Several areas of water intrusion into the structure were identified. Additionally, the exterior brick veneer had no visible weep hole locations. As noted in the previous case study, a lack of weep holes does not allow for adequate drainage of the wall cavity, causing water to be trapped in the cavity and to possibly penetrate the building materials at the inside cavity surface. In general, it is recommended that weep holes be spaced at 24" on-center (Beall, 1993).

Many of the doors and windows show evidence of water penetration and damage. The flashing and sealing at doors and windows was generally poor. Several roof leaks were also apparent. Leaks at the roof were caused by missing and displaced slate tile (roof tile) and high-maintenance details at the roof, causing trapped water and flashing joint separations. Leakage through the roof eave vents was also evident.
