## **Hail Evaluation of Bituminous Roofing Membranes: Understanding Interply Mopping Voids**

### **Abstract**

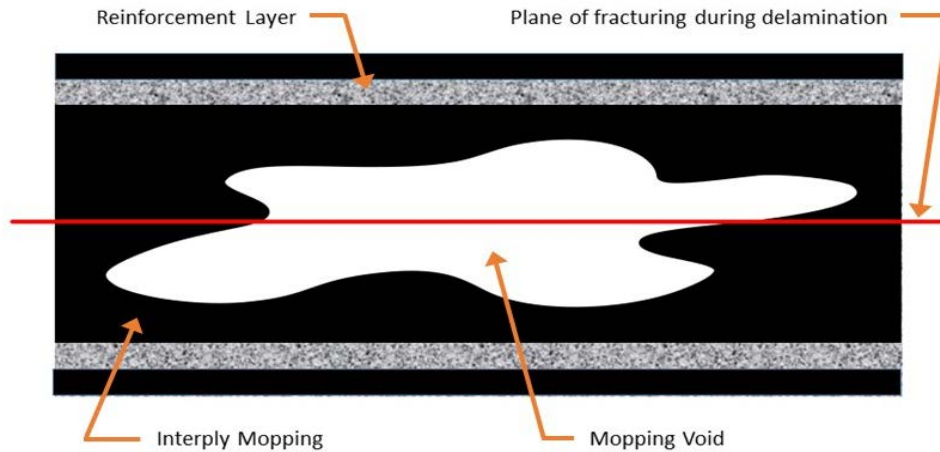
Mopping voids have distinctive features that can be easily identified after delamination. Delamination of membrane plies provides a detailed view of any mopping voids between those plies. A schematic magnified example of an interply mopping void between two membrane plies, shown in cross-section, is provided in **Figure 1**. To help visualize how delamination provides a view of a mopping void, the figure also shows a representation of where an interply mopping will typically split during delamination.

**Figure 1** – Schematic magnified view of a mopping void

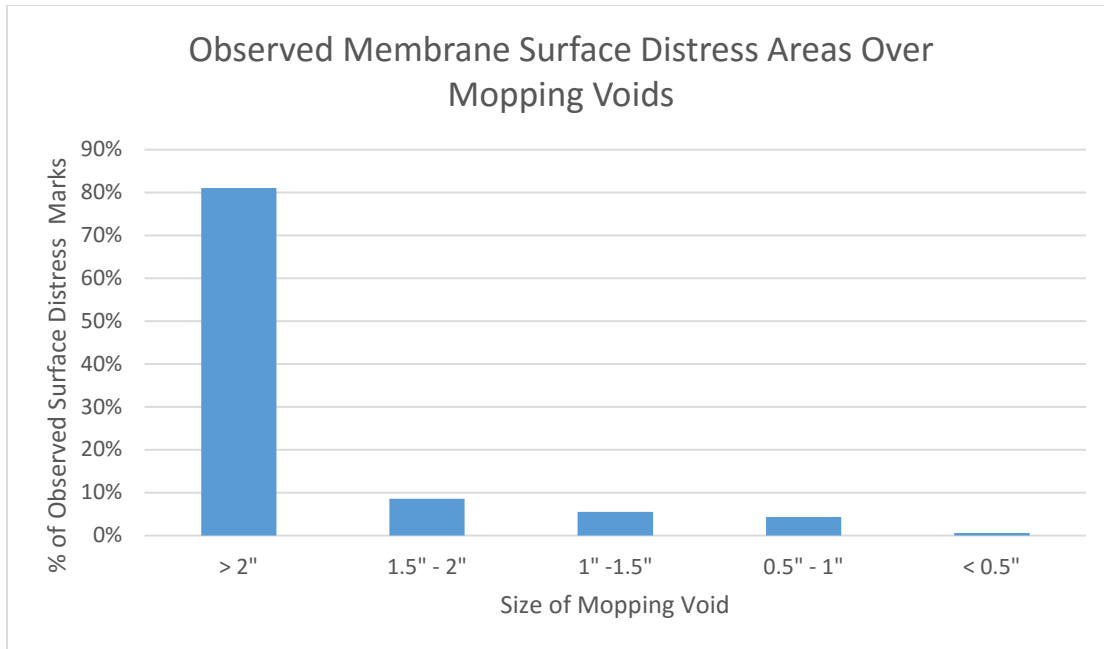
- *The Size of the Void:* The larger the void is, the more likely it is that a discrete area of surface distress will form over the void. **Figure 4** shows the relationship of void size to the presence of surface distress. When voids matched the location of surface distress, the void size was equivalent to 2" in diameter or larger approximately 81% of the time. The void was between 1-1/2" and 2" in diameter 8.6% of the time, between 1" and 1-1/2" in diameter 5.5% of the time, between 1/2" and 1" in diameter 4.3% of the time, and smaller than 1/2" in diameter 0.6% of the time.

**Figure 4** – Relationship of Membrane Surface Distress to Mopping Void Size
