## **Masonry Veneer Failure: A Case Study of Wall Tie Corrosion**

Erik L. Nelson, Ph.D., P.E., M.ASCE  
Deepak Ahuja, M.S., P.E., M.ASCE  
Peter Schönwetter, M.S., E.I.T., Assoc.M.ASCE<sup>1</sup>

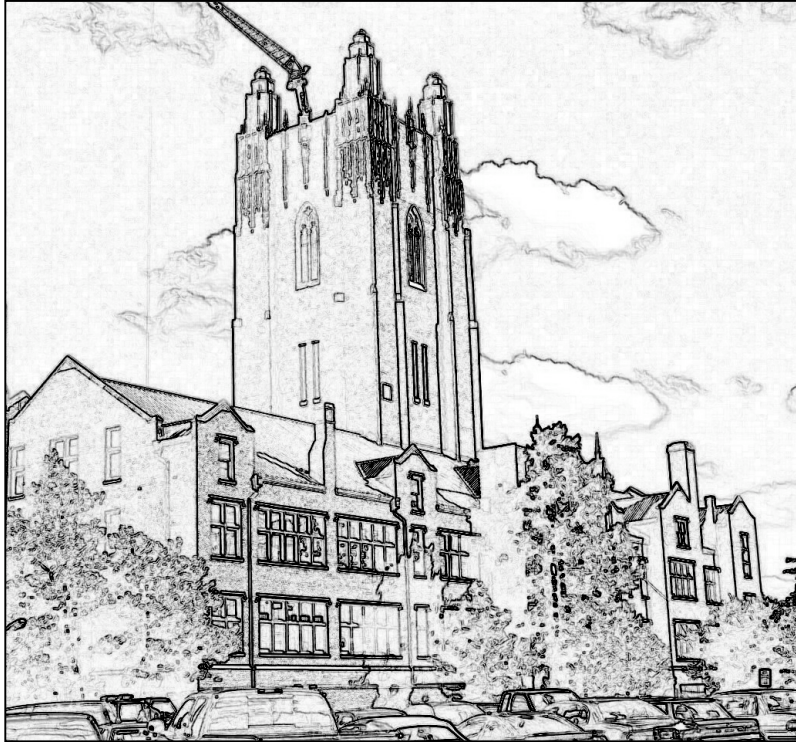
**Figure 1**

The Old Tower at Generic City College<sup>2</sup> is a 4-story administrative building with a 9-story tower centered on the East side (Figure 1). The building was constructed in 1922 and has been owned by the college since that time. The veneer is brick masonry with "university gothic" cast stone accents. Renovations to the interior and veneer were performed in 1992, but the majority of the original veneer and superstructure were retained. Previous repairs at portions of the brick veneer and many of the cast-stone decorative spires were reported and observed.
