Potential Pitfalls of a Green Building Material: A Case Study of Cellulose Insulation

CASE STUDY

Introduction

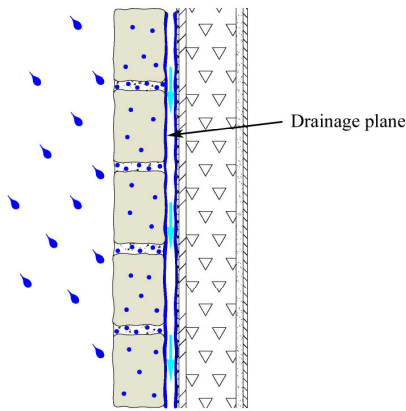
If the water cannot shed properly from and through the air space, it will collect in the air space, locally increasing the humidity inside the building envelope and eventually finding another path to escape the air space such as migrating towards the interior of the structure. **Figure 3(a)** illustrates a properly constructed cavity wall where moisture that has traveled through the porous veneer drains down the drainage plane within the air space to the exterior. **Figure 3(b)** illustrates a non-functioning air space filled with mortar. The moisture absorbed by the veneer migrates across the mortar by capillary suction and into the wood framing and insulation.

Figure 3(a). Properly constructed wall cavity

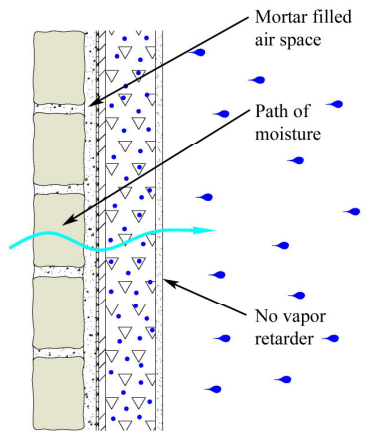
The mold growth on the interior wall surfaces was noted behind the finished hardwood and painted wood trim, but not at the exposed painted gypsum board walls. The relevant difference between the gypsum board and the enameled wood trim and varnished paneling is that the latex-painted gypsum board is vapor permeable, while the enamel-finished wood trim and varnish-finished plywood paneling act as vapor retarders.

Moisture was trapped at the back side of the varnished and enameled materials because these finishes are vapor retarders and prevent the wet cellulose insulation from drying to the inside of the structure. Moisture passed across the vapor permeable painted gypsum board surfaces. **Figure 4(a)** represents the walls with painted gypsum board finish. **Figure 4(b)** represents the walls covered with hardwood paneling and painted trim.

Figure 4(a). Moisture passes through wall
