Wright House, Wrong Peril A Case Study in Hail Damage to a Frank Lloyd Wright Residence

Erik L. Nelson, Ph.D., P.E., M. ASCE ¹

Abstract

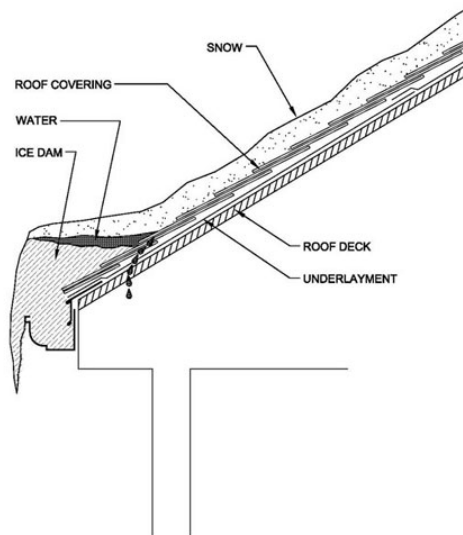
The homeowner's expert and former FLW apprentice honed in on an "ice dam" theory, attributing all of the water intrusion due to ice damming at the eaves as a result of the hail storm (**Figure 4**). The only problem with that was the temperature, which according to NOAA (Weather 2003) ranged from approximately 50°F to 80°F on April 5, 2003. Ice damming per the NRCA (NRCA 1996) typically only occurs for northern climates that experience average January temperatures of 30°F (Dallas' average temperature in January is approximately 43°F).

Figure 4. Ice Damming per NRCA (NRCA 1996)
