Analysis of a Fire Riser Failure below a Concrete Slab-on-Grade Foundation

T. Greenberg, B.S., P.E.¹ and T. Ebisch, M.S., P.E.²

ABSTRACT

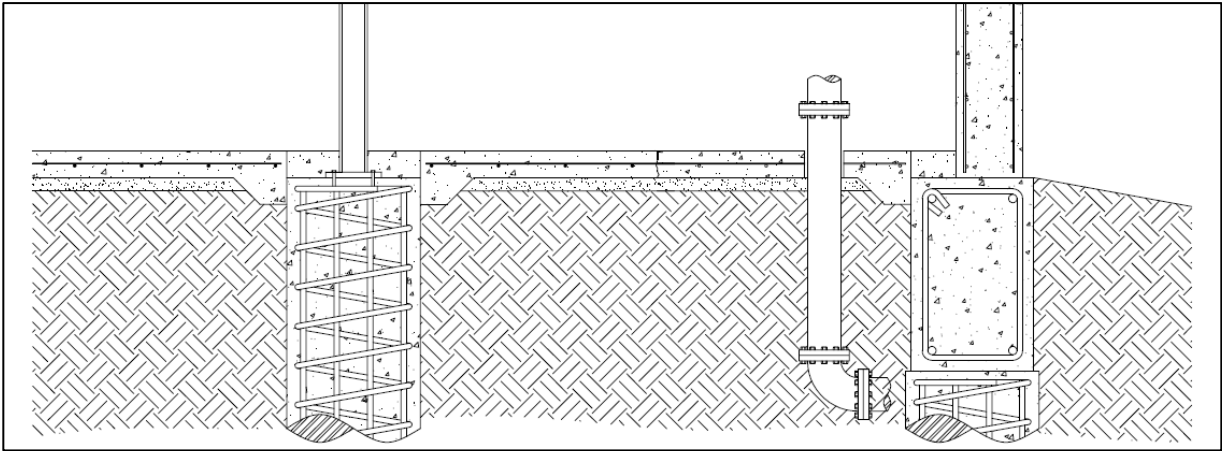
Figure 1: Representative view of a conventionally reinforced concrete (floating) slab-on-grade foundation prior to a fire riser rupture

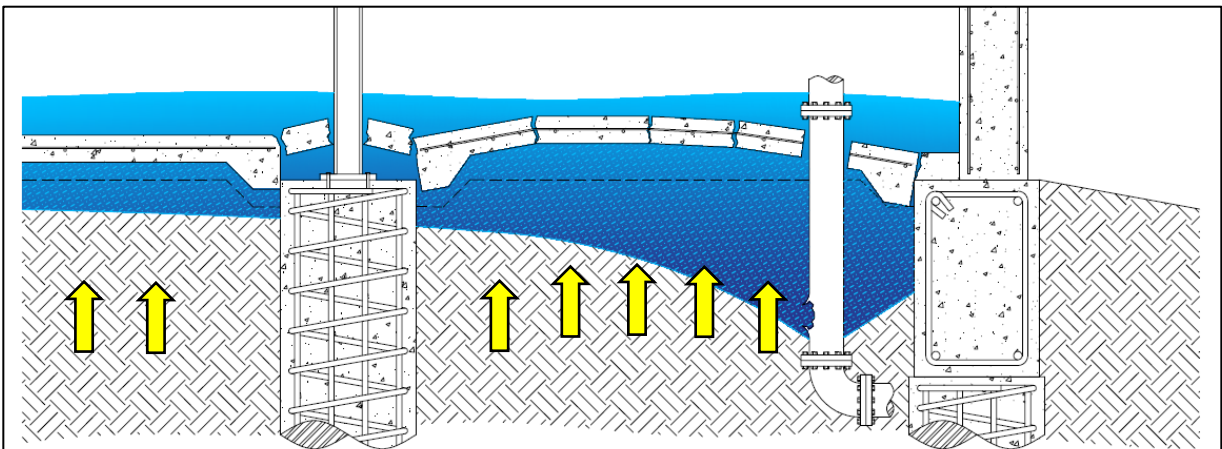
Figure 2: Representative view of the same foundation experiencing a net upward force (shown with yellow arrows) resulting from the fire riser rupture

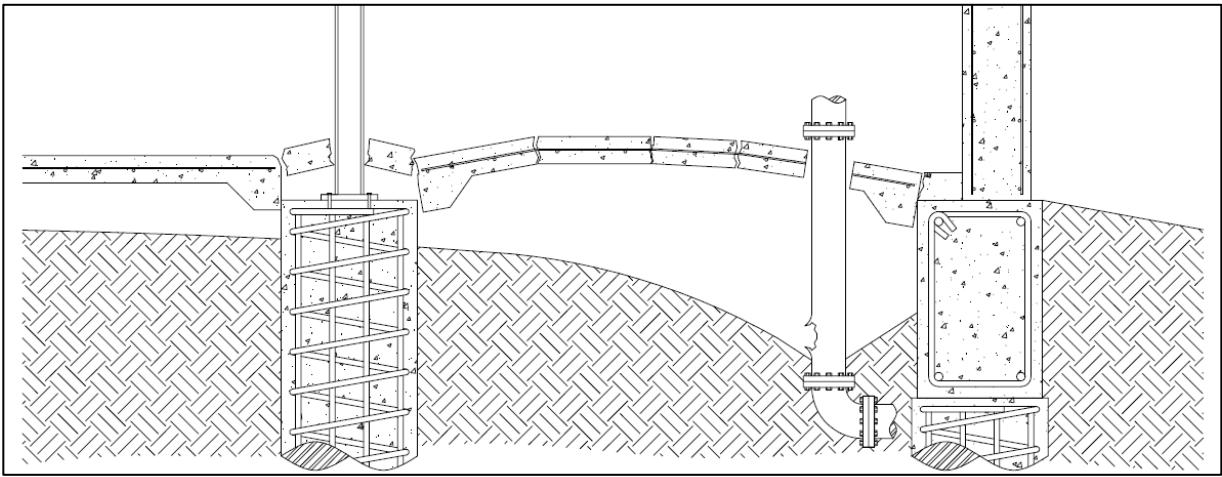
Figure 3: Consequential void underneath the displaced slab after the fire riser rupture

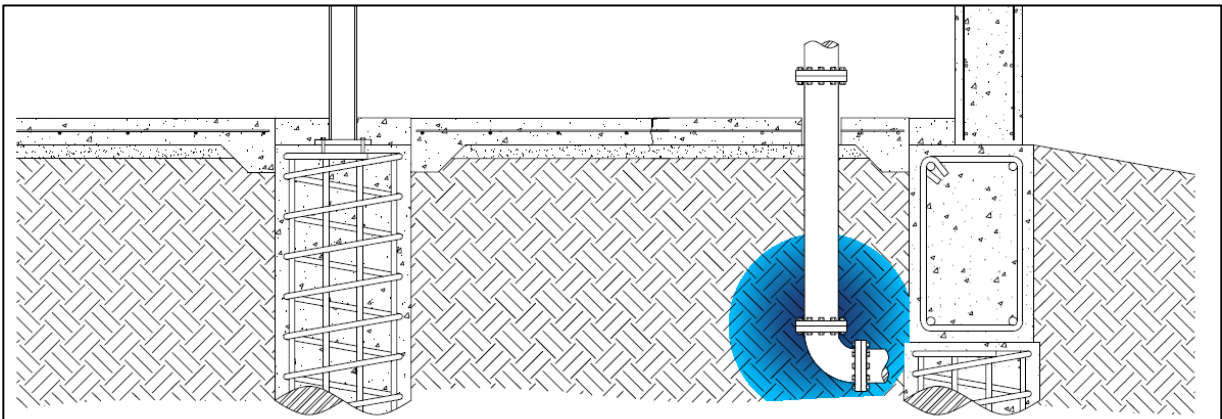
Figure 4: Immediately subsequent to a fire riser rupture, the surrounding clay soils with a low hydraulic conductivity begin to absorb the moisture

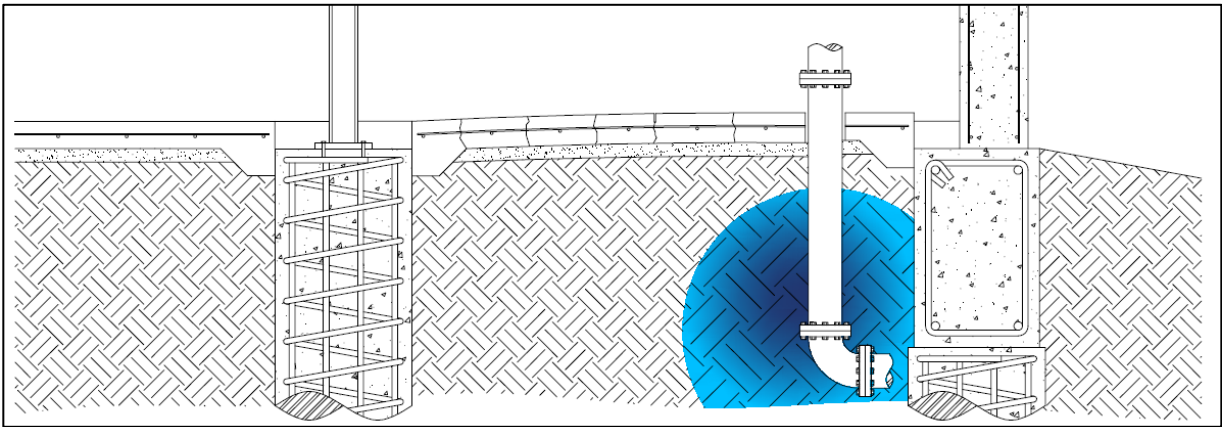
Figure 5: As time progresses, the surrounding soils expand from the excess moisture, resulting in minor damages to the slab
