Hail Impact Effects on the Wind Uplift Resistance of Fully Adhered Single-Ply Roof Membranes

Justin Donaldson, P.E., M. ASCE¹, Marco DeLeon, M.E., P.E., M. ASCE², and Kyle J. Savage, P.E.³

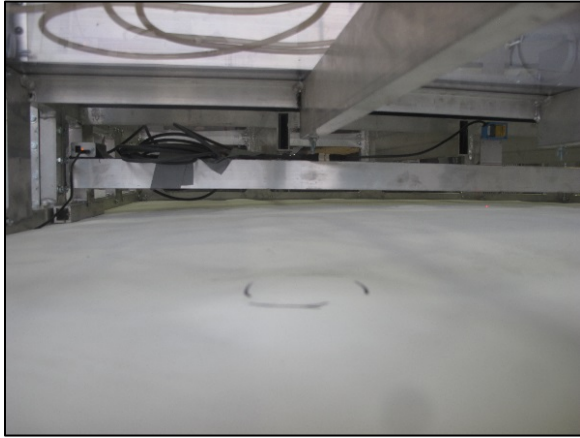
Figure 5: Membrane bubbling over insulation fastener locations at 105.0 psf

- ❑ As negative pressure was increased during the testing, the membrane would bubble over several of the insulation fastener plates (**Figure 5**).
- ❑ Membrane bubbles over fastener plates gradually increased in size with the increasing negative pressures, but typically remained stable during the pause at each pressure step. At negative pressures of 120 psf and greater, some areas of bubbling over fastener plates expanded into widespread areas of debonding and eventually became unstable resulting in continuous expansion under constant pressure and ultimate failure (**Figure 6**).

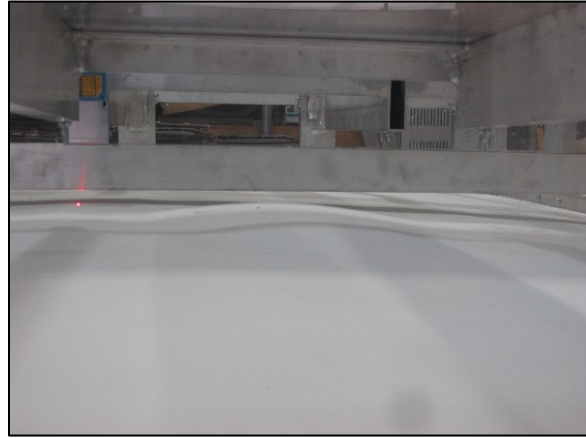
Figure 6: Expanding debonding area over a fastener location at 127.5 psf

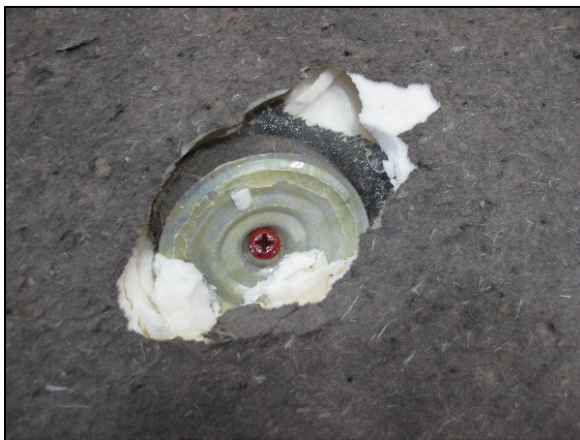
Figure 7: Polyiso insulation fractured at fastener

- ❑ The fastener plates nearest the center of the test area were typically deformed upward due to deflection of the polyiso insulation.
- ❑ During several of the tests, the polyiso insulation fractured or pulled through the fasteners nearest to the center of the test area (**Figure 7**).

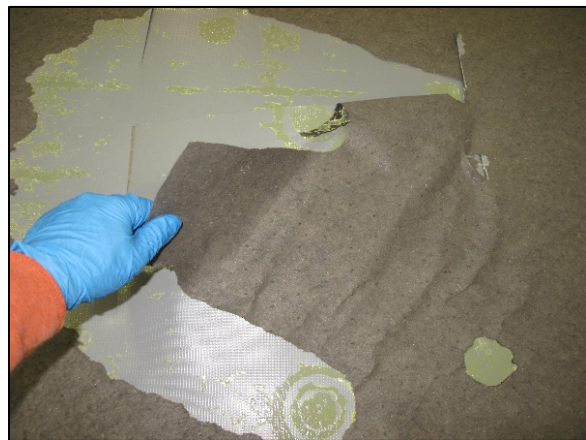
Figure 8: Underside of membrane at area where membrane separated from insulation

- At areas where the membrane was separated from the insulation, the failure did not always delaminate or tear the insulation facer from the polyiso core, but in multiple instances the insulation facer was wrinkled at an area where separation occurred (**Figure 8**).

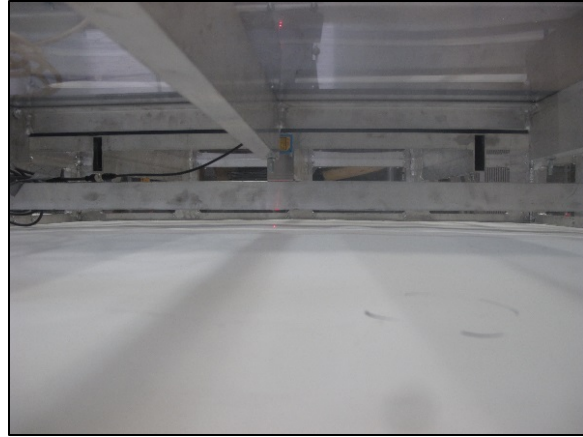
Figure 10: View across membrane for 5.0% debonded (1" diameter fractures) test at 97.5 psf uplift pressure

The referenced model structure represents a conservative exemplar building, which would have design pressures higher than or equal to the vast majority of structures in the United States that may utilize a fully adhered single-ply membrane roof system. This model structure has a 94 psf design uplift pressure for the roof's highest wind pressure zones. Therefore, the performance of the test mock-ups up to the 97.5 psf pressure step is a good indicator of the influence of the tested debonding scenarios within typical design conditions. None of the test mock-ups exhibited bond failure between the membrane and polyiso insulation at or below this step (**Figure 9** and **Figure 10**).
