Benefits of Evaluating Interply Bitumen in Bituminous Roofing Membrane Samples in Assessments of Hail Impact Distress

Justin Donaldson, P.E., M. ASCE¹
Marco DeLeon, M.E., P.E., M. ASCE²
Garrett Simpson, E.I.T.³

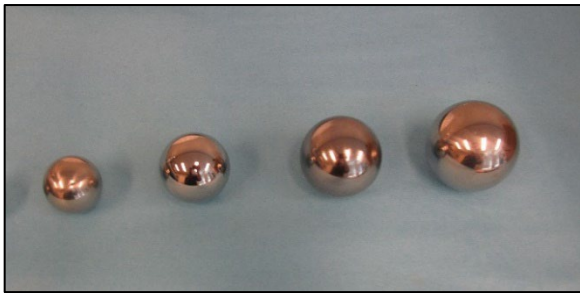
Figure 1: Steel balls used as impact strikers

Steel ball drops can be used as a way of simulating hailstone impacts. Underwriters Laboratory (UL) Test Standard 2218 is an example of a test standard that utilizes steel ball drops. Consistent with UL-2218, four different sized steel ball projectiles were used in this experiment: 1.25" [31.8 mm], 1.50" [38.1 mm], 1.75" [44.5 mm], and 2.00" [50.8 mm] (**Figure 1**).

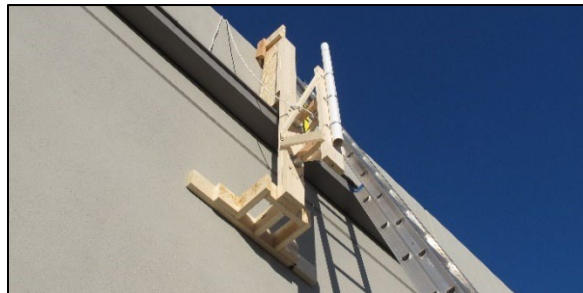
Figure 2: Dropping apparatus, setup for a 20' [6.1 m] drop height

The BUR membrane samples were systematically impacted by the aforementioned steel balls. The balls individually impacted the samples by free falling from a targeting apparatus. This apparatus was similar to that described in ASTM D7052/D7052M - 17, "*Standard Test Method for Determining Impact Resistance of New Low Slope Roof Membranes Using Steel Balls*". The apparatus generally consisted of a tube affixed above, and perpendicular to, a test sample (**Figure 2**). The tube length was approximately 59". A pin in the tube allowed for a ball to be loaded into the top of the tube and then released in a controlled manner. For this experiment, two separate tubes were used: a 2.00" [50.8 mm] diameter smooth PVC pipe for dropping the two larger ball sizes and a 1.50" [38.1 mm] diameter smooth PVC pipe for dropping the two smaller ball sizes. The tubes could be lowered or raised along the apparatus frame to adjust the drop height for each different size of ball.

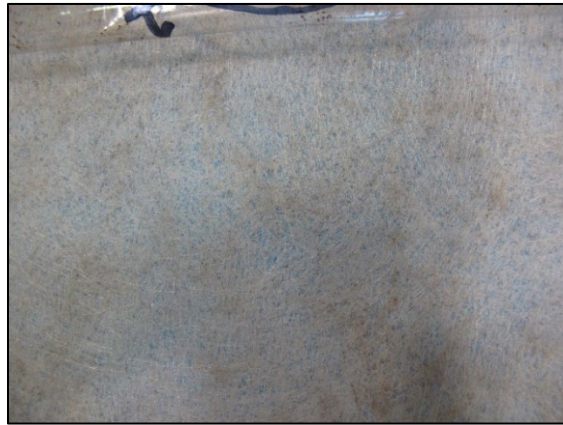
Figure 6: Same felt ply and location as shown in Figure 5, after desaturation

After desaturation, no bitumen disturbances could be identified as the bitumen component had been dissolved and removed from the plies. Additionally, there were no corresponding disturbances of the felt plies that specifically mimicked the locations/extents of the previously observed bitumen disturbances (i.e., there was no evident transmission or translation of the full bitumen disturbance to the felt ply reinforcement). Felt ply ruptures were observed at several of the impacts. However, for every impact that resulted in felt ply ruptures, the ruptures were first observed while the membrane was in its delaminated state, meaning desaturation was not necessary to find that ruptures had occurred.

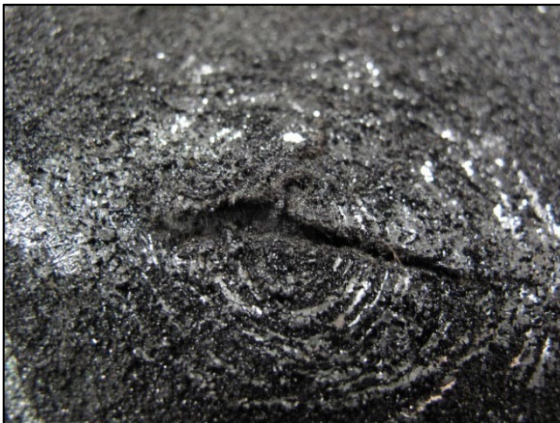
Figure 7: Interply bitumen disturbance with felt ply rupture evident, from impact F-2 (light pressure applied from below)

The authors also observed that ply ruptures were evident at several of the impacts (**Figure 5** and **Figure 7**). Similar to the bitumen disturbances, the likelihood of a ply rupture being present, and the sizes of such ruptures, increased with increasing steel ball sizes. In all cases where a ply rupture occurred, a bitumen disturbance was also present; however, not all bitumen disturbances coincided with a ply rupture. The ply ruptures occurred as linear, arc-shaped, or multi-legged fractures and extended through, or immediately adjacent to, the center of the impact disturbances. In no situation did an impact cause a distinct oblong or circular hole through a felt ply. While the ply ruptures were typically evident from visual evaluation alone, application of light pressure at the rupture made them more visible and easier to photograph (**Figure 7**).

The impact disturbances to the interply bitumen were visually distinctive, which is generally consistent with the authors' experiences with samples evaluated as part of actual hail-damage investigations. This allows for a straight-forward visual evaluation of the sample. The distinct visual evidence in the bitumen also focused the evaluator's attention to the specific impact location on the plies, where targeted supplementary tactile evaluation could then be used. In contrast, the evaluation of the desaturated felts proved to be a more difficult visual task. While in the delaminated state, ply ruptures contrasted with the immediately surrounding bitumen, providing a visual clue of their presence. However, this contrast was lost from desaturation, making strict visual identification of the ruptures more difficult after desaturation (**Figure 5** and **Figure 6**). The loss of visual cues in the bitumen also necessitated a more tactile approach to evaluation of the desaturated felts, which was more tedious than the straight-forward visual evaluation of the delaminated plies. In either state, application of light tactile pressure at a rupture made it easier to identify and photograph (**Figure 7** and **Figure 8**).

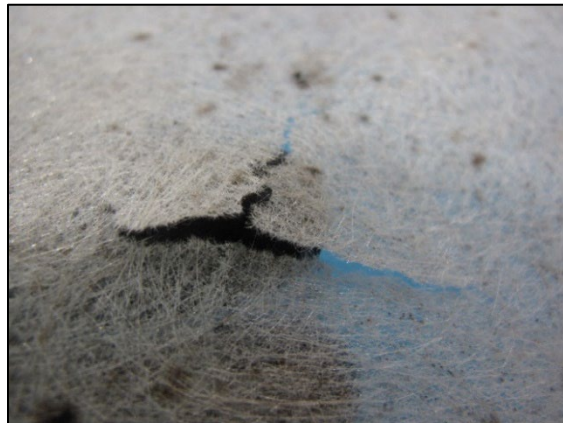
Figure 8: Same felt ply and location as shown in Figure 7, after desaturation (light pressure applied from below)

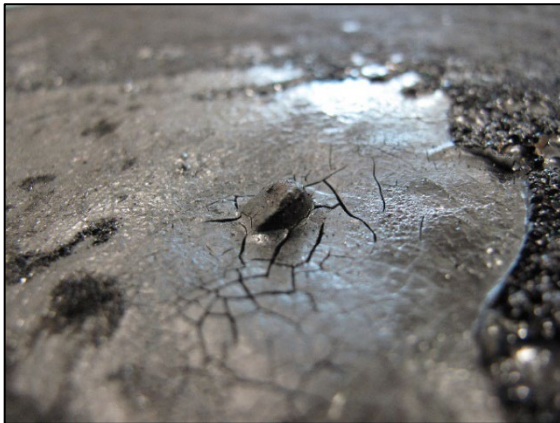
Figure 10: Small rock trapped between a sample's membrane plies, from an actual hail-damage investigation

Impact disturbances are not the only bitumen conditions lost during desaturation testing, as-built conditions within the bitumen are lost as well. This can result in improper identification of felt ply distress. For example, large as-built mopping voids may exist. Previous research has indicated that mopping voids can result in the development of localized membrane surface distress that may be mistaken for hail-impact damage (Donaldson, et.al 2015). Other evidence lost during desaturation can include small debris items (e.g., rocks) that were trapped between membrane plies during installation. The authors have encountered both voids and trapped debris in numerous samples from actual hail-damage investigations. In cases of trapped debris, the debris can be plainly seen in a delaminated state but may fall out of the sample during desaturation when it disengages from the dissolved bitumen that had previously encased it. If an entrapped piece of debris had damaged a felt ply due to its mere presence, then that damage would be seen after desaturation without the full context of the actual cause (**Figure 10** and **Figure 11**).

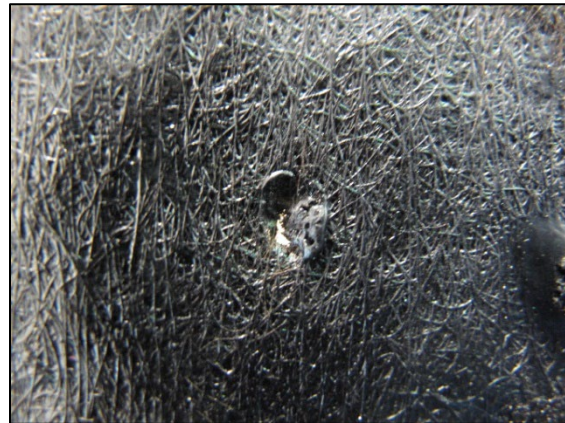
Figure 11: Adjacent felt ply indented and ruptured from the entrapped rock shown in Figure 10 (not consistent with impact)
